Detection and Sizing of Baffle Plate Erosion and Fretting using Eddy Current Array Technology

Abstract

The paper describes the evaluation of current state of the art Eddy Current Array (ECA) technology used for the detection and sizing of heat exchanger tube baffle plate erosion and fretting type defects. For validation purposes, all defects were also subject to Internal Rotary Inspection System (IRIS) ultrasonic evaluation. Results of the study indicate that a probability of detection (POD) figure of 84.6% is achievable for the ECA method with a probability of sizing (POS) mean measurement error of approximately +6.9% when compared to the IRIS sizing results.

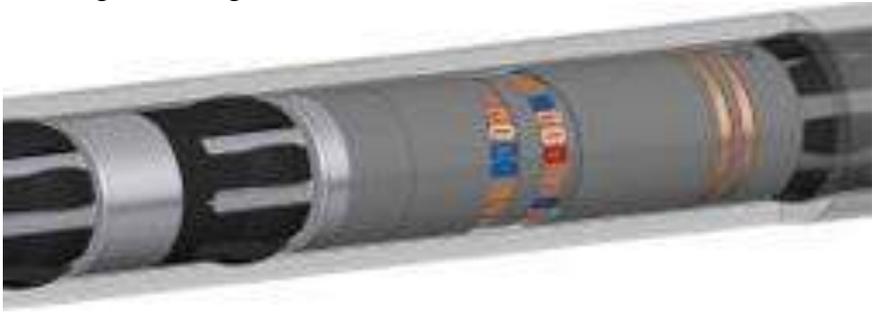
Figure 1 DefHi Eddy Current Probe Configuration

ECA technology uses several individual coils, grouped together into one probe. To minimise cross-talk due to mutual inductance, individual coils are multiplexed, allowing the coils to work together. Internal diameter ECA probes used for tube inspection can have their coils organised in such a way as to completely sweep the interior circumference of each tube. The probe used in this study is the DefHi probe [2] supplied by EddyFi with coils configured in transmit-receive arrangement as illustrated in figure 1.

With this coil configuration, eddy currents induced in the tube wall flow perpendicular to any circumferential defects encountered, and therefore making them easier to identify and undertake estimates of circumferential length and position. A typical display for a detected defect using this configuration is given in figure 2.

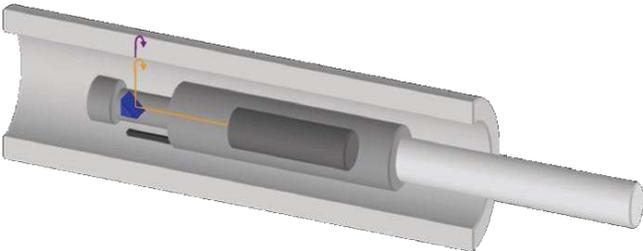
Figure 3 IRIS transducer principles [3]

The IRIS system utilises an ultrasonic transducer along with a water pressure powered turbine driven rotating mirror, to allow for through wall wave propagation, as illustrated in figure 3.

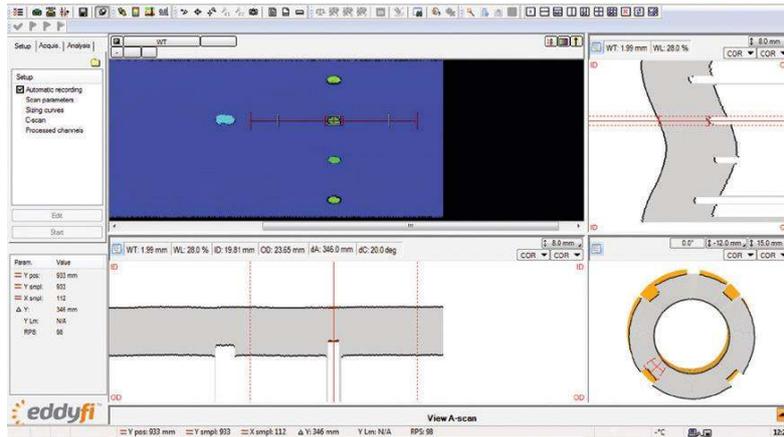
Figure 4 IRIS Data Display

A typical IRIS data display is given in figure 4, where it can be seen that inner and outer wall reflections are used to provide a cross sectional circumferential display of tube wall thickness.

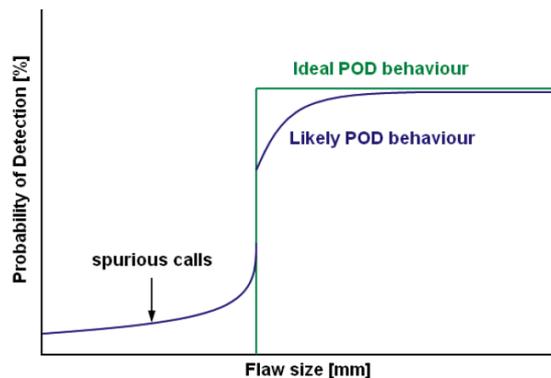
Figure 5 Ideal and likely POD Curve

POD analysis is carried out on Hit/Miss data and can be visualised in the form of a POD curve. A POD curve estimates the capacity of an inspection technique to detect defects with respect to discontinuity feature. This could include parameters such as depth, length, orientation etc. For an ideal technique, the POD for flaws smaller than an established critical size would be zero. Whereas, discontinuities greater than this critical size would have a POD equal to 1, or 100% of probability of detection. In practise such ideal techniques do not exist, resulting in POD curves not having this ideal behaviour. Figure 5 illustrates a real and ideal POD curve [5].

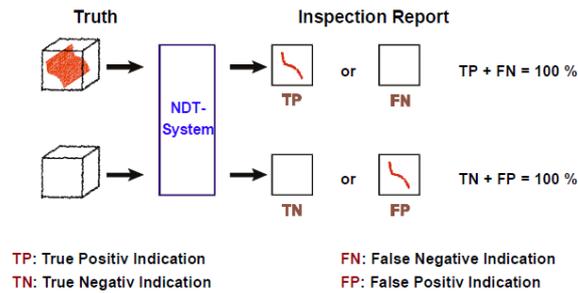
Figure 6 The four possible outputs for an NDT result

With regards the assessment of the reliability of an inspection process, it is possible to extend the POD method to incorporate the four possible outcomes for a testing result, as indicated in figure 6.

These four possible outputs can then be combined to produce POD and Probability of False Alarm (POFA) figures for the inspection method and used to create performance points on a receiver operating characteristic (ROC) reliability surface [5]:

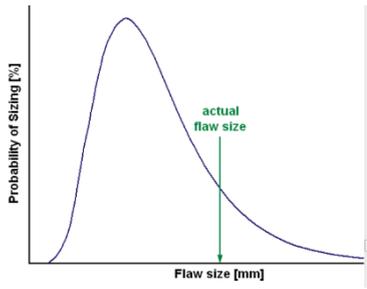
Figure 8 Typical sizing distribution

Probability of Sizing (POS) is a measure of an inspection method's ability to accurately size a defect. An example of a POS distribution for a typical flaw size is given in figure 8 [6]. In this illustration it can be seen that in this instance, the method or procedure used will generally under predict the actual defect size.

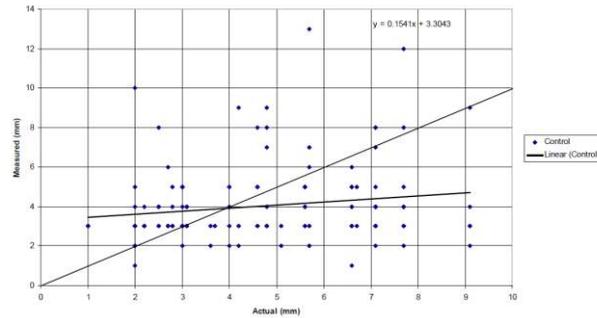
Figure 9 POS curve of estimated flaw size as a function of true flaw size

Extending this for a whole range of flaw size estimation and comparing them to their true size allows for the production of a POS curve comprising a full range of defect sizes used in the POD study, an example of which is given in figure 9 [7].

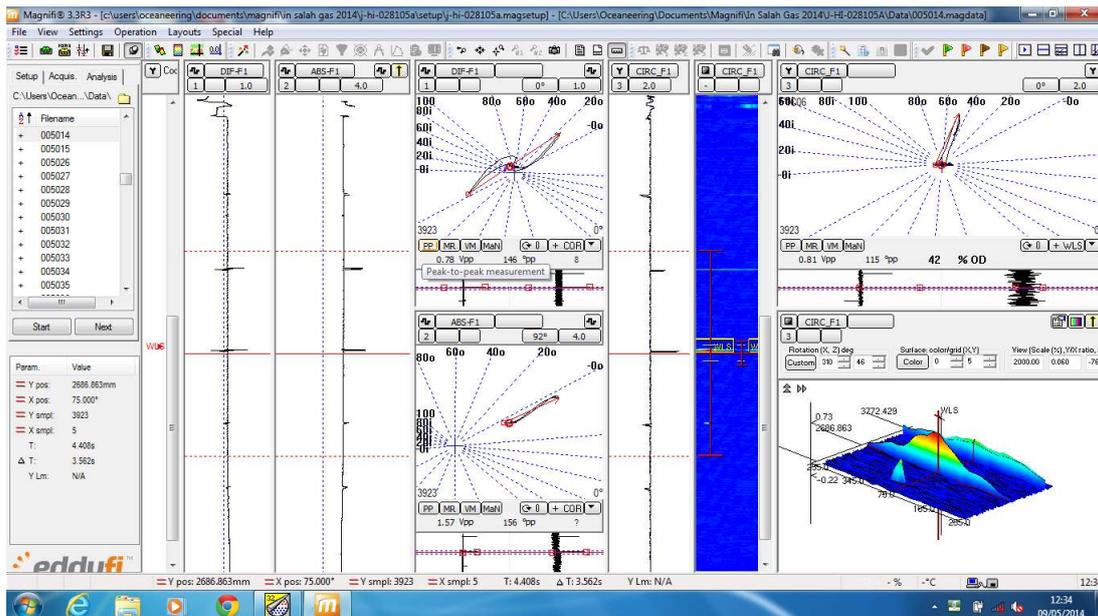
Figures 10 and 11 provide examples of both ECA and IRIS signatures for the same defect. In these examples it can be seen that, although the defects are detected in both instances, the ECA analysis is oversizing when compared to the IRIS analysis. Figure 12 is a photograph of typical fretting found during the evaluation.

Figure 10 Baffle Plate Fretting - Row 5 Tube 14 - ECA 42% Estimated Loss at BP 3

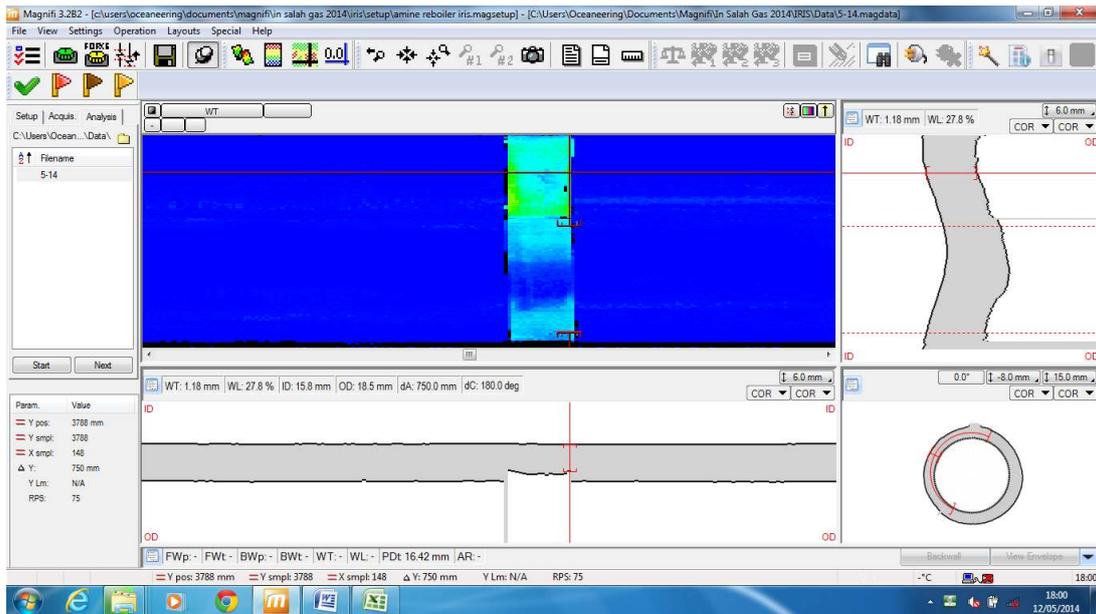
Figure 11 Baffle Plate Fretting - Row 5 Tube 14 - IRIS 28% Loss at BP3

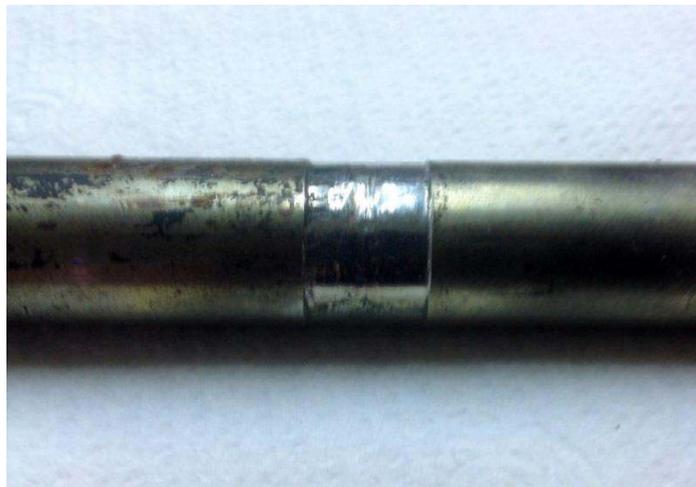
Figure 12 Typical Fretting

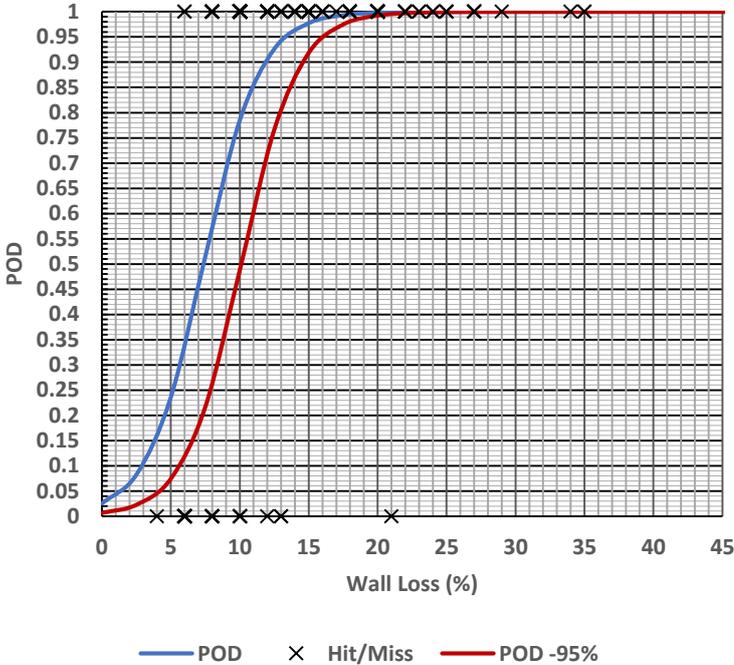
Figure 13 ECA POD Analysis

With regards defect detection and minimum wall loss detectable, a binary regression analysis was undertaken, using the IRIS results as a means of determining the presence of a defect to carry out a Hit/Miss comparison. The results of this analysis are given in figure 13, where the Hit/Miss, POD and -95% curves are given. From this analysis it can be stated that the ECA method, as applied in this study results in a 90% probability of detecting wall loss (A_{90}) in excess of approximately 10%. Extending this to include a lower 95% confidence limit ($A_{90/95}$) increases this slightly too approximately 14.5%.

In summary, overall a probability of detection of figure of 84.6% for the ECA method when used to detect baffle plate erosion and fretting type defects. In addition, it was also found that defects of this type in excess of 10% wall loss could be detected with a 90% probability of detection.

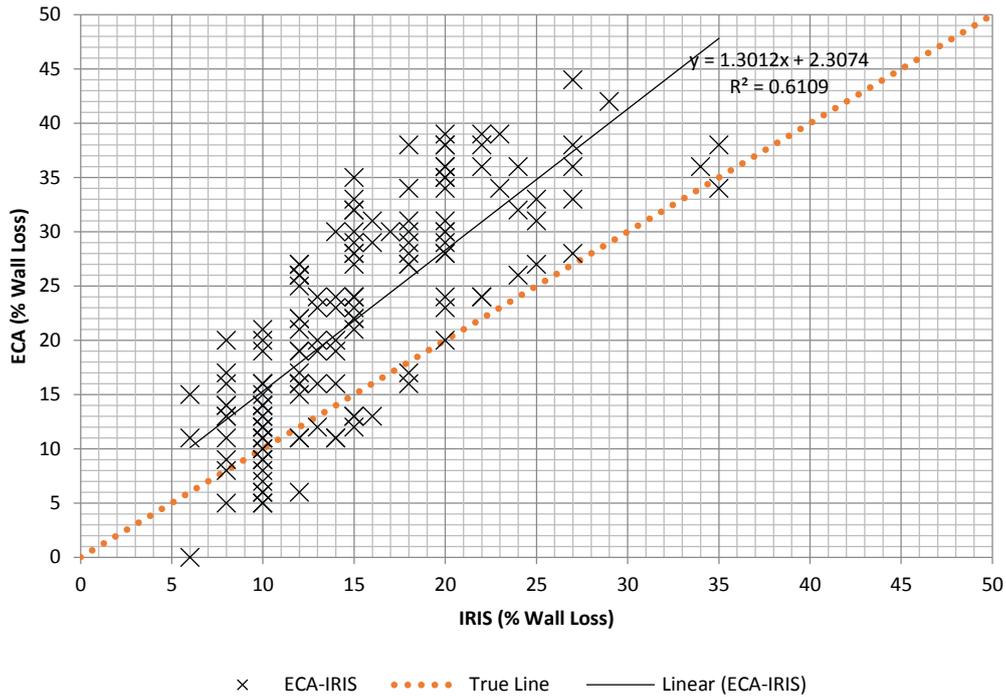
Figure 14 POS Plot - ECA flaw size as a function of IRIS flaw size

To determine the relative sizing accuracy for the ECA method a POS has been performed. As the actual true flaw sizes aren't known directly the evaluation is performed comparing ECA size estimates to sizes resulting from IRIS analysis of detected defects. The resulting scatter plot given below in figure 14, provides a direct comparison of the two sizing estimates obtained from the two NDT methods.

A linear trend line has also been added to the plot, along with the resulting equation. The trend illustrates both a positive system offset along with a gradient greater than 1, indicating that the ECA method generally oversized detected defects when compared to size estimates resulting from application of the IRIS method. This trend of oversizing generally increases as a function of defect size. This can be further illustrated if the distribution of sizing errors for discrete flaw sizes is analysed. To this end, ECA sizing error distributions for defects indicating IRIS size estimates of 10%, 15%, and 20% have been developed. These are given in figure 15, below.

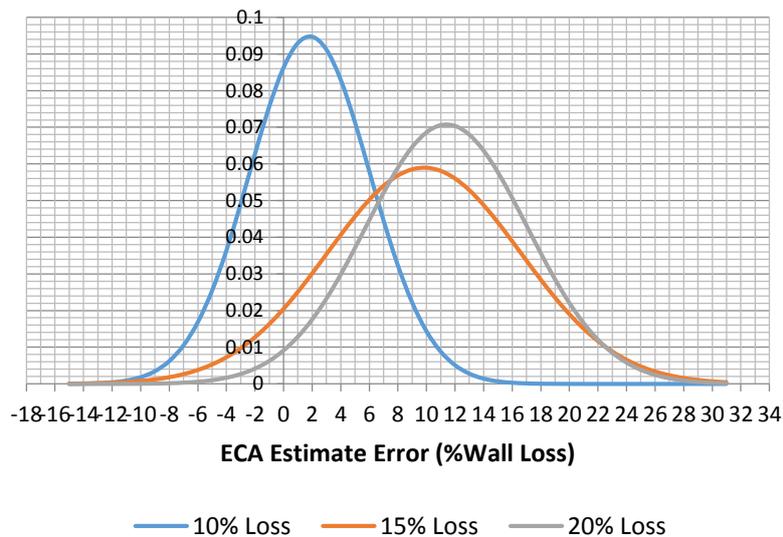
Figure 15 Sizing Error Distributions for 10%, 15% and 20% Wall Loss Defects

As indicated in the figure, we can see that the mean sizing error increases as a function of defect severity, from approx. 4.2% for 10% wall loss to approximately 11.4% for 20% wall loss defects.

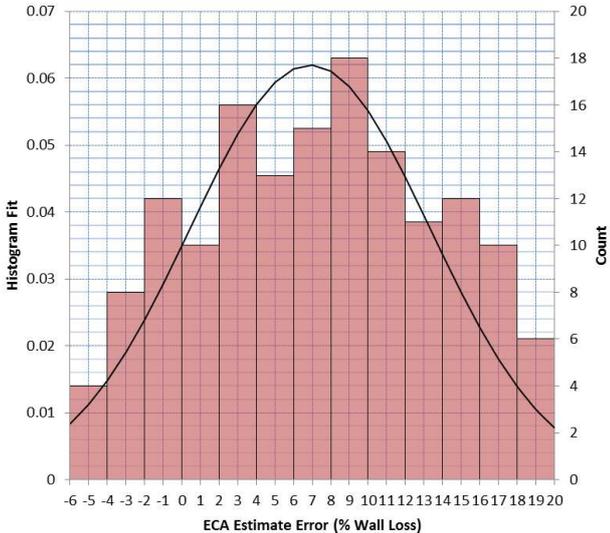
Figure 16 Distribution of ECA Measurement Errors

To provide an overall estimate of sizing accuracy and dispersion, summary statistics and the distribution of sizing measurement errors (ECA-IRIS defect size estimates) were produced. These results are given in table 2 and figure 16 below.

From these results it can be stated that the mean ECA measurement error when compared to the IRIS estimated defect size is approximately +6.9% with a standard error of approximately 0.53%.
