# Ultrasonic Evaluation of Artificial Kissing Bonds in CFRP Composites

The primary aim of this paper is to create artificial inter-laminar kissing bond-like defects in CFRP panels for ultrasonic inspection. Carbon fibre reinforced polymer structures pose a unique problem, as unlike metal-to-metal bonds (single bond line) carbon fibre reinforced polymer composites have multiple bond lines (between each laminate layer and between the individual carbon fibre bundles). This increases the number of locations for kissing bonds and other defects to lie. Published works look at bonding defects in joints (lap joints, and solid-solid bonding). This paper looks at inter-laminar bonding. A number of samples are created and attempts are then made to detect these kissing bonds using ultrasonic techniques. Further investigation into contaminants for artificial defect creation is advised and destructive verification of the kissing bond samples is still required.

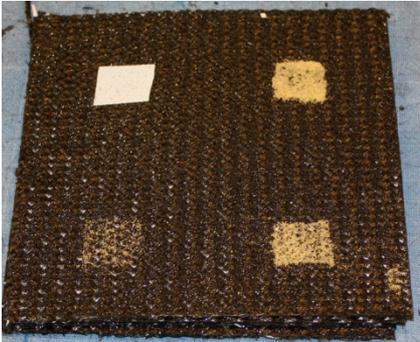
Figure 2 ~ Sand Contamination

A Clean Sample was created to record baseline setting for comparison. Using an identical layup procedure, samples were then created with a PTFE delamination reference and various levels of inserted contaminants (680 heavy weight oil, Frekote release agent, baking powder, sand and wax). Following the curing process, a visual examination of the panels was carried out, revealing the oil and wax samples to have released much of the inserted contaminant, and thus failing to create the kissing bonds.

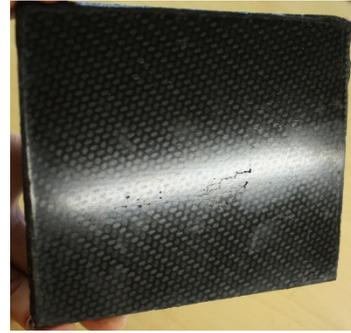
Figure 4~ Failed Oil Sample

The visual inspection revealed noticeable defects in sample 002 and 006. These are the oil and wax (liquid) contaminants. This was disappointing as it meant that two of the five contaminants had failed before any ultrasonic inspection had taken place. The ultrasonic immersion testing then revealed the first of the dry contaminants (baking powder) to be visible to conventional ultrasound, leaving only two samples in the running. Whilst it is disappointing to lose the potential kissing bonds (as a considerable amount of work had gone into their creation), it is equally important to know which contaminants do not work for kissing bond synthesis. The visual testing and immersion tank ultrasound testing did not conclusively prove that liquid contaminants could not be used to produce artificial inter-laminar kissing bonds. It simply proved that the liquids used (and their quantities) were not suitable for this type kissing bond production.

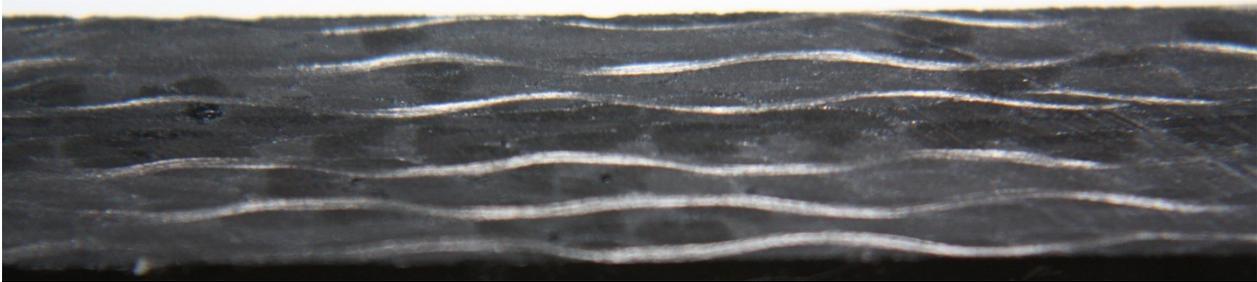
Figure 9 shows the cross section of sample 002. As you can see, the oil has spread out of its implanted region, and migrated through the multiple layers of the composite. Small pockets of liquid still exist (dark spots), and are slowly releasing the remaining liquid, making the oil more visible. It can be difficult to see as photographing dark patches on a black surface allows for little contrast. A close up of the area can be seen in Figure 10.

Figure 10 ~ Section 002 D4 Close Up

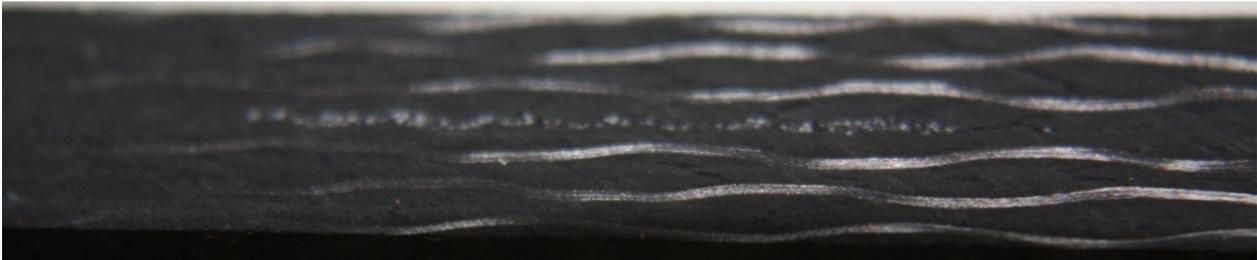
Sample 005 was then sectioned (Figure 12). The inserted contamination is more visible at D2 than in D4. This is in line with the levels of inserted contaminant. Figure 13 shows a close up of the sand contaminations, showing areas of constant sand. Although no attempt has been made to quantify the change in bond strength, due to a lack of test equipment, the strength of sand is significantly less than that of epoxy, and so should fail at greatly reduced loads.

Figure 13 ~ Section 005 D2 Close Up
