A critical investigation of the use of infrared thermography
in determining the condition of composite materials

Submitted in partial fulfilment for the award of the degree of
Doctor of Philosophy

University of Wales Trinity Saint David

2017

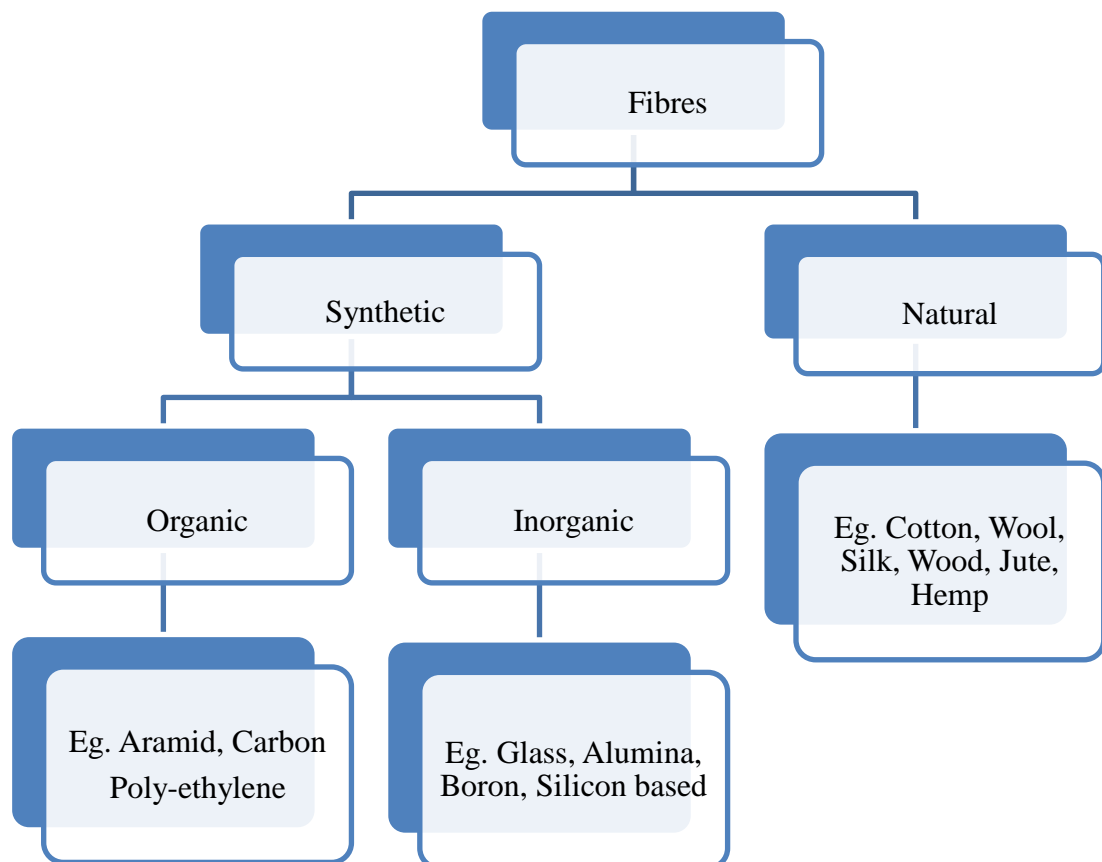
For the design of fibre composite material, it is important to understand the fibre characteristics such as elastic modulus, strength and density so that the fibres could be arranged in a sequence to produce the desirable material properties. The following is a flow chart explaining the different types of fibres which form the reinforcements in the composite material.

Figure 1 Classification of Fibres (Matthews and Rawlings 1999, Chawla 2001)

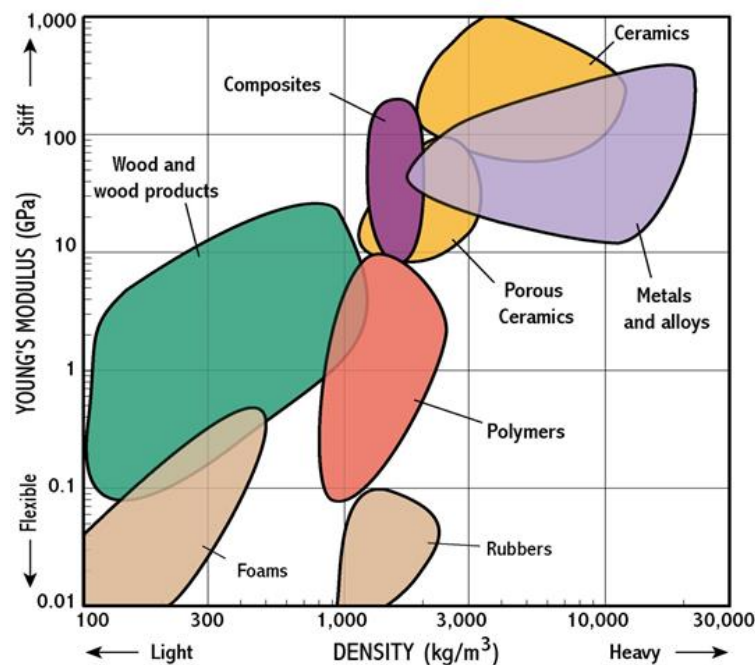
The following is a chart illustrating the various materials currently in use based on their Young's modulus and density.

Figure 2 Material Selection Chart classifying various material systems based on Young's modulus and density. Source: Cambridge University (University)

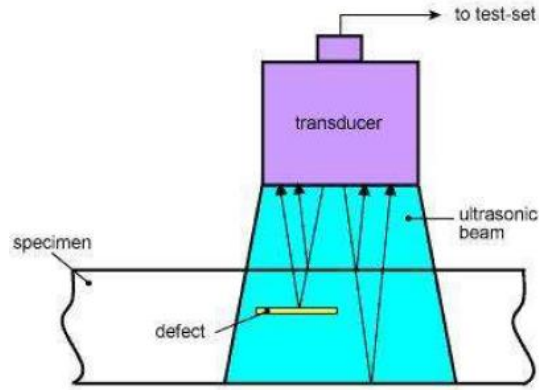
With the establishment of pulse-echo immersion ultrasonic testing (PEUT) as an NDT technique, PMC materials are being inspected by this method increasingly. In this method both the part and the transducer are immersed in water. The transducer is

positioned above the component to be inspected and an ultrasound pulse is applied to the sample. The direction of the ultrasound in this case is normal to the surface of the component.

Figure 4 Set-up of Ultrasonic Testing (Kapadia 2013)

It can be seen from the above figure (Figure 4) that the ultrasound travels through the material until it hits the boundary and reflects back. Now it can be seen that the reflection could be from the back-wall of the component and also from the boundary of the defect whichever occurs first along the path of the ultrasound. Based on the time taken for the reflected wave to the probe, the defect is identified and then measured. The test takes into account the delay due to travel of ultrasound in water and the distanced travelled in water is referred to as *waterpath*.

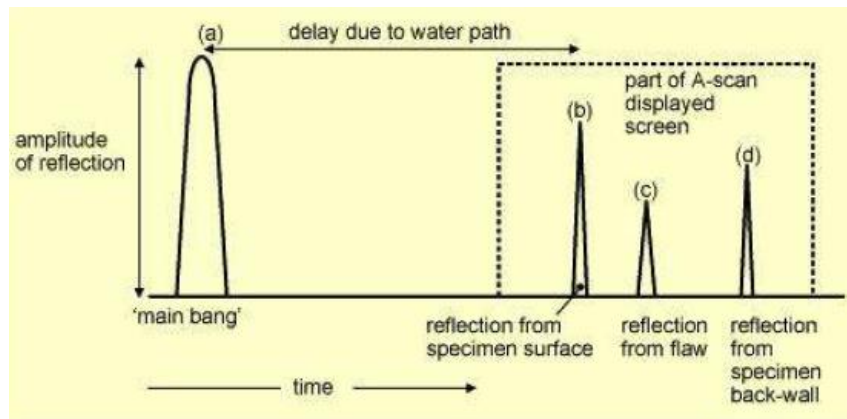
Figure 5 A-Scan from a typical Pulse-Echo UT test of CFRP Panel (Matthews and Rawlings 1999; Kapadia 2013)

- A – Scan: represents echoes of different features along the path of the ultrasound at a point. (See Figure 5 which shows main ultrasound impulse (a), surface of the component (b), defect (c), and back-wall of the component (d))
- B – Scan: the A-Scan obtained at each point is combined together to form a 2D ‘slice’ section through the inspected component. (See Figure 6)
- C – Scan: can be interpreted as a ‘Plan’ view of the component. (See Figure 6)

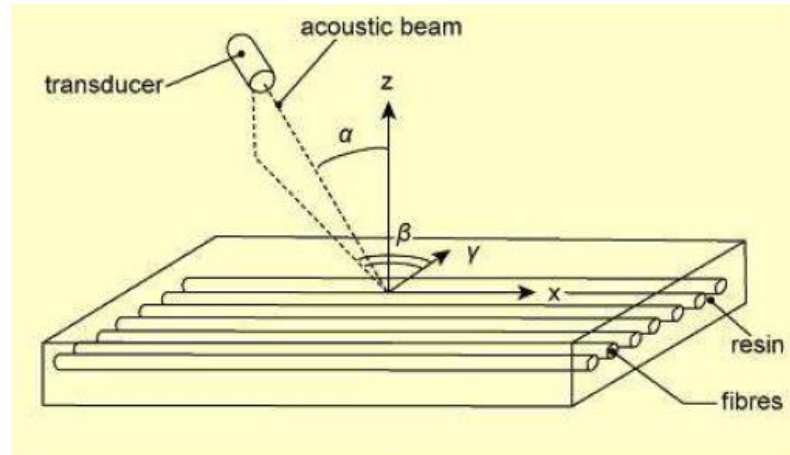
probe in the calculated inclined angle (α) and either the component or the transducer is rotated along the axis β normal to the surface of the part being inspected (See Figure 7 below). This technique is referred to as *Back-Scatter* technique (Matthews and Rawlings 1999; Kapadia 2013).

Figure 7 Set up of Back-scatter technique using Pulse-Echo (Kapadia 2013)

The back-scatter techniques can be used to inspect for defects such as porosity, fibre waviness and laminar cracks. This technique also helps to check the stacking sequence of the component.

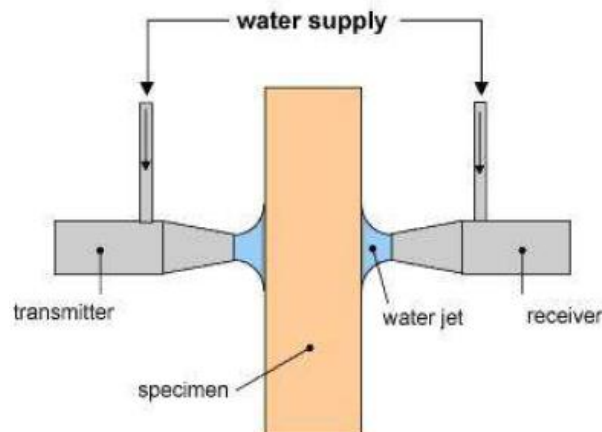
As the name suggests, two probes are used on opposite surfaces of the component where one probe transmits the ultrasound and the other receives the signal. This technique uses a water jet system where the water jet forms the coupling fluid for transmitting and receiving the ultrasound.

Figure 8 Through-transmission testing using a water jet system (Kapadia 2013)

Typically, C-Scan results obtained from through-transmission technique are used to detect flaws including delamination, inclusions, fibre volume fraction and cracks (as long as they are along the path of the ultrasound). The biggest disadvantage with this technique is that it does not provide information on the defect depth. Care should be taken when aligning the probes as both surfaces of the component need access.

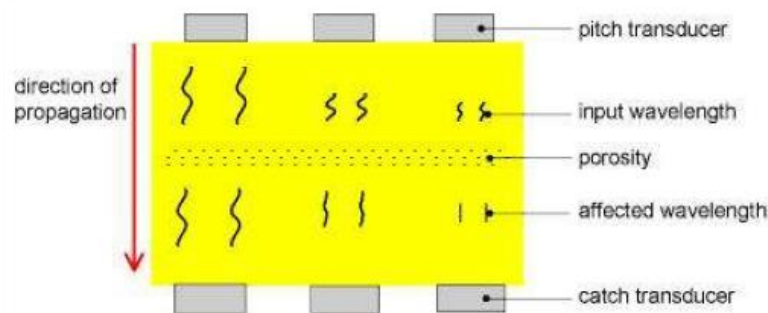
This technique can be better understood based on the through-transmission technique. In this case the probes are in direct contact and frequency of the transmitted wave is compared with the received wave. Whenever a defect is present along the path of the ultrasound, the frequency of the transmitted wave is altered especially in the harmonic mode which is dependent on the change in vibrations of the fibre-matrix.

Figure 9 Ultrasonic Spectroscopy set up showing wavelength difference due to presence of defects (Kapadia 2013)

This technique helps detecting defects when the pulse length is smaller than the thickness of the specimen. Based on a calibration scale, each independent frequency can be isolated and compared to determine the change in amplitude due to the presence of a defect. However, for thin samples, the pulse length is bigger causing interference which needs to be assessed carefully. This technique is helpful in detecting delaminations, under cured matrix and porosity. However it should be noted that the results could only be interpreted from a large database of similar inspections as the received signal is easily attenuated due to the structure of the composite (Adams and Cawley 1988; Matthews and Rawlings 1999; Kapadia 2013).

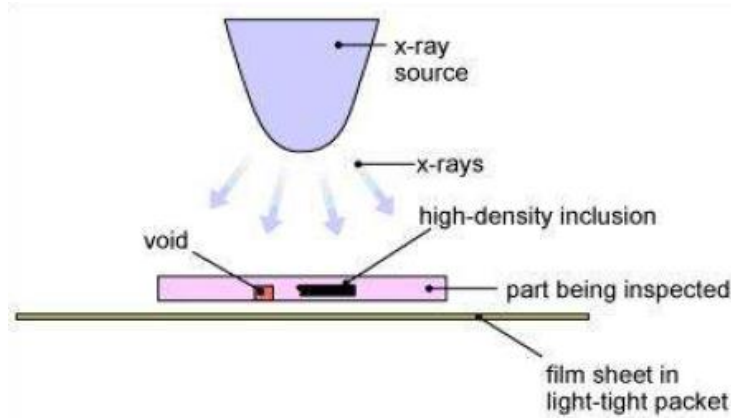
X-Radiography is the measurement of the absorbed and unabsorbed electromagnetic radiation which is obtained when a beam of X-rays are bombarded on to a test sample. The measurement is usually in the form of film which is placed behind the part. The radiation after passing through the part to be inspected is exposed to the film which is then developed to obtain a shadow image.

Figure 10 Set up of X-Radiography system (Kapadia 2013)

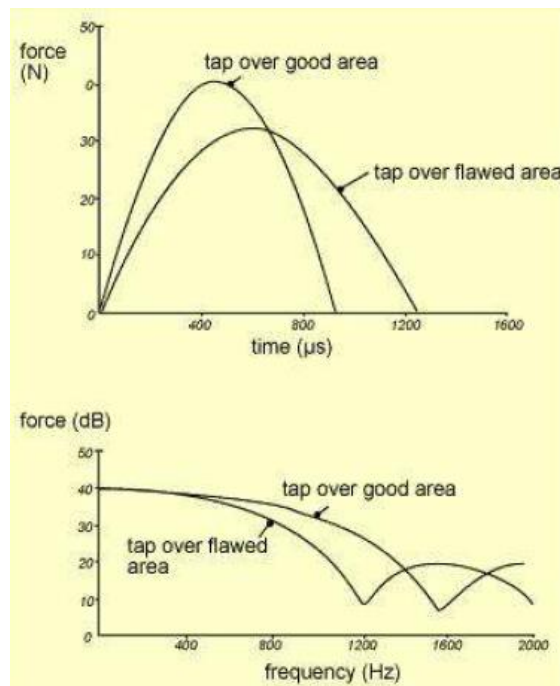
The simplest version of local test method is a traditional tap test where a coin or a hammer is used to strike the test sample at a predetermined point and the sound resonating from the sample is monitored. The difference in sound indicates the difference in local stiffness of the test sample indicating the presence of flaws.

Figure 11 Force-time and force-frequency records illustrating the difference between sound and defective areas of adhesively bonded structure (Matthews and Rawlings 1999; Kapadia 2013)

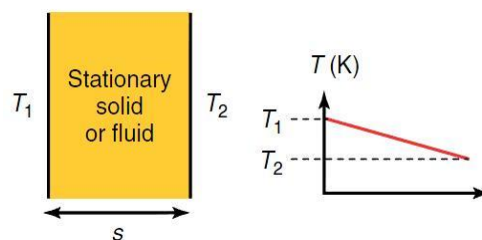
Figure 15 Heat transfer across a wall: Conduction (Vollmer and Möllmann 2010)

Thus heat transfer across a wall can be measured in terms of heat flux when the surface area A , and the temperature difference is known. This condition is true in the case of solids and liquids, though the rate of conduction would be much lower in terms of liquids.

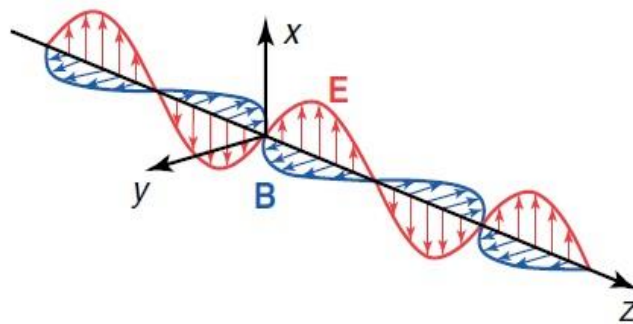
Infrared (IR) waves are a part of the EM spectrum which occur at the red end of the visible light. Typically, in the EM spectrum, the waves propagate due to magnetic and electrical disturbances and travel perpendicularly with each other along the direction of propagation (Figure 18). The amplitude of the wave is determined from the maximum disturbance of the wave (Janna 2000; Vollmer and Möllmann 2010).

Figure 18 Illustration of IR waves in an EM spectrum (Vollmer and Möllmann 2010)

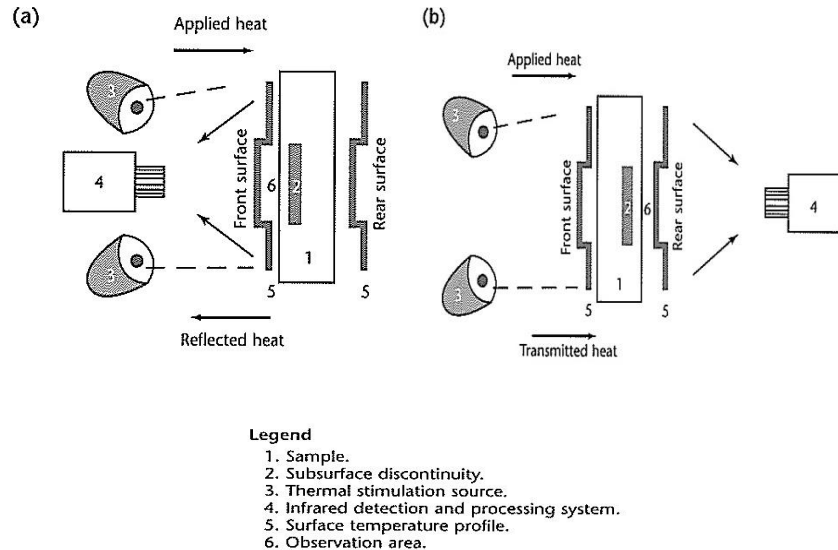
- (a) Reflection mode – where the pulse thermal source and the infrared camera are on the same side of the inspection sample when the anomaly is close to the heat surface

(b) Transmission mode – where the pulse thermal source is on the front side and the infrared camera on the rear side when the anomaly is close to the rear surface

Figure 19 Basic arrangements for a pulsed thermography system (Maldague, Beaudoin et al. 2001)

The reflection mode is more preferred as access to the rear side of the material under inspection may not be accessible. It was also noticed that the depth of the discontinuity could not be established using the transmission mode as the time taken by the thermal wave to reach the back surface was always the same.

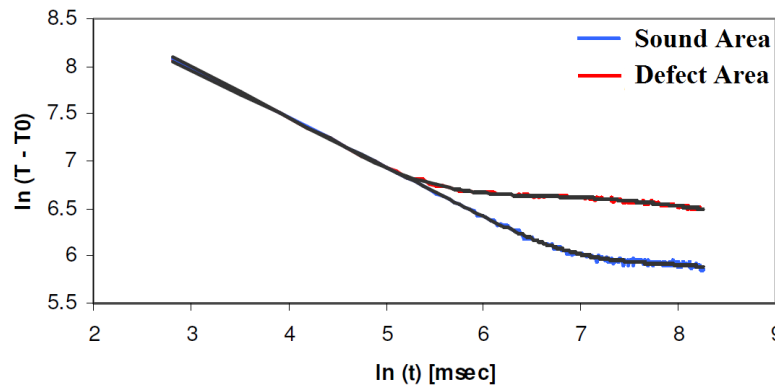
When a natural logarithmic plot for a pixel representing a sound area is obtained using the above equation (Eq. 26), a linear profile with a slope of -0.5 is obtained. It was noticed that when another plot from the surface pixel from a defective area was plotted, the logarithmic temperature profile now deviates from the one plotted before thus confirming the presence of a subsurface anomaly as seen in Figure 20 below.

Figure 20 Log time temperature plot showing pixel temperature decay profile of the parent material and damage (Shepard 2007)

The plot in Figure 20 shows two temperature decay profiles; the blue curve indicating the characteristics of a sound area. Once the part was flash heated, there is instantaneous temperature rise followed by a linear temperature decay in the logarithmic domain. After a set time ‘t’, the temperature deviates from linearity which is confirmed with the change in slope of the curve. This change is mainly due to the fact that the heat has diffused through the material thickness and has now reached the back wall. This time is referred to as t^* throughout this work and in line with the findings of Shepard (2007) and Zhao, Tinsley et al. (2016). When the same is applied to the defect area, the deviation occurs much earlier due to the fact that the

defect in this case holds more heat indicating change in heat diffusion characteristics as represented by the red curve in Figure 20.

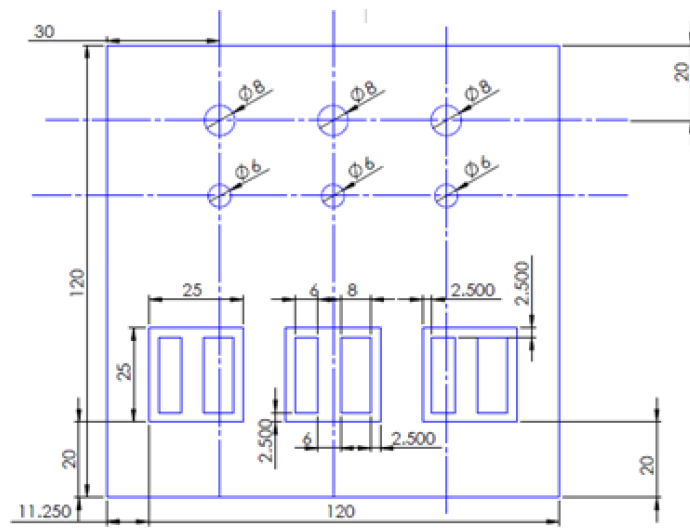
- Circular dots – having two diameters 6mm and 8mm
- A 25mm square part – with a 6mm and 8mm rectangular material taken off from the square part.

See Figure 21 below for the CAD model of the geometric shape and location of the defects.

Figure 21 CAD drawing of the defects introduced at the lay-up stage (all dimensions in mm)

As described in the previous chapter mild steel shim defects of 20µm thickness were introduced into 120 × 120mm UD carbon fibre composites. Refer section 3.3 for lay-up procedure, Figure 21-Figure 22 for defect morphology and Appendix 3 for the stacking sequence. Only TWI layup was used for this study.

Teflon inserts (500µm thick) were introduced into 120 × 120mm UD carbon fibre composites. 3mm, 6mm and 9mm thick samples were made in the hot press. Refer to section 3.3 for lay-up procedure, Figure 21-Figure 22 for defect morphology and Appendix 3 for lay-up sequence. Only TWI layup was used for this study.

Bagging film inserts (20µm thick) were introduced into 120 × 120mm UD carbon fibre composites as before. 3mm & 6mm thick samples were made in the hot press. Refer section 3.3 for lay-up procedure, Figure 21-Figure 22 for defect morphology and Appendix 3 for lay-up sequence.

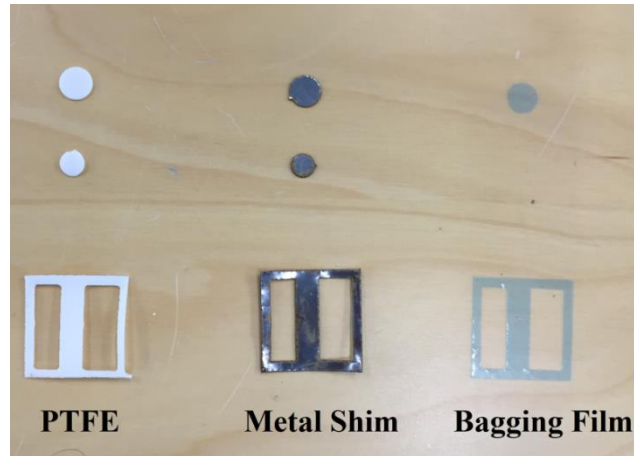
Figure 22 Inserts of PTFE, metal shim and bagging film

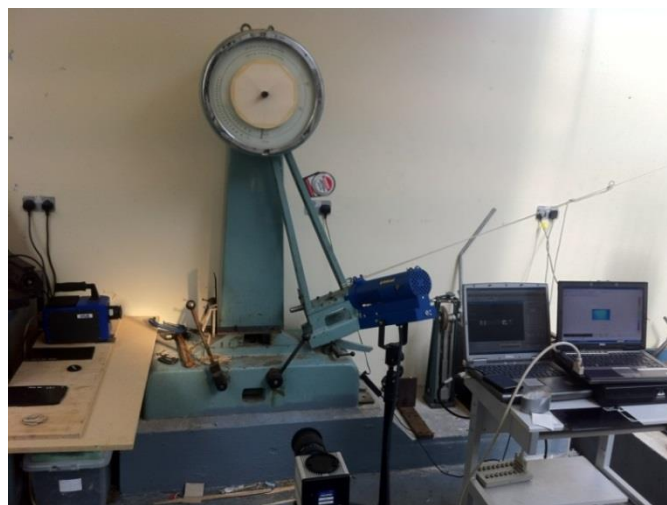
- A controlled definite impact using a modified Charpy with a hemispherical indenter of 24mm diameter; as suggested in the literature, was setup to create damage for three low energies; 4.5J, 8J and 12J.

Figure 23 The modified Charpy impact test setup with infrared and high speed camera

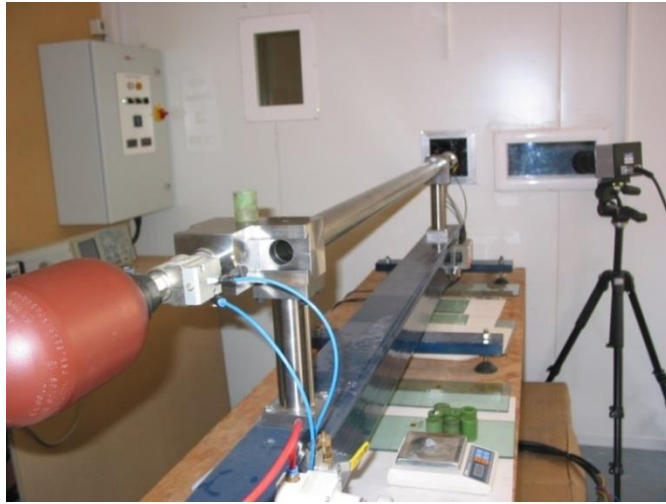
Figure 24 The ballistic gas gun

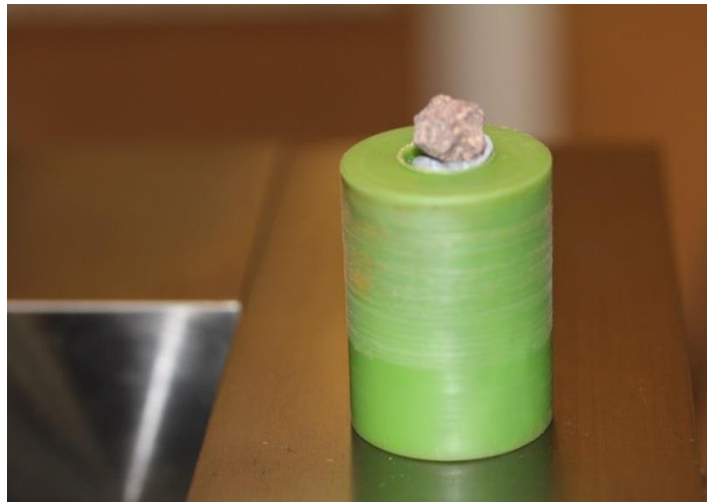
Figure 25 Sabot with stone that was introduced into the gas gun barrel for impact test

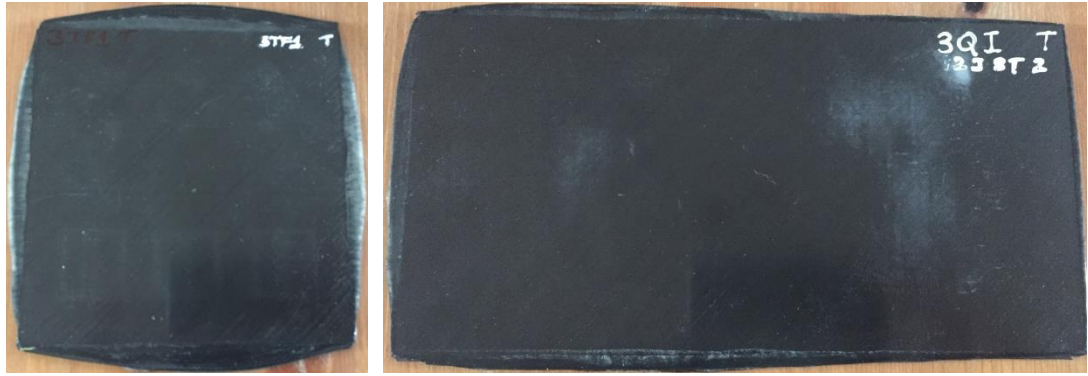
Figure 27 Representative parametric insert sample (120×120mm) (left) and impact sample (200×100mm) (right)

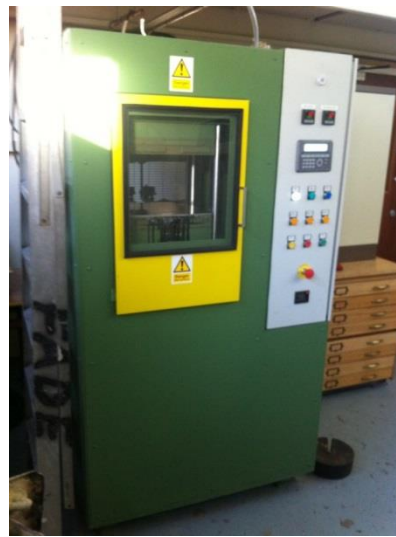
Figure 28 Hot Press

The prepreg stacked up samples were manufactured using the in-house hot press as seen in Figure 28 below. Two metal plates were first coated with a mould release agent, Frekote supplied by Henkel. At least three coats of the release agent were applied before the prepreg material was laid up on one of the metal plate with the

The prepreg material was then introduced into the hot press for the curing process. The cure pressure was set to 2 tonnes and cure temperature to 120°C. The cure time was 60 minutes for the samples. These settings were based on the prepreg material supplier information. The hot press cooling function was set to 30°C and was water cooled. Care was taken especially during the sample introduction as the hot plate was allowed to heat up to 120°C.

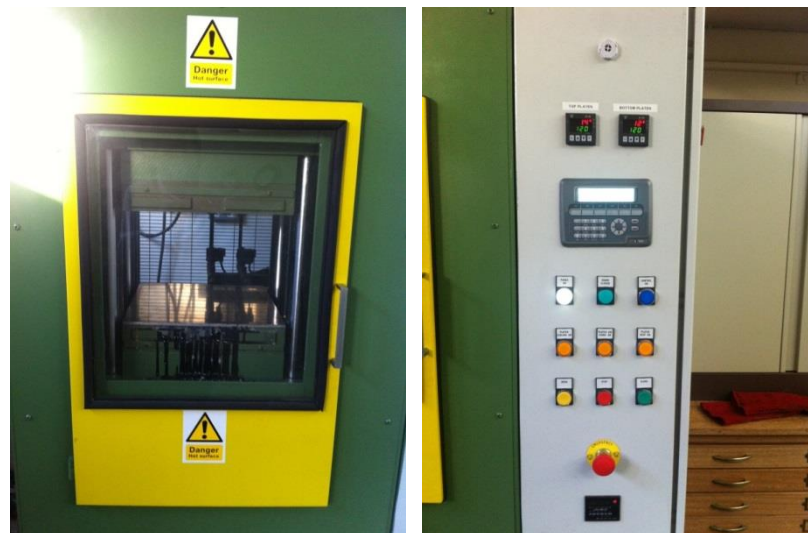
Figure 29 The hot plate (left) and the control unit (right)

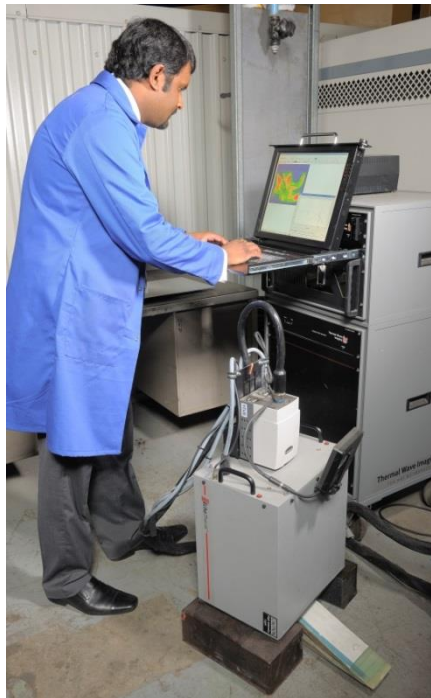
The pulsed thermography system used was a commercially available unit by the trademark EchoTherm® manufactured and supplied by Thermal Wave Imaging Inc., USA. The system consists of an integrated computer control unit and houses the capacitor banks that power 2 xenon flash lamps. These flash lamps are enclosed in a hood system on which sits an advanced, cooled, quantum detector based, infrared radiometer and goes by the commercial name Phoenix manufactured by Cedip – FLIR Systems. The radiometer is a 640×512 pixel, indium antimonide (InSb) detector based; Stirling cooled system with ability to acquire data at 100Hz at a full frame size of 640×512 pixels. The detailed specification sheet can be found in Appendix 5 below.

Figure 30 EchoTherm pulsed thermography system in use.

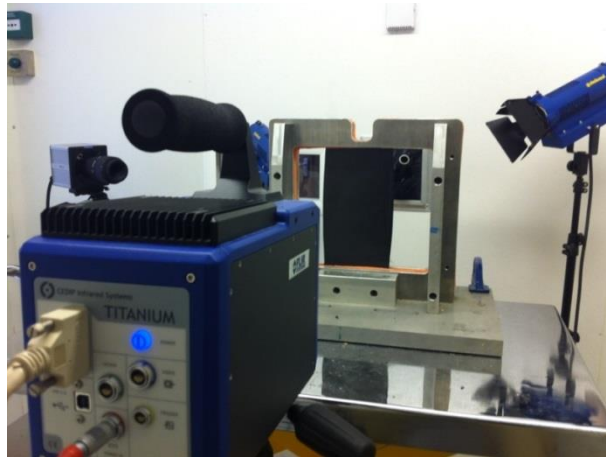
Name & model	FLIR - Titanium
Detector Name & Type	InSb, Quantum
Equipment Type	Cooled
Operating wavelength	3-5 μm
Operating Temperature	5°C - 300°C
Frame rate	100 Hz – 1.4kHz (based on windowing)
Pixel pitch	15 μm
Sensitivity	15-20 mK
Software controller	Altair, Altair LI, Cirrus

Figure 31 FLIR Titanium infrared radiometer

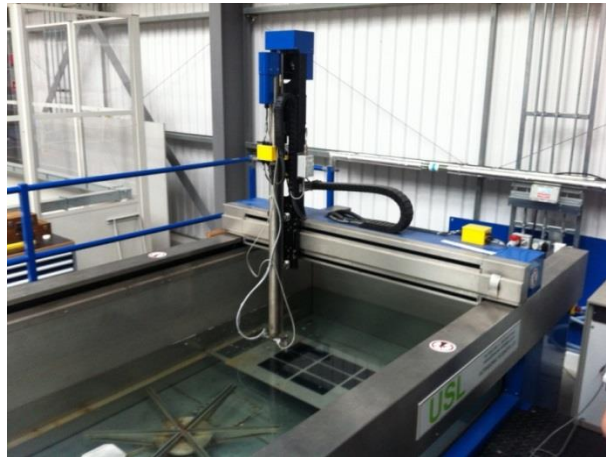
Figure 32 Pulse echo immersion UT testing setup using USL Scanner

As seen in the image above, an ultrasonic probe controlled by a robotic coordinate measuring machine (CMM) arm scans the laminates that are fully immersed in deionised water. The entire scan is controlled by the in-house software, which includes the positioning of the system, and scan settings. The specifications of the scanner can be found in Table 6.

The pulse echo immersion UT method employs a single transducer that does both transmission and reception of the sound signal. The working principle is as described in section 2.3.1. The equipment used for this research is a commercial system with the name USL Scanner manufactured by Ultrasonic Sciences Ltd and the test setup can be seen in the image below (Figure 32).

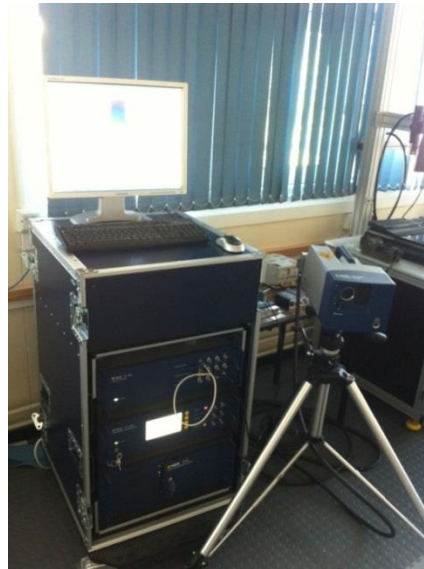
Figure 33 The Polytec PSV-400 laser doppler vibrometer

A Polytec PSV-400 laser doppler vibrometer (as seen in Figure 33) was used for the vibrational analysis. The system consisted of a laser scanning head, a computer controller, junction box and a signal generator unit.

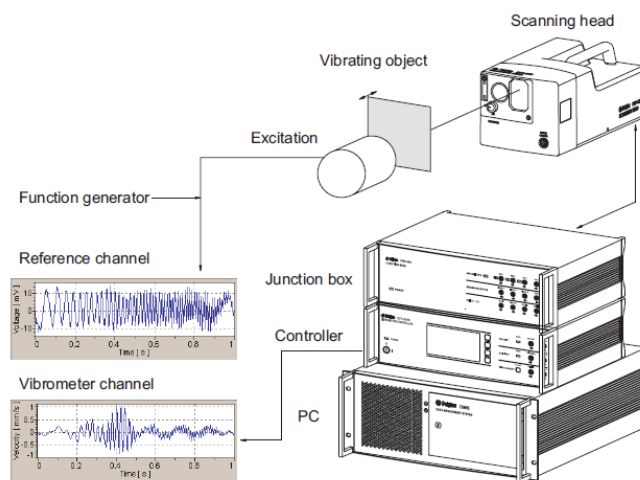
Figure 34 PSV LDV experimental setup

A typical LDV measurement setup is as shown in Figure 34 below.

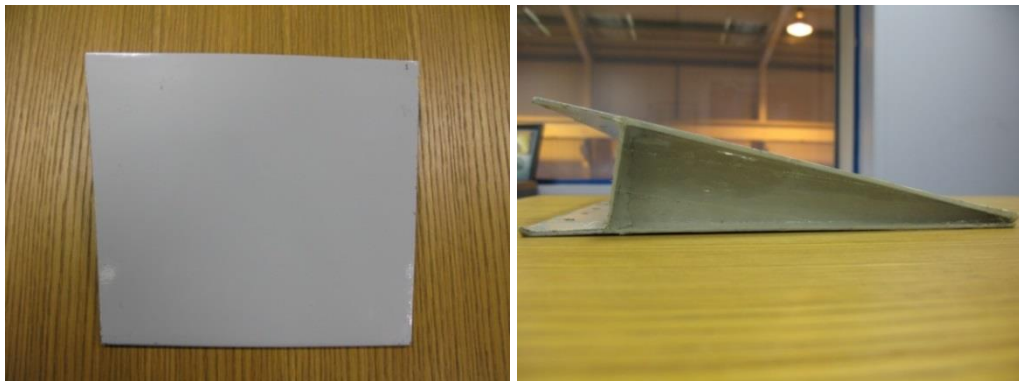
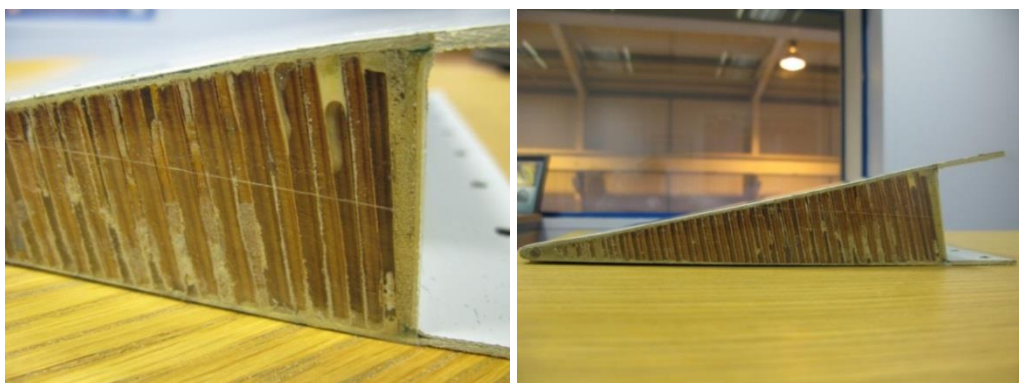
The samples were a cut section of a tail plane wedge of a commercial airliner (300×320mm). The sample was made up of glass fibre reinforced polymer (GFRP) composite outer skin and wood/paper honeycomb material (Nomex®). Figure 35 and Figure 36 show a representative image of the tail plane wedge with the cut edge revealing the internal honey comb structure. The sample was sealed to prevent any additional damage to its internal structure.

Figure 35 Tail plane wedge (a) top view; (b) side view

Figure 36 Tail plane wedge, side view

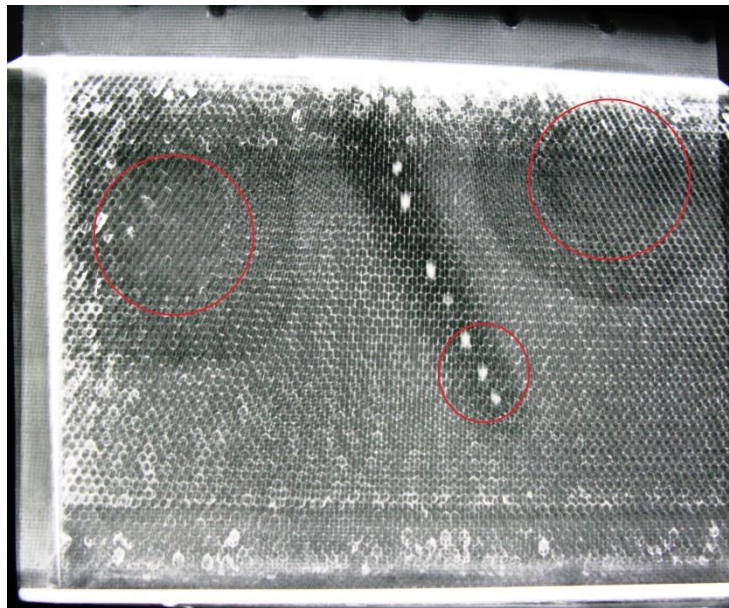
Figure 37 Radiograph image of ADAT 1 with red circular markers indicating the defect location

to the fact that the heat wave either conducts quickly or gets trapped causing localised hot or cold spots over a period of time. In this case, it was noticed that three different defects could be identified in the thermogram corresponding with the defects highlighted in the X-ray image (Figure 37). Though the X-ray image showed the defect locations, it failed to identify and characterise the defects. The thermogram on the other hand gave additional information helping characterise the defects. It was noticed that one of the defects was at a higher temperature and the other at a lower temperature than the overall temperature of the sample.

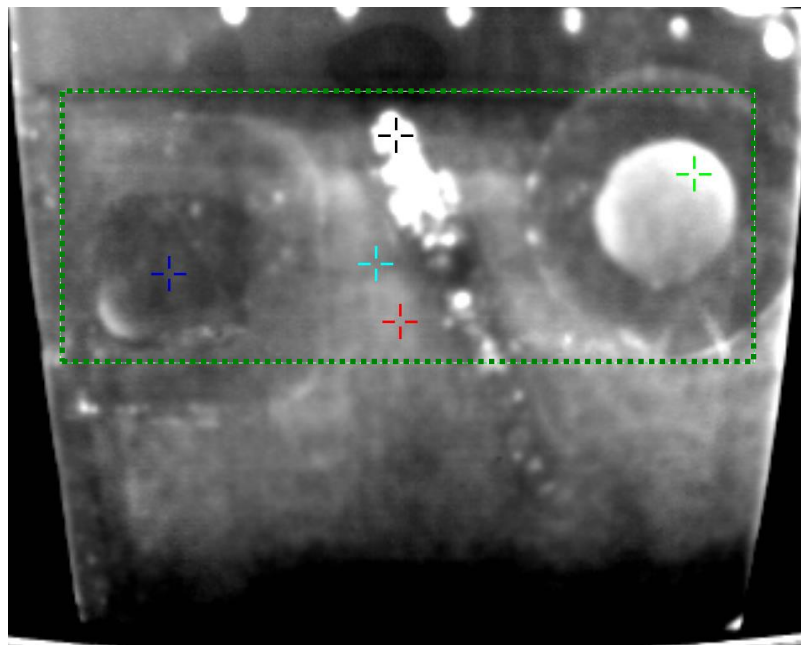
Figure 38 RAW image of ADAT 1 sampled at 5.973 seconds

The green box in Figure 38 focuses on the region of interest in the sample. The colour markers on the image represent the position of the defect and defect free areas and correspond to respective curves in the log plot. Figure 38 shows the infrared image obtained at a sampling time of 5.973s (t^*) (Shepard 2007) for an acquisition rate of 60Hz.

The third defect represented by the Black curve (Figure 38) could be because of the presence of a different material in the honey comb structure. This may be either a problem of water ingress in the material or excess adhesive in those cells of the honeycomb structure. The RAW image clearly highlights all the subsurface defects

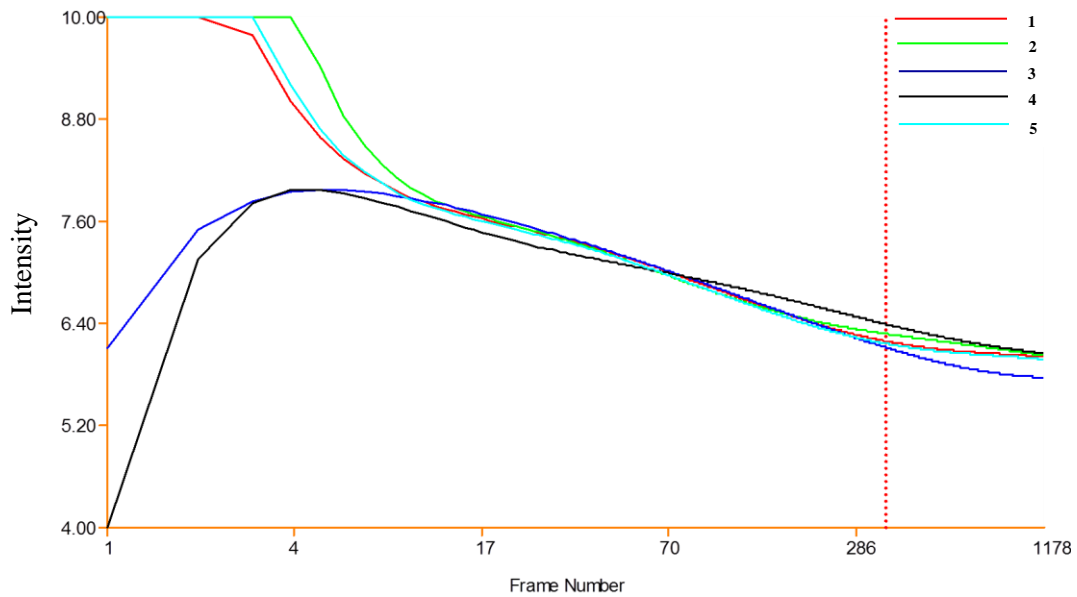
Figure 39 Log plot representing the RAW image for ADAT 1; 1&5 – No defect, 2 – delamination, 3 – disbond and 4 – excess adhesive/water ingress

It can be inferred from the log plot (Figure 39) that the pulse energy was targeted on the sample and there was a rapid rise in the surface temperature due to the heat dissipated from the flash lamps. The mode of heat transfer by which the energy heated up the surface of the sample was radiative in nature. It was noticed that after about 83ms, the surface temperature of the sample started to cool down as the heat diffused through the upper skin of the sample. The Red & Cyan curves, represented by respective markers from the thermogram, represent the surface temperature decay profile over time and are dependent on the material characteristics of the upper skin of the sample. Further the log plot (Figure 39) revealed that temperature decay characteristics changed indicating that the heat has now diffused through the upper skin, which is referred to as t^* .

The sample surface was flashed instantaneously using the flash lamps for a pulse length of 25ms and the infrared radiometer recorded the changes in surface temperature just before the flash to the set time of 19.67 s (post flash) acquiring 1179 frames at an acquisition rate of 60Hz. The regions of interest have been represented by red circular markers in the X-ray image (Figure 37). The data obtained from the pulse thermography system was represented in terms of thermograms and time-temperature log plots which were evaluated using the Mosaiq software. The following thermogram was obtained for the time at which the temperature gradient deviated from the linear decay profile for a sound area on the parent material which is referred to as t^* . The frame at which the sampling was done can be inferred from the RAW graphical data. (Represented by a red vertical dotted line. See Figure 39).

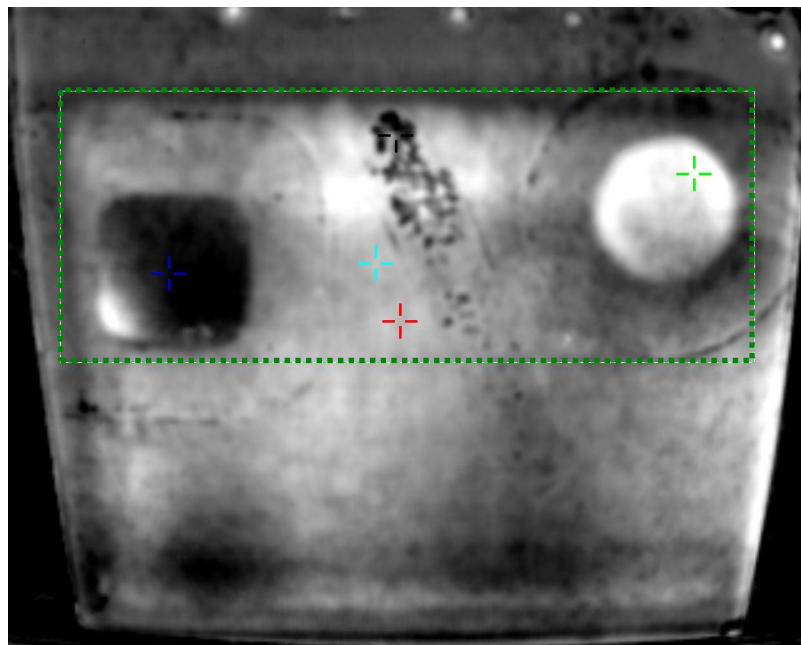
Figure 40 1st Derivative (1D) image of ADAT 1 at 5.973 seconds

The first derivative image (1D) (rate of change of time and temperature) also detects the defects. This 1D image and data are acquired at the same sampling time (5.973s) as the RAW image. The colour markers are representative of the position and characteristics of the defects identified previously from the RAW image. The following is the data obtained for the 1D condition (Figure 40-Figure 41).

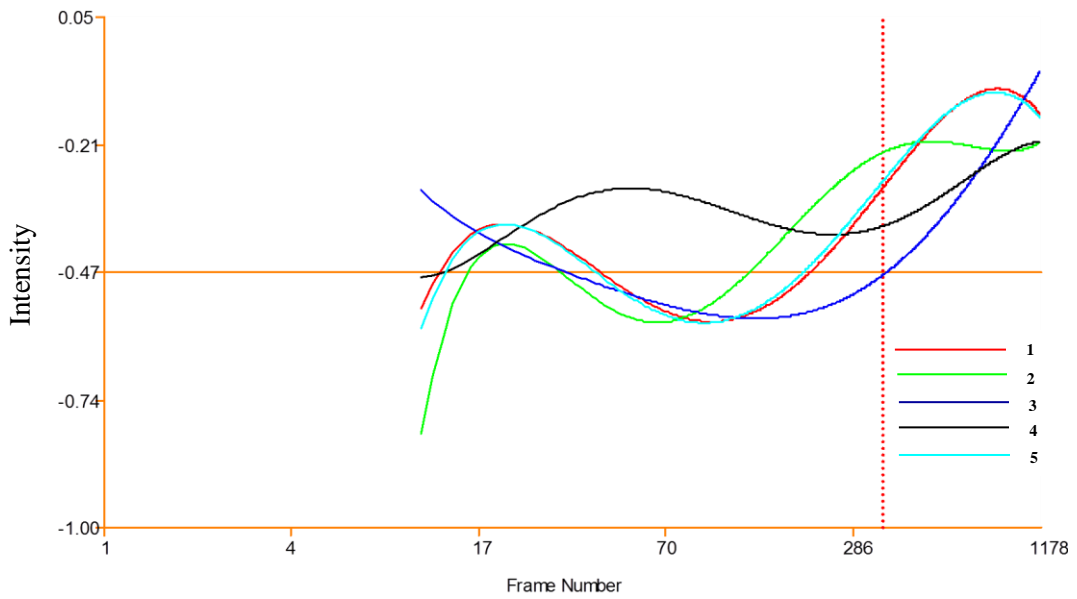
Figure 41 Graph representing the 1D data of ADAT 1; 1&5 – No defect, 2 – delamination, 3 – disbond and 4 – excess adhesive/water ingress

It can be inferred from the above graph that the characteristics of the parent material are superimposed on each other. However, the defects show a different pattern when compared with the parent material confirming them as defects.

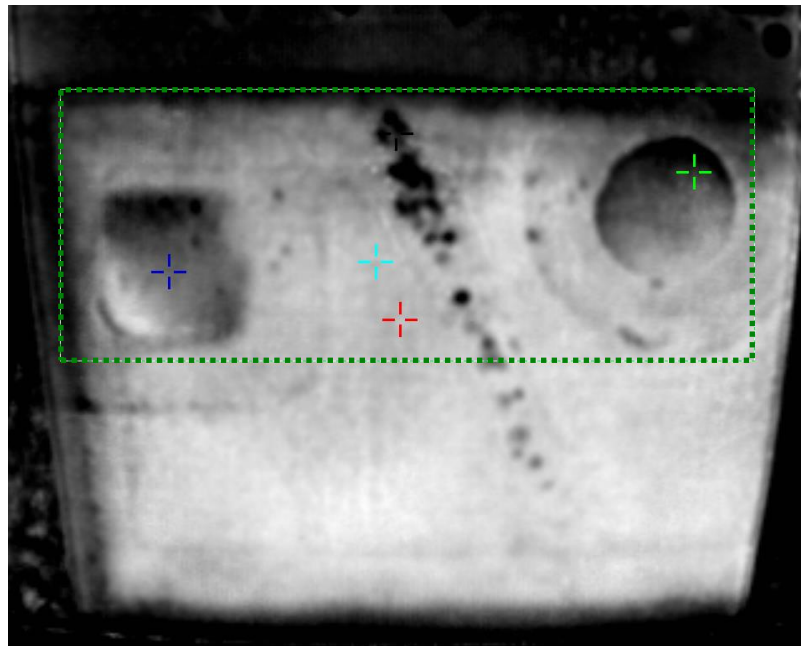
Figure 42 2nd Derivative (2D) image of ADAT 1 at 5.973 seconds

The following is the second derivative (2D) image and graphical data obtained at 5.973 seconds as before (Figure 42-Figure 43).

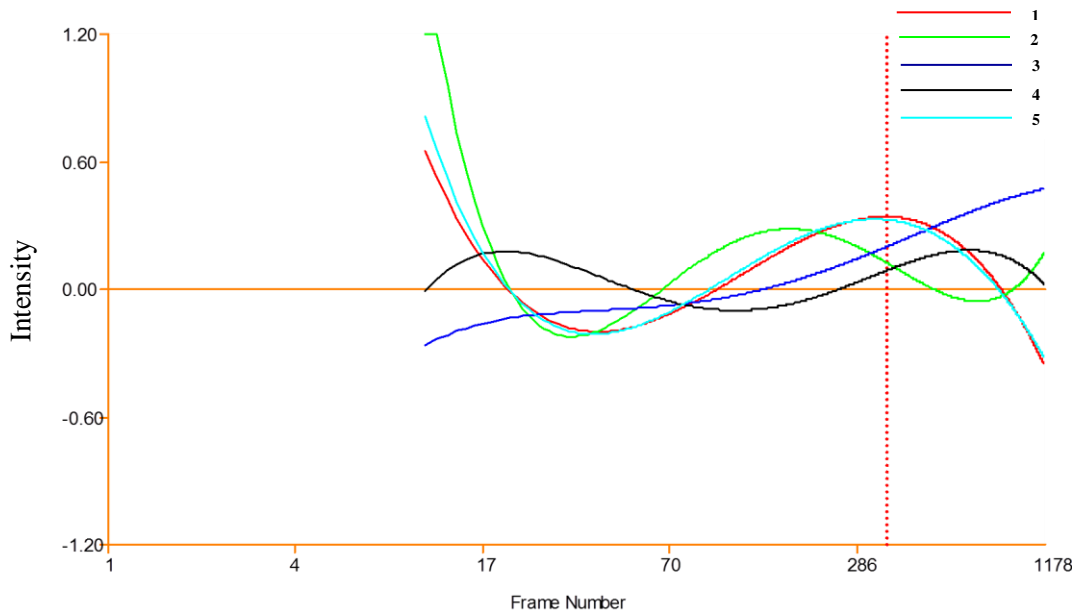
Figure 43 Graph representing the 2D data of ADAT 1; 1&5 – No defect, 2 – delamination, 3 – disbond and 4 – excess adhesive/water ingress

As before, it can be noticed from the 2D graphical plot that the parent material represented by the Red and Cyan curve show a decline in temperature, whereas the defect curves show a different pattern and is representative of the samples damage characteristics. The 2D plot for the parent material show a complete peak directly corresponding with the t^* confirming that the heat has completely diffused through the upper skin. Now the delamination curve (Green curve) peaks significantly ahead of the 2D peak of the parent material, confirming its occurrence through thickness of the upper skin whereas the disbond peak does not yet occur indicating that the peak would be much later than the parent material. This indicated the need for an extended data capture to investigate the disbond further. However, taking in view the qualitative nature of the data, the results were found to be sufficient to yield conclusive results where all defects were identified by the inspection.

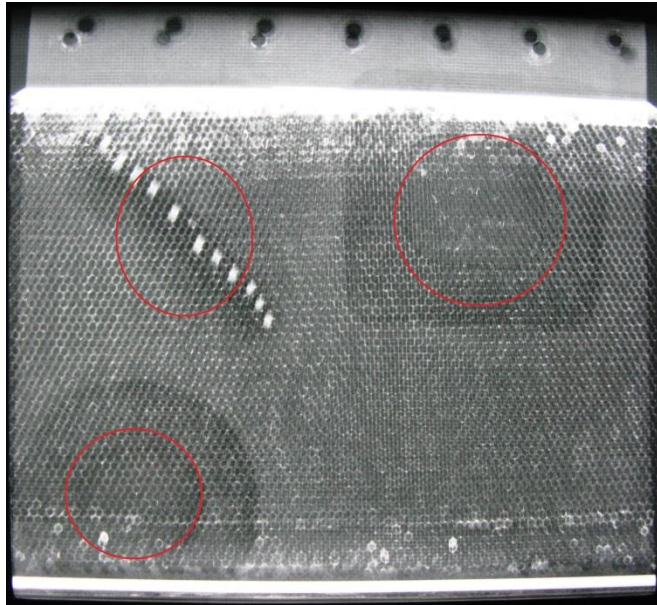
Figure 44 Radiograph of ADAT 3 with red circular markers showing the defect location

- a) To detect sub-surface defects present in the artificially made samples using pulse thermography and confirm if they are in line with the findings of ADAT1.
 - i. Figure 35& Figure 36 show a representative sample to be tested
 - ii. Radiograph of the sample (Figure 44) with the location of the defects indicated by arrows.
- b) The test is conducted on an EchoTherm system. (Please refer to Section 3.4.1 for construction and working principle of the pulse thermography system)

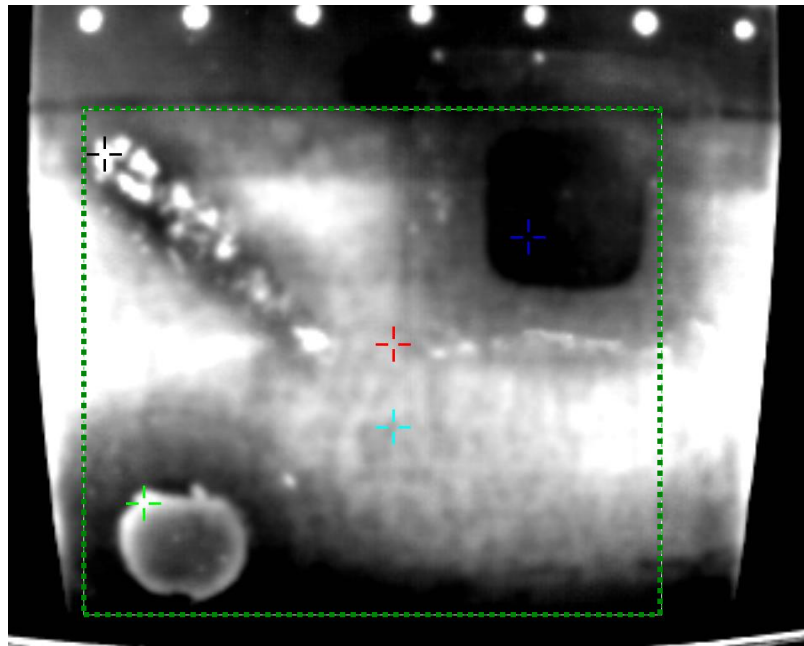
Figure 45 RAW image of ADAT 3 sampled at 5.973 seconds

This experiment has been conducted with the same settings as in the case of ADAT 1. Hence a similar colour marking system has been adapted. As before, the green box (Figure 45) focuses on the region of interest in the sample. The different colour markers on the image represent the position of the defect and defect free areas and correspond to respective curves in the log plot.

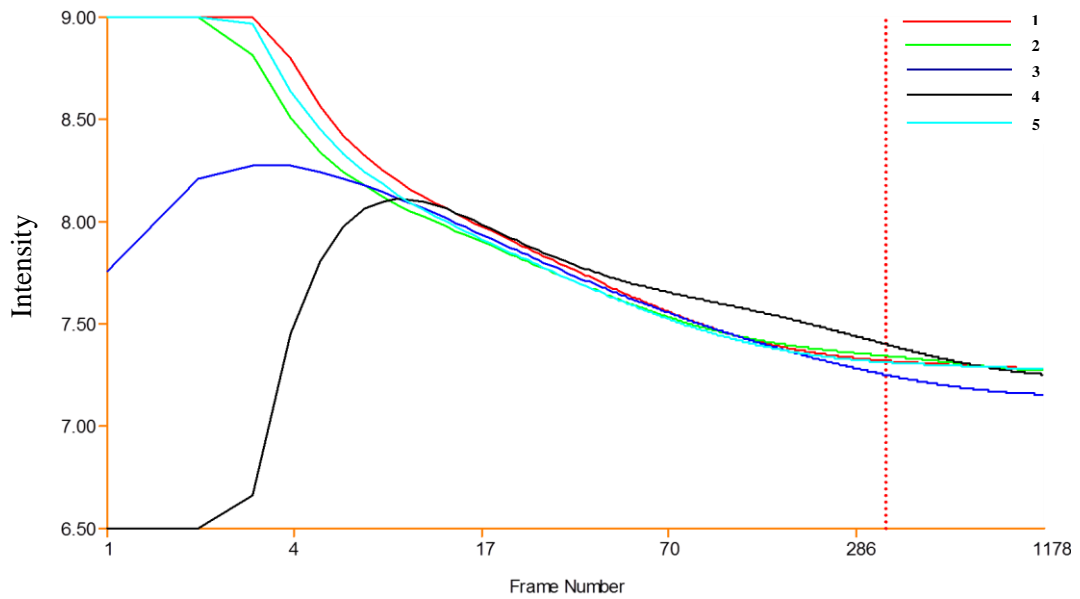
Figure 46 Log plot representing the RAW image for ADAT 3; 1&5 – No defect, 2 – delamination, 3 – disbond and 4 – excess adhesive/water ingress

As before, the setting used to acquire data for ADAT 1 was used to acquire data for ADAT 3. The sample surface was instantaneously heated with a 25ms flash and the infrared radiometer recorded the surface temperature profile of the sample. The data was acquired at 60Hz for a time of 19.67s accumulating a total of 1179 frames (post flash). As before, the time t^* at which the change in slope of the parent material occurred in case of ADAT 3 was found to be at 5.973 seconds matching

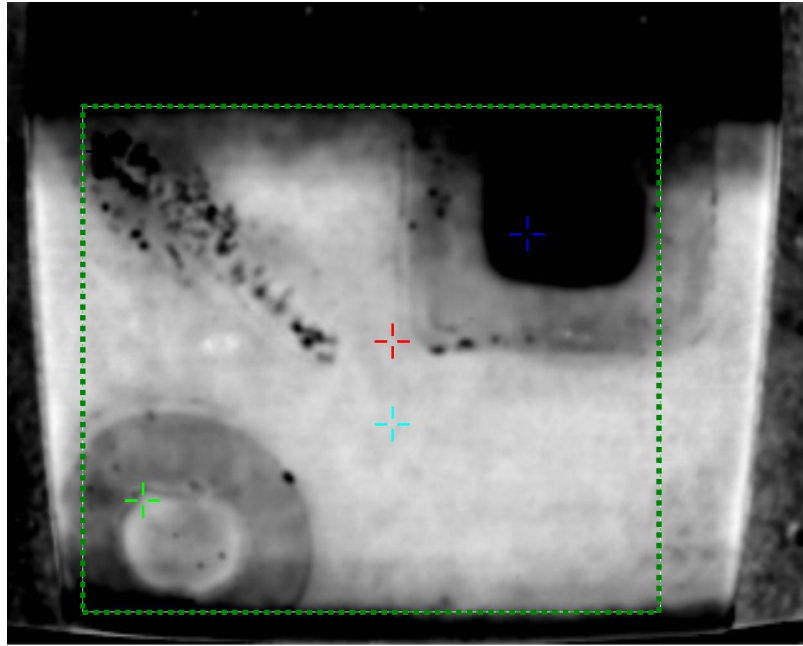
Figure 47 1st Derivative (1D) image of ADAT 3 at 5.973 seconds

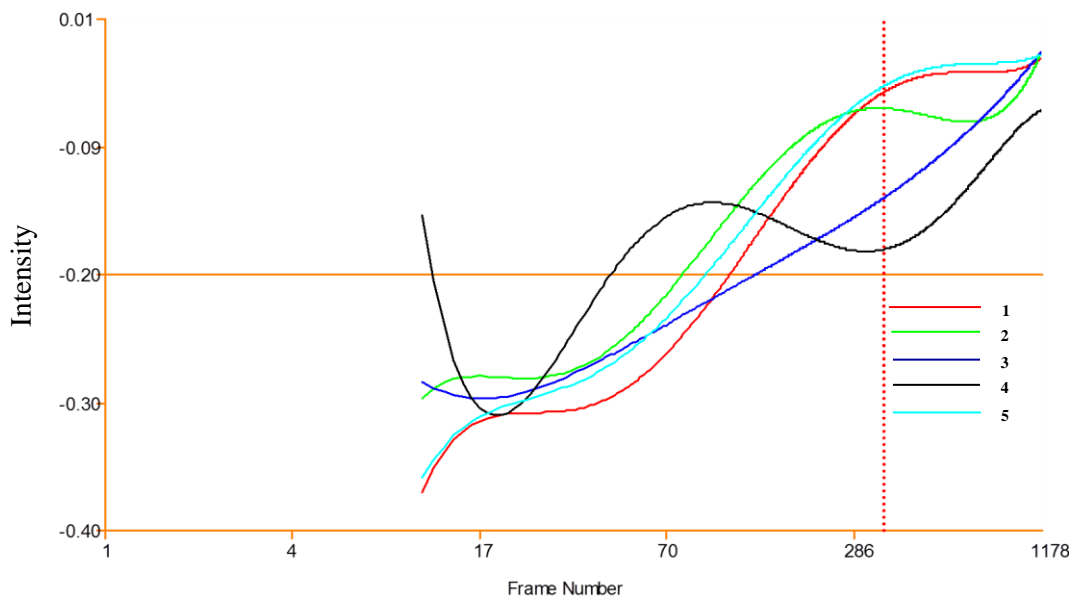
Figure 48 Graph representing the 1D data of ADAT 3; 1&5 – No defect, 2 – delamination, 3 – disbond and 4 – excess adhesive/water ingress
