A critical investigation of the use of infrared thermography
in determining the condition of composite materials

Submitted in partial fulfilment for the award of the degree of
Doctor of Philosophy

University of Wales Trinity Saint David

2017

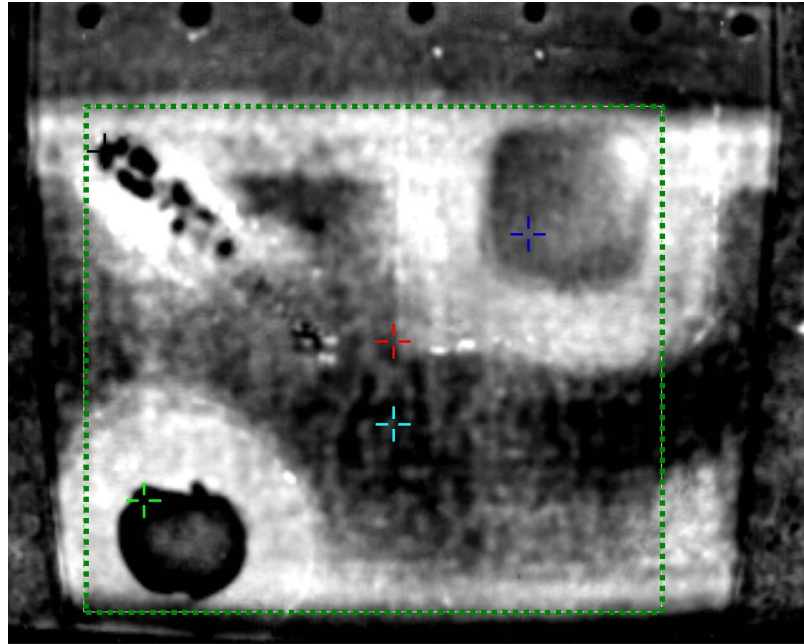
Figure 49 2nd Derivative (2D) image of ADAT 3 at 5.973

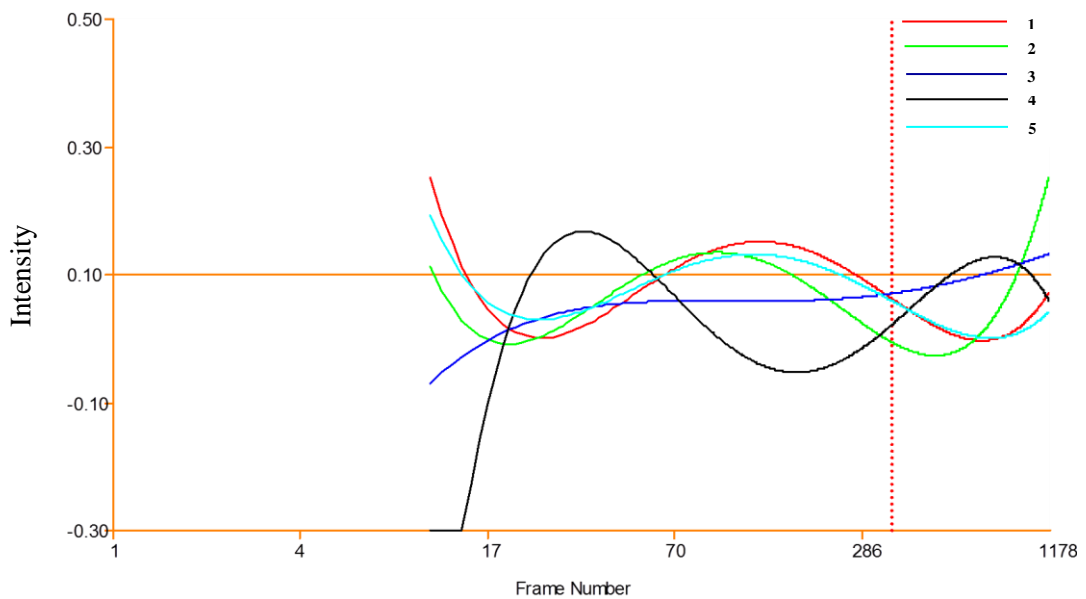
Figure 50 Graph representing the 2D data of ADAT 3; 1&5 – No defect, 2 – delamination, 3 – disbond and 4 – excess adhesive/water ingress

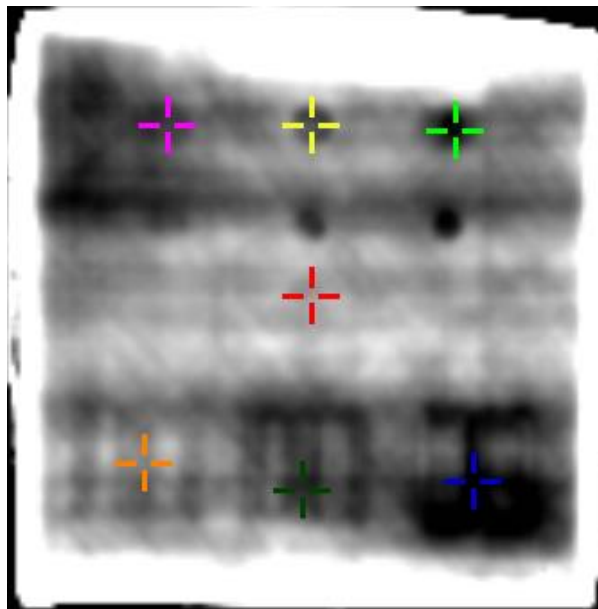
Figure 51 RAW Thermal image - Sample: 3SS2 (120×120mm); Sampling time: 0.7s

From the log t-T plot (Figure 52) the t^* for the 3mm thick laminate was estimated at 3.97s. The thermogram above (Figure 51) shows the defects at depths 0.5mm and 1mm which relate to the defects on the right and centre of the laminate respectively. The third set of defects were barely visible on the left hand side which were at a depth of 1.5mm from the surface of the laminate.

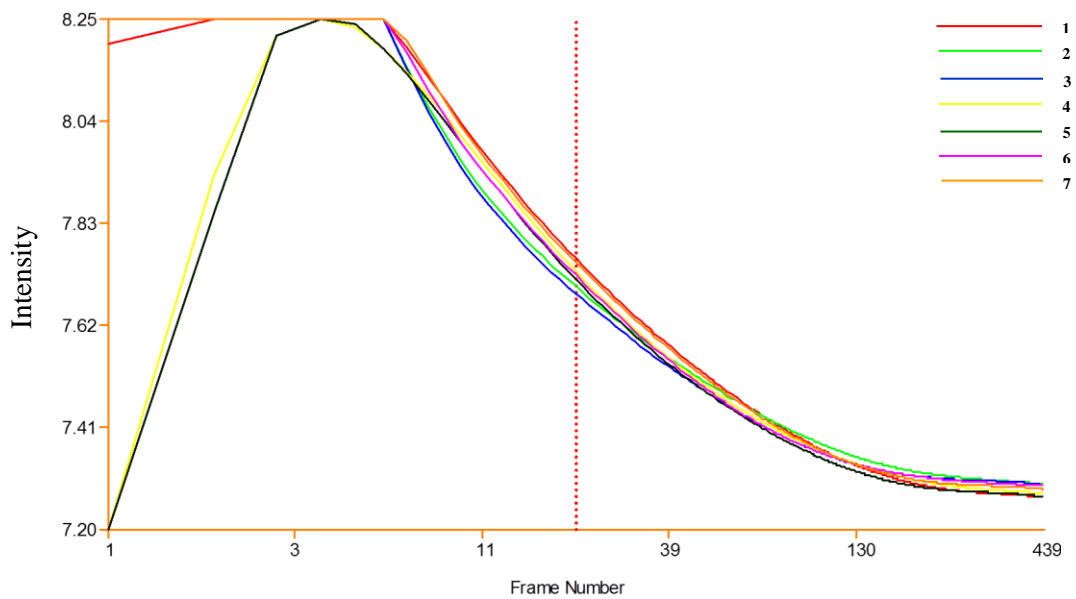
Figure 52 Log t-T plot for the RAW data; Sample: 3SS2; 1 – No defect; 2,3 – 0.5mm depth; 4,5 – 1.0mm; 6,7 – 1.5mm.

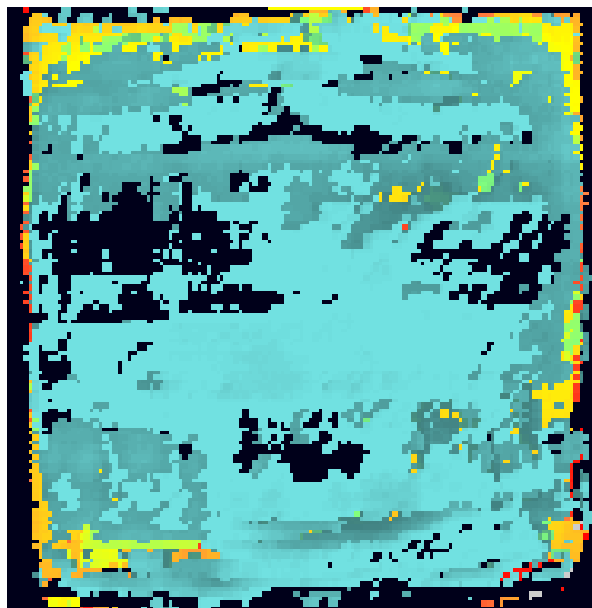
Figure 53 Time of flight (ToF) image for 3mm laminate (120x120mm) - Sample: 3SS2

The results from the PEUT technique measured the laminate thickness to be 2.52mm. However the time of flight or ToF image did not detect the defects and thus the results were found to be inconclusive. Further this laminate in particular was found to be quite noisy indicating that the manufactured quality was not optimum.

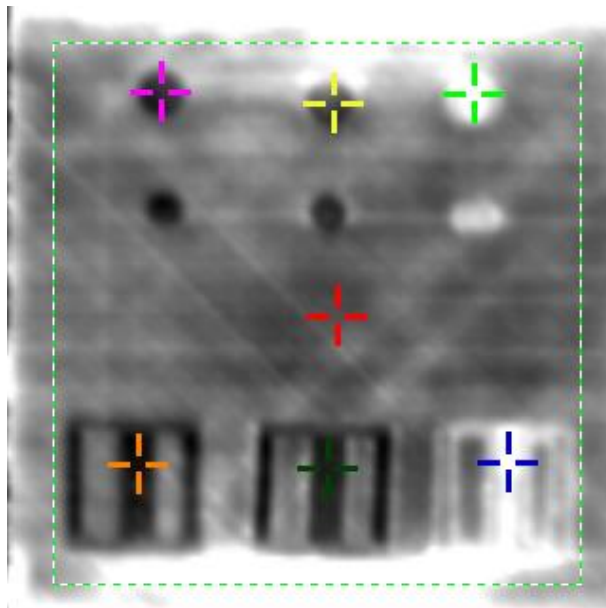
Figure 54 RAW Thermal image - Sample: 3TF1 (120×120mm); Sampling time: 0.27s

From the log t-T plot the t^* was estimated at 3.97s which is exactly the same as seen in the case of 3mm laminate with steel shim insert. Based on the above results presented in Figure 54, the following observations were made;

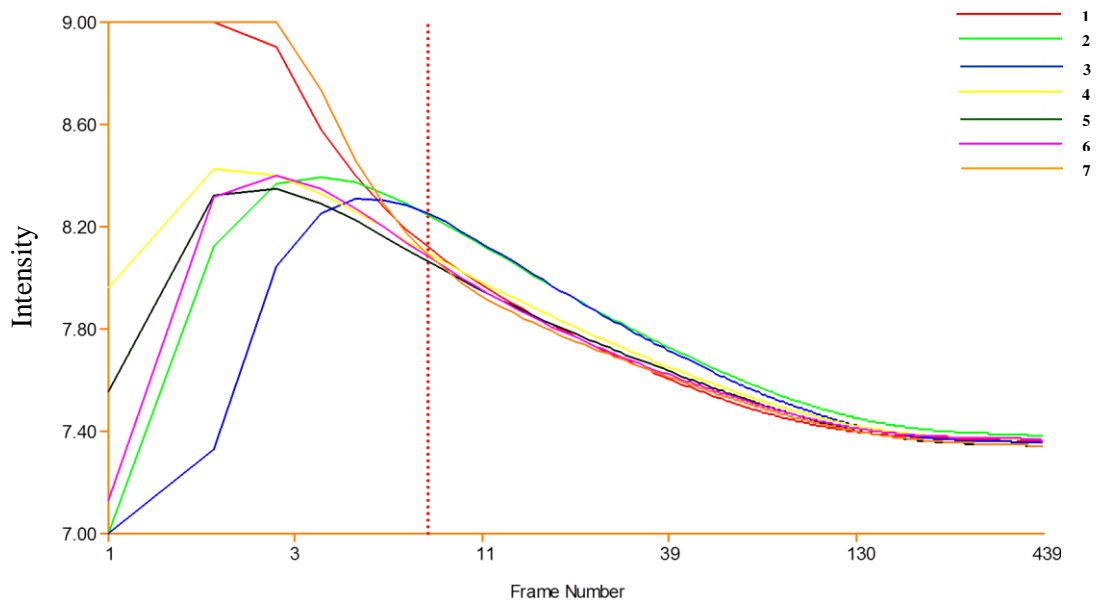
Figure 55 Log t-T plot for the RAW data; Sample: 3TF1; 1 – No defect; 2,3 – 0.5mm depth; 4,5 – 1.0mm; 6,7 – 1.5mm

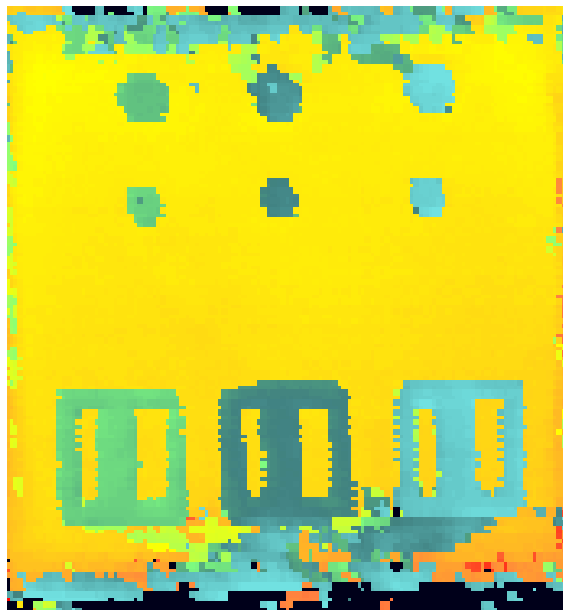
Figure 56 Time of flight (ToF) image for 3mm laminate (120×120mm) - Sample: 3TF1

The UT results in this case clearly picked up all the defects. The ToF image showed the three sets of defects with a slight colour gradient suggesting that the defects occur at different depths.

Thus all three sets of defects occurring at 0.5mm, 1mm and 1.5mm were easily detected using both pulsed thermography and immersion ultrasonic testing. Further the UT results validated the pulsed thermography results.

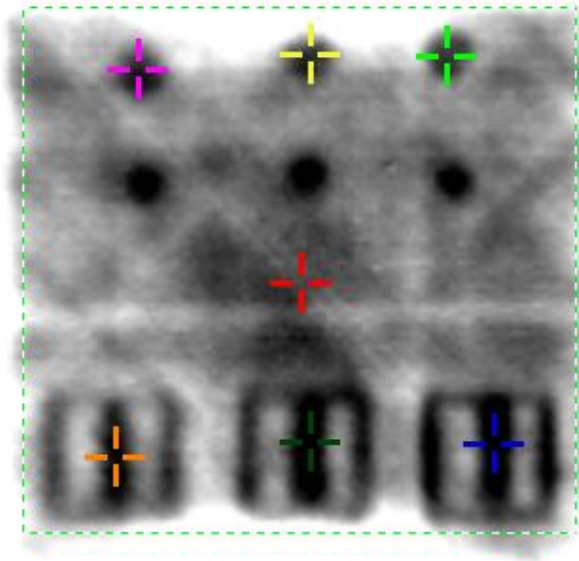
Figure 57 RAW Thermal image - Sample: 6TF1 (120×120mm); Sampling time: 0.92s

As before, from the above figures, (Figure 57-Figure 58) all the control defects, both dots and the slotted aperture inserts are visible in the thermal image. These defects follow a similar cooling pattern to that of the 3mm thick Teflon sample, 3TF1 mentioned in the sub-section above. Though the thermogram in Figure 58 clearly indicated all the control defects, it was noticed from the log plot that the temperature decay pattern is very close to the sound area of the sample and the t^* in this case was at 16.68s. As before, the thermogram was acquired for a sampling time of 0.92s which achieved the maximum thermal contrast that clearly identified all embedded defects.

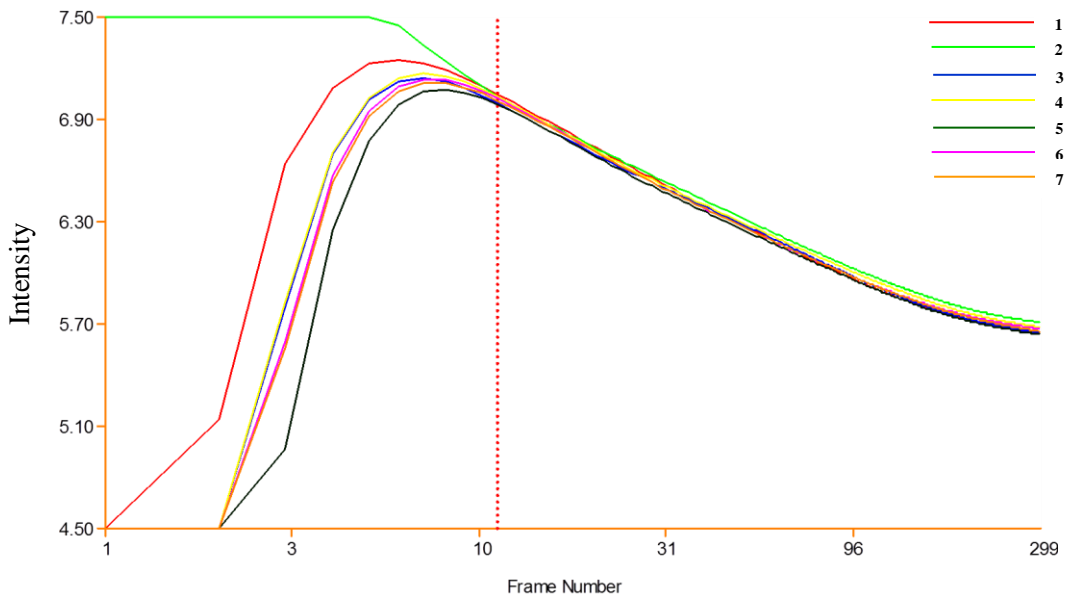
Figure 58 Log t-T plot for the RAW data; Sample: 6TF1; 1 – No defect; 2,3 – 2.0mm depth; 4,5 – 2.5mm; 6,7 – 3.0mm

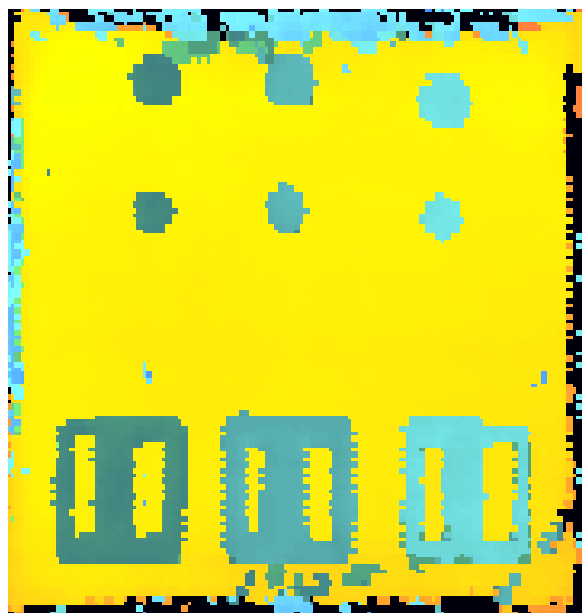
Figure 59 Time of flight (ToF) image for 6mm laminate (120x120mm) - Sample: 6TF1

As before, the UT ToF image detected all Teflon defects introduced into the laminate validating the pulsed thermography data. There is also difference in amplitude measurements between different sets of defects confirming their variation in depth of the laminate.

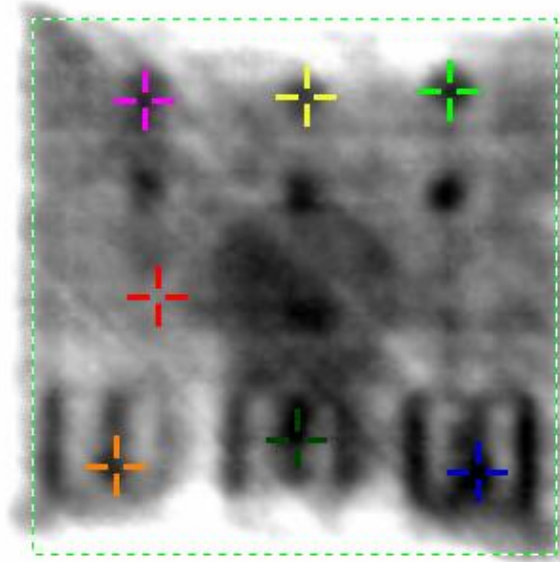
Figure 60 RAW Thermal image - Sample: 9TF1 (120×120mm); Sampling time: 1.4s

All buried defects were identified by the inspection. However, the set of defects occurring at a depth of 4.5mm are just faintly visible on the thermogram and have the same pattern as the sound area.

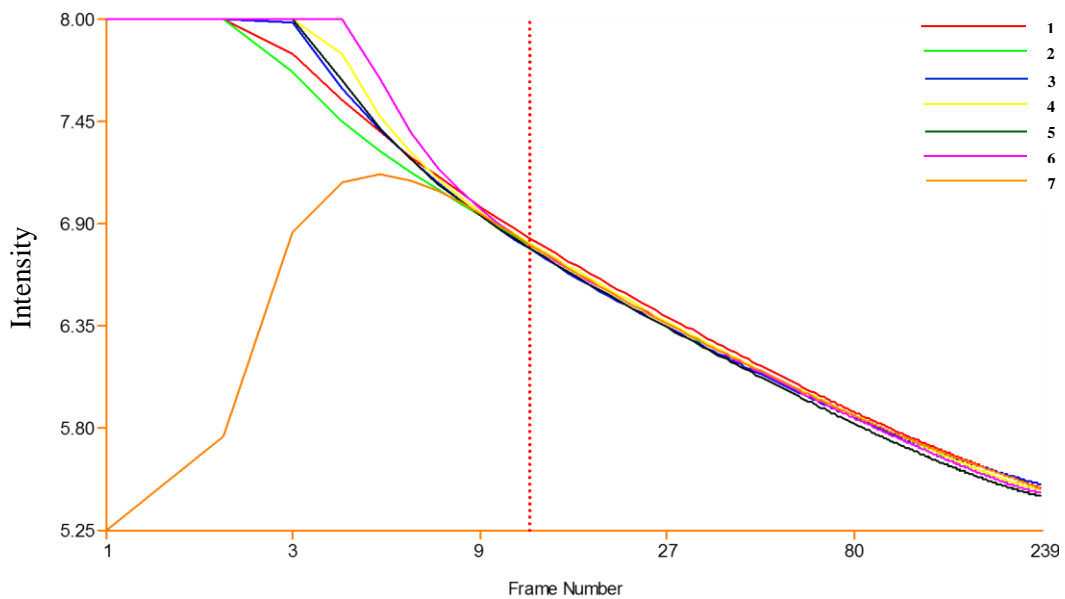
Figure 61 Log t-T plot for the RAW data; Sample: 9TF1; 1 – No defect; 2,3 – 3.5mm depth; 4,5 – 4.0mm; 6,7 – 4.5mm

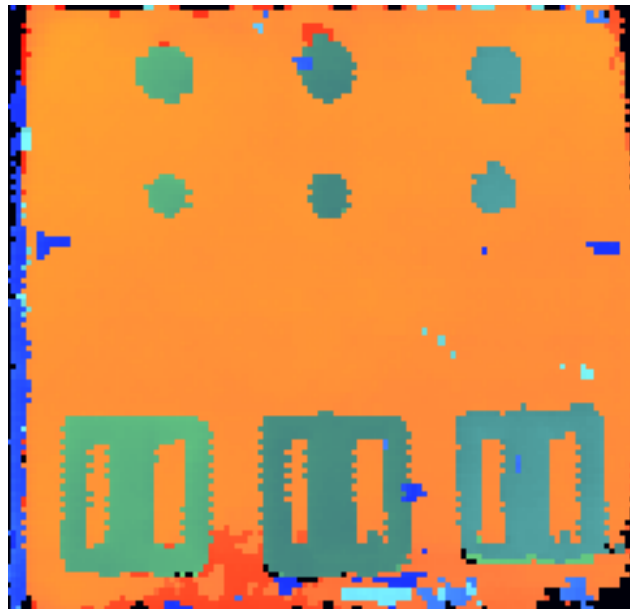
Figure 62 Time of flight (ToF) image for 9mm laminate (120×120mm) - Sample: 9TF1

The UT results picked up all the Teflon inserts in the 9mm thick laminates. It was observed that there was a loss in thickness measurement based on the waterpath suggesting that there was attenuation of the ultrasound in the material. However, all

defects were detected by the UT system, confirming the findings of the pulsed system.

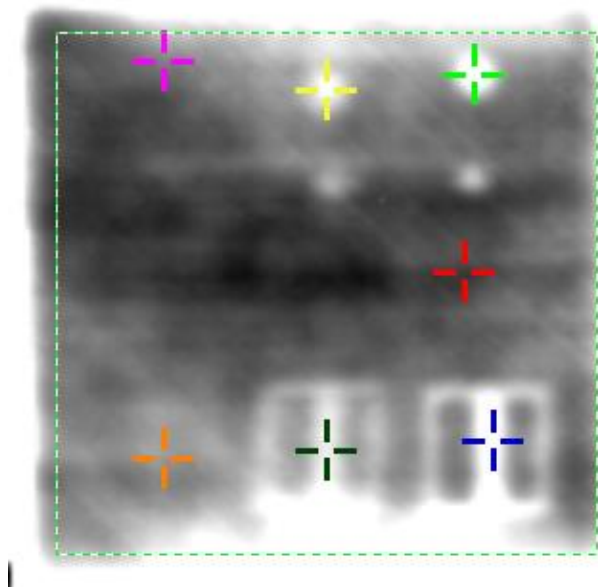
Figure 63 RAW Thermal image - Sample: 3BGF1 (120×120mm); Sampling time: 1.47s

Figure 63-Figure 65 present the pulsed thermography inspections results of the 3mm laminate with bagging film defects inserted at locations as per Table 24. For this sample, the t^* was estimated as 3.97s as seen with other 3mm thick laminates. The following observations were made from the results:

- The inserts close to the surface at 0.5mm are on the right hand side of the thermogram and are clearly visible on the thermogram. As expected, these set of defects exhibit a higher temperature profile (represented by Green and Navy Blue markers) than the parent material (Red marker).

- Even the 2nd set of defects occurring in the middle section of the laminate are visible showing a slightly higher temperature decay profile (represented by Yellow & Dark Green markers) than the sound areas of the parent material.

- Similar conclusions could be made for the bagging film type inserts. Again the thickness of the material was 20 μ m. As before, both the 0.5mm and 1.0mm inserts were easily picked up in the RAW thermal image. The 1.5mm deep defect was only picked up in the 2D image indicating that the noise of the laminate was quite high masking the contrast of the defect in the first instance. This feature was found only in the case of the bagging film defect and not the steel shim insert indicating that the material conductivity was key in this image and signal improvement was achieved through the use of 2nd derivative of the RAW image as seen in the 2D image (Figure 64). In other words, the heat wave when hit the steel shim, them being conductive in nature diffused the heat much faster. However, the bagging film material being non-conductive in nature provided the necessary insulation to heat diffusion. This meant that, the SNR improved in the 2D image thereby picking up the defect. When a 6mm laminate with defects at 2.0mm, 2.5mm and 3.0mm depths was tested, none of the defects were identified even in the 2D image establishing the limitation of the pulsed thermography system to 1.5mm for bagging film inserts.

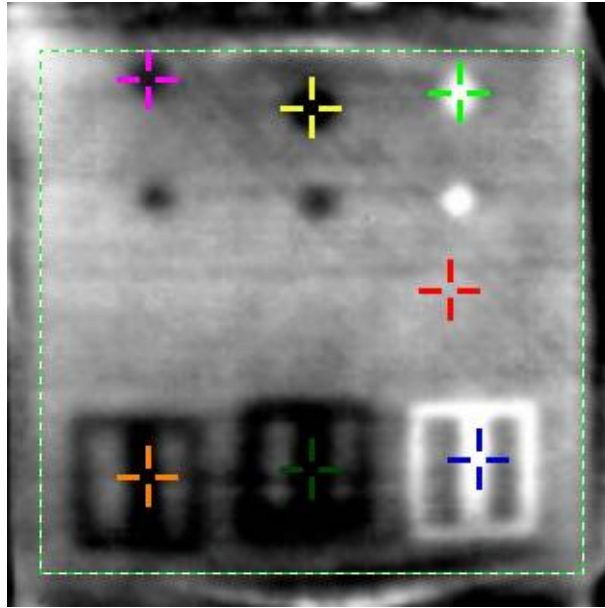
Figure 64 2nd derivative (2D) Thermal image - Sample: 3BGF1 (120×120mm); Sampling time: 1.47s

- However, the RAW thermal image fails to identify the 3rd set of defects occurring at 1.5mm depth. A further investigation revealed that a 2nd derivative image (Figure 64) showed this defect clearly. This feature was found to be only appearing in this type of defect.

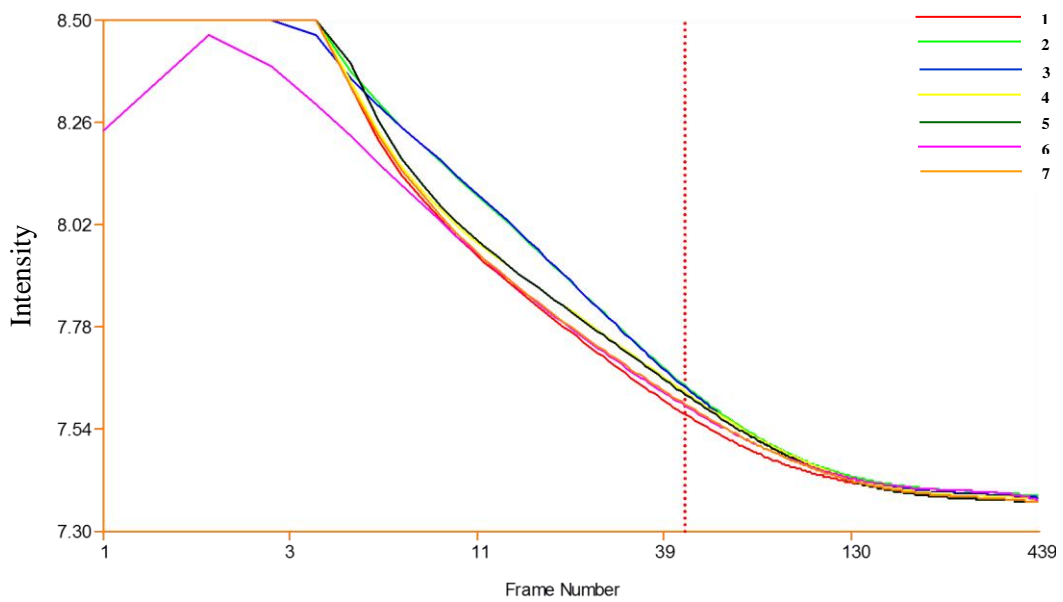
Figure 65 Log t-T plot for the RAW data; Sample: 3BGF1; 1 – No defect; 2,3 – 0.5mm depth; 4,5 – 1.0mm; 6,7 – 1.5mm

- There was no indication of defect in the log t-T plot as the RAW data failed to identify the 3rd set of defects, although a 2D image clearly identified it.

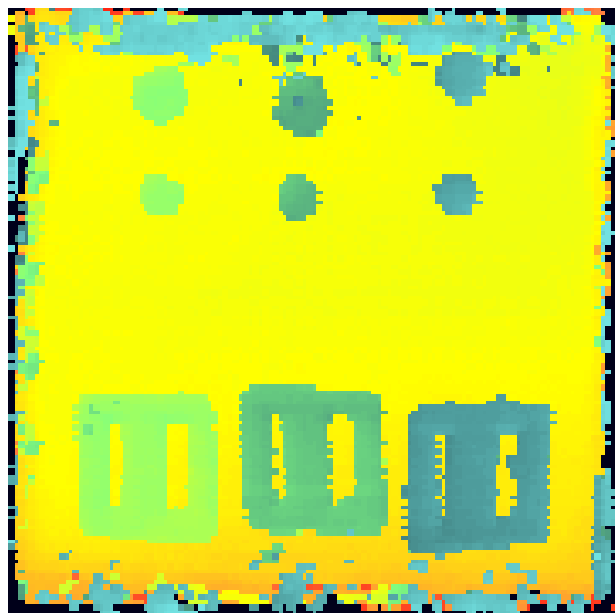
Figure 66 Time of flight (ToF) image for 3mm laminate (120×120mm) - Sample: 3BGF1

As before, the UT results picked up all the defect inserts validating the pulsed thermography results. The ToF image (Figure 66) show the depth variation in terms of colour map.

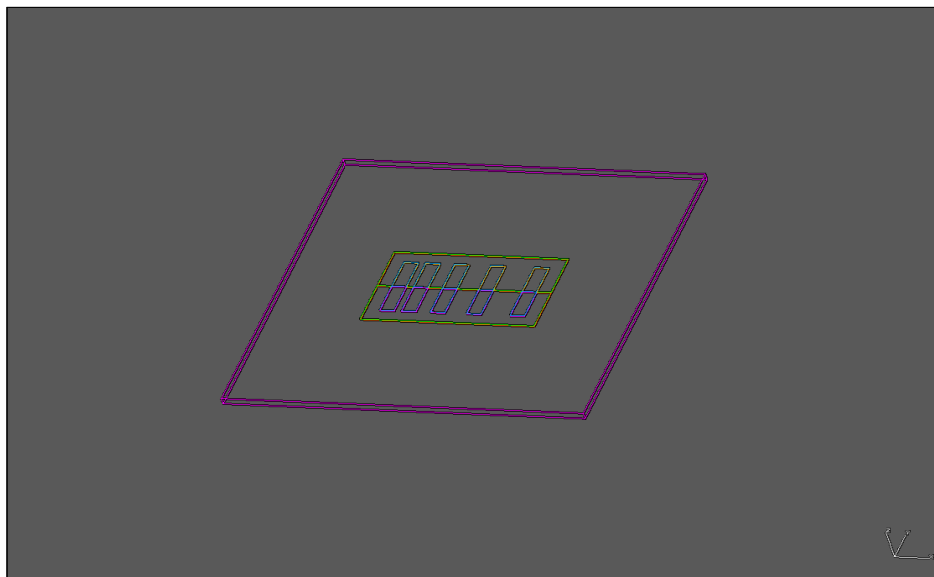
A Finite Volume Method (FVM) solver was used to simulate the pulsed thermography experiment. A geometric model was designed in Siemens NX-Ideas and a mesh density of 10 elements per smallest defect (rule of thumb) was used to resolve the smallest geometric detail. Thermal material properties were used for the CFRP, PTFE and Air (Appendix 7). It was assumed that the CFRP laminate material was homogeneous. In order to understand and validate the thermal results obtained from the parametric defect study (Section 4.2.1), thermal modelling approach using Ideas TMG was used. A preliminary test using a GFRP laminate with PTFE and representative air gap was modelled. The laminate was designed to be 4mm thick and had the PTFE with airgap at about 2mm, and as part of the model, a 1kW heat flux was applied onto the top surface of the model as seen in Figure 67 below.

Figure 67 The model with the slotted aperture insert - wire frame mode

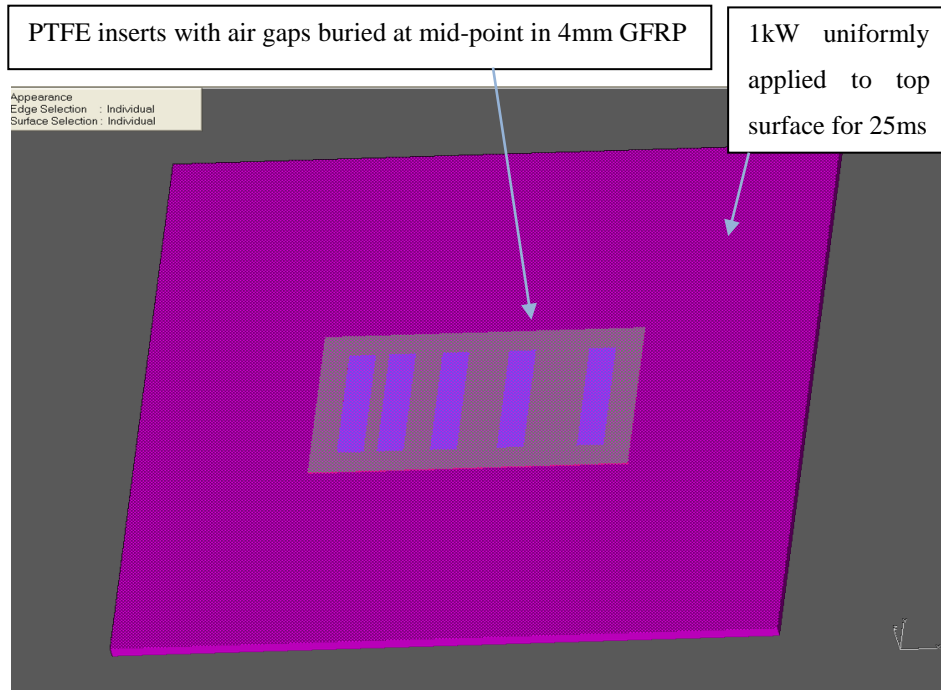
Figure 68 Ideas model showing the laminate with the slotted aperture insert at 2mm from the top surface.

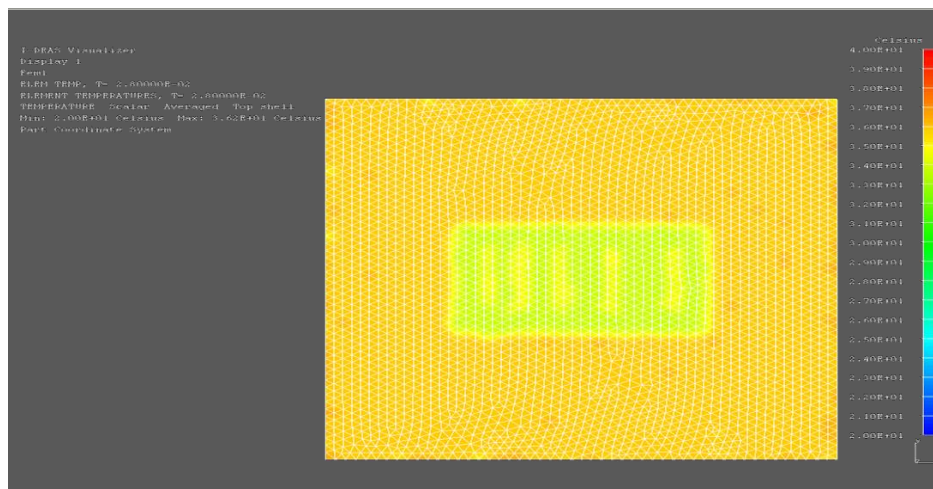
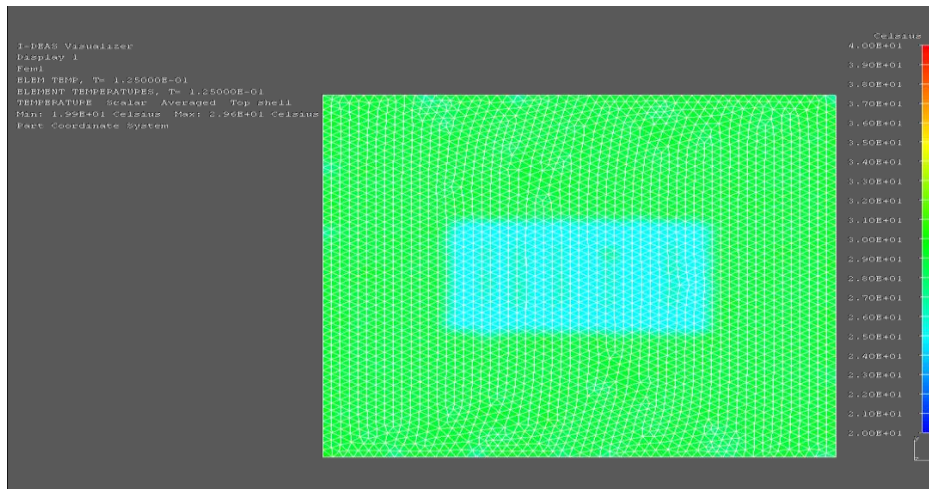
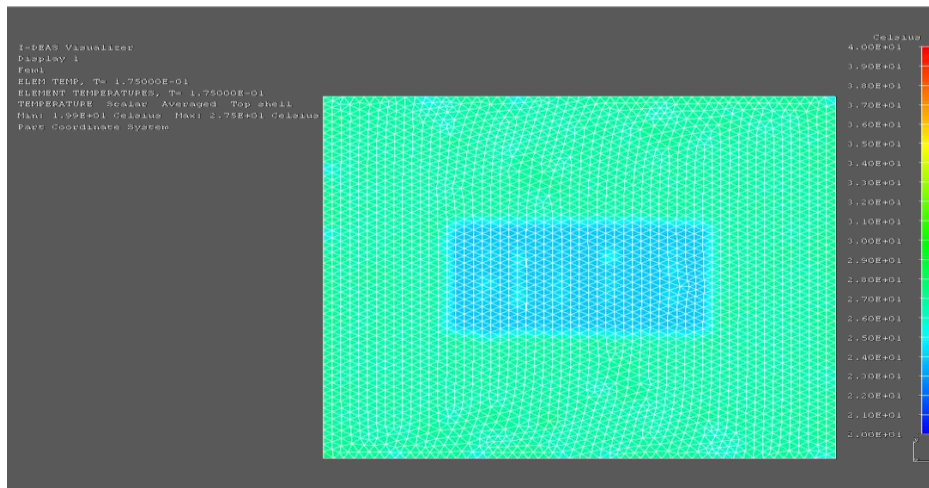
Figure 69 Laminate thermogram at sampling time 28ms

Figure 70 Laminate thermogram at sampling time 150ms

Figure 71 Laminate thermogram at sampling time 175ms

Figure 69-Figure 71 show snapshots of the surface temperature at various times after the application of the pulse. This proof of principle clearly shows that, for a 4mm sample, good contrast is obtained between the sound and defect area. It was observed that the thermal model detected the sub-surface defect as early as 28ms. The decay profile continued to show the defect on the surface temperature model.

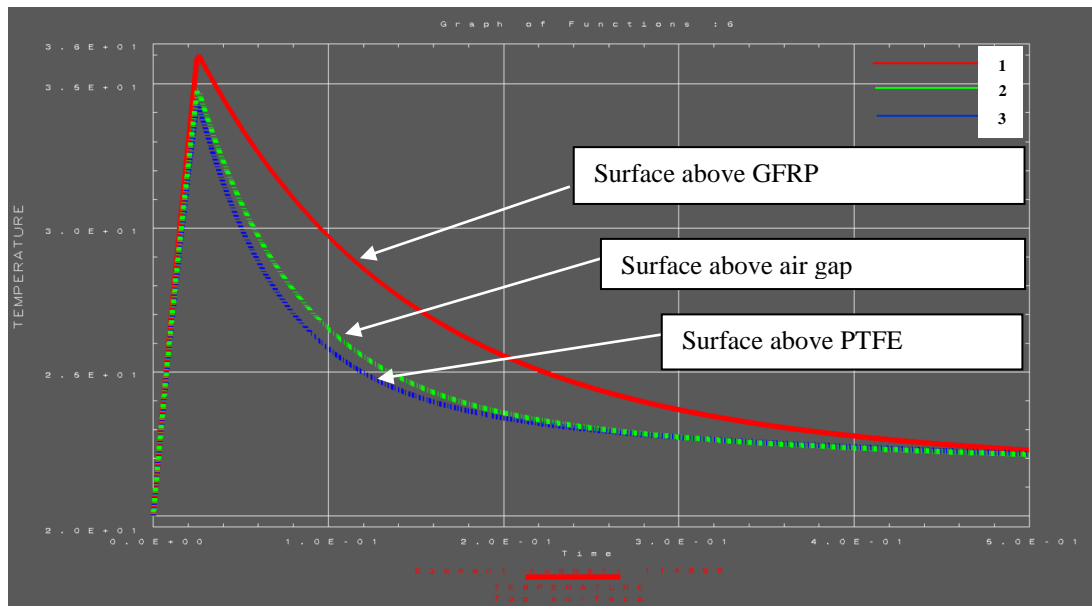
Figure 72 Log t-T plot for the laminate with PTFE; 1 – GFRP, 2 – Air Gap, 3 - PTFE

Figure 72 shows the log t-T plots for three selected points on the irradiated surface, directly above the defect-free GFRP, above the PTFE and above the air gaps. Again, these curves indicate good discrimination between the sound and defect area. The initial observation showed that the GFRP surface temperature for a sound area node showed a higher temperature than the air gap and PTFE. This model was obtained from a basic model with relevant boundary conditions as required. This clearly showed not only the ability of the software to reproduce a pulsed thermography model but also confirmed the experimental approach as a viable technique for detecting defects in composite samples of 4mm thickness.

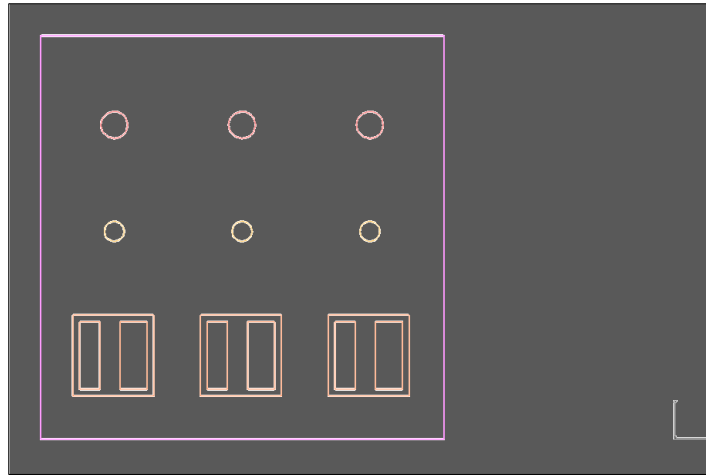
Figure 73-Figure 74 show the geometric model of the laminate with defects.

Figure 73 3mm laminate model with PTFE defects at different depths; top view

Figure 74 3mm laminate model with PTFE defects at different depths; side view

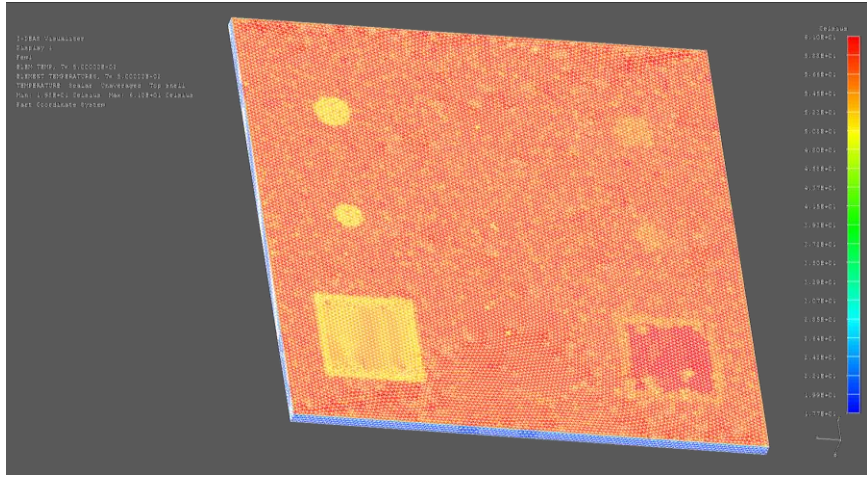
Figure 75 3mm laminate (120×120mm) with PFTE and air gap inserts; thermography sampling at 0.5s

Figure 75 illustrates good contrast between the laminate and defects obtained at 0.5 sec. Figure 76 (a)-(c) show the resultant log t-T plots for a 25ms pulse on the upper surface for defects at 0.5, 1.0 and 1.5mm below surface. Three points were selected: above the defect-free CFRP, above the PTFE and above the air gaps. The results indicate that defects in a 3mm sample are easily detectable by the thermography system with a sensitivity of $\pm 0.2^{\circ}\text{C}$.

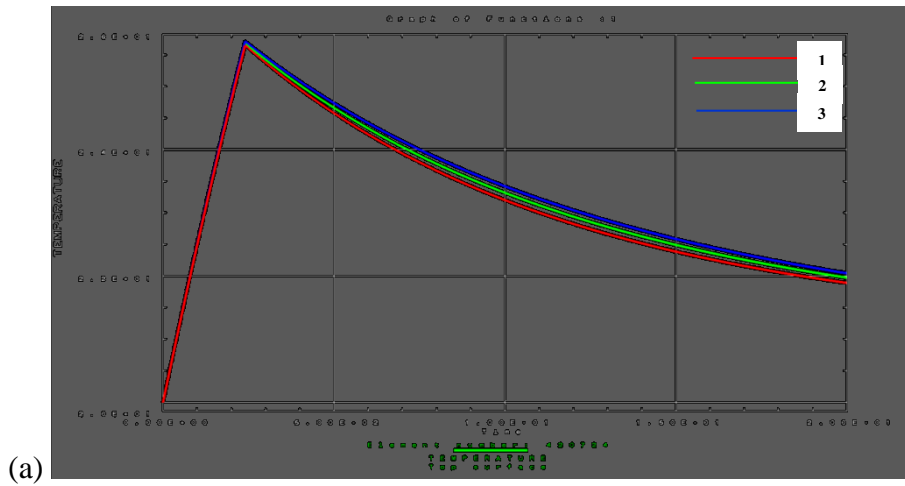
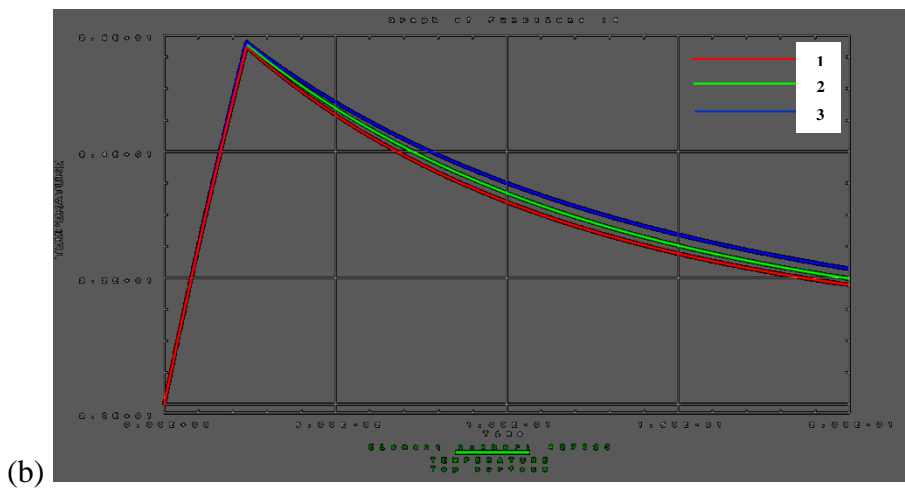
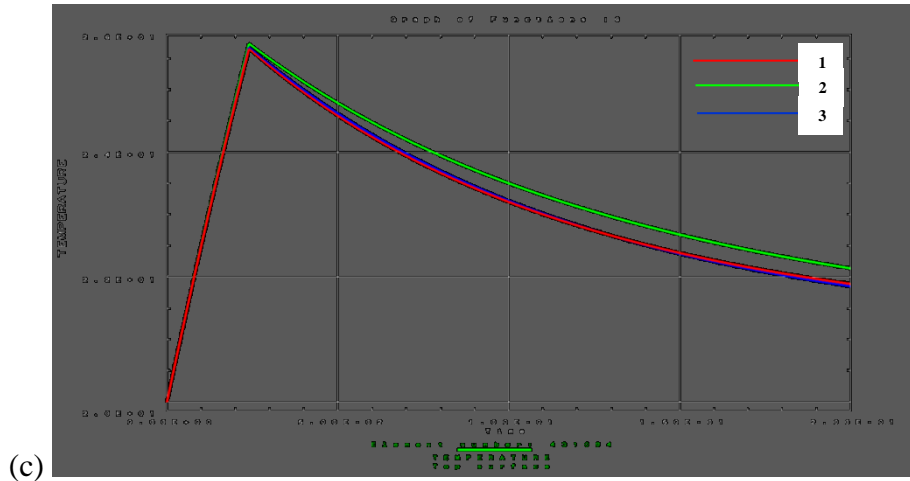
Figure 76 Log t-T plot for the 3mm laminate model with 1 – CFRP (Red curve); 2 – Air gap (Green curve); 3 – PTFE (Blue curve); Defect depth: (a) 0.5mm, (b) 1.0mm and (c) 1.5mm below surface

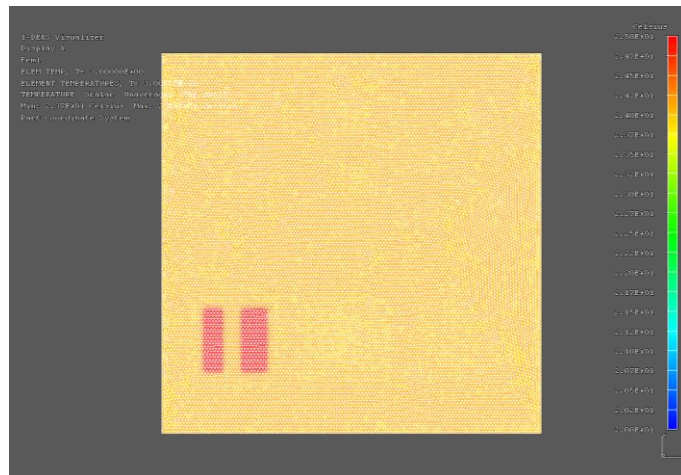
Figure 77 6mm laminate with PTFE and Air gap inserts; computed thermogram at 3s

Figure 78 – Figure 80 are the log t-T plot for the 6mm laminate with the individual defects occurring at depths 2.0mm, 2.5mm and 3.0mm. As before the CFRP is represented by the Red curve and the PTFE and air gap by Blue and Green curves respectively. It was observed that there was slight change in their thermal profile which is associated with their depth location. However, the trend line follows the sound areas curve represented by the Red curve. It was observed that the air gap defect appearing closest to the surface had an overall higher decay profile in comparison with the laminate profile. However, the computed thermogram does not identify all the buried defects as indicated by the time temperature plots.

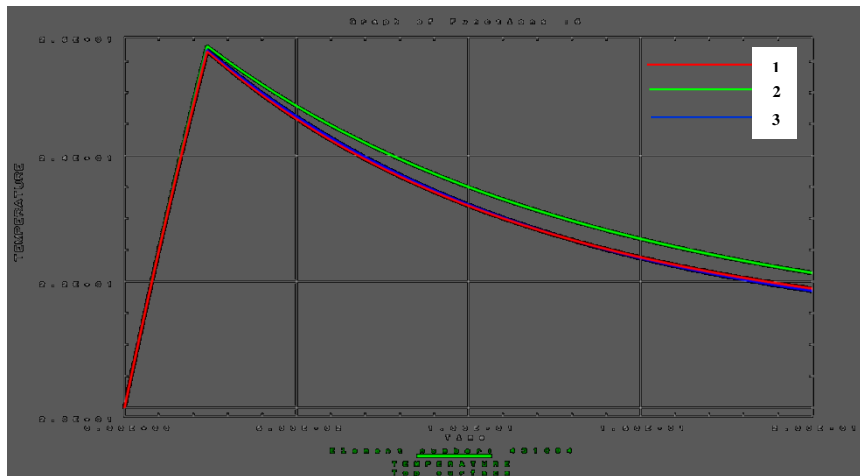
A further simulation was undertaken for a 6 mm CFRP sample, with PTFE/air defects buried at three levels; 2.0mm, 2.5mm and 3.0mm. Figure 78 shows the log t-T plot for the sampled points above the defects located at 2mm below the surface. Though we see the slotted aperture defect, we now observe the lack of discrimination relative to the defect free point, suggesting that pulsed thermography would struggle to detect defects at this depth.

Figure 78 Log t-T plot for the 6mm laminate model with 1 – CFRP (Red curve); 2 – Air gap (Green curve) and 3 – PTFE (Blue curve); Defect depth – 2.0mm

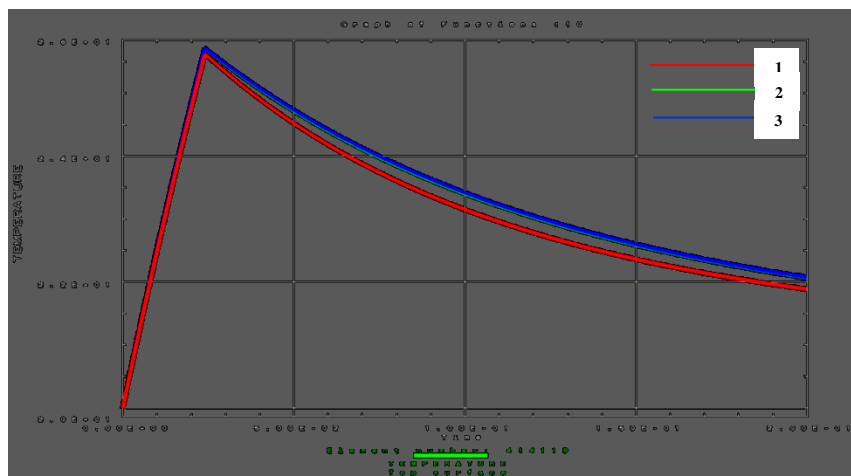
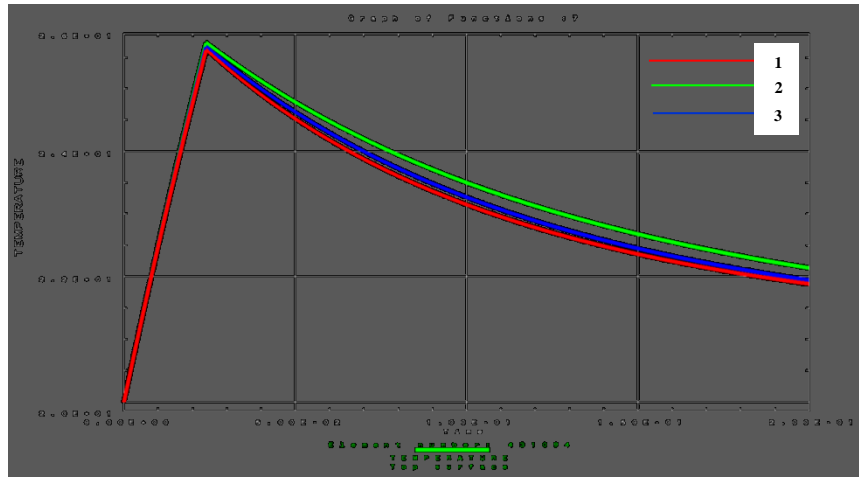
Figure 79 Log t-T plot for the 6mm laminate model with 1 – CFRP (Red curve); 2 – Air gap (Green curve) and 3 – PTFE (Blue curve); Defect depth – 2.5mm

Figure 80 Log t-T plot for the 6mm laminate model with 1 – CFRP (Red curve); 2 – Air gap (Green curve) and 3 – PTFE (Blue curve); Defect depth – 3.0mm

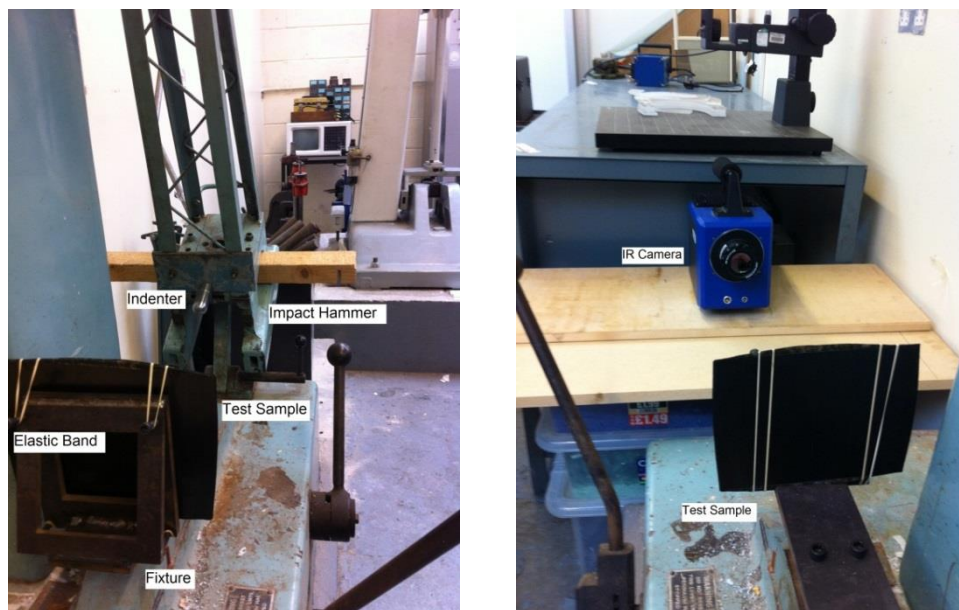
The impact experiment was carried out on Sample 1 using a modified Charpy impact tester. Figure 81 shows the initial experimental setup. A hemispherical indenter of 14mm diameter was attached to the conventional Charpy impact tester (Figure 82). A custom fixture as seen in Figure 82 was fabricated to hold the test sample in place. The fixture was designed based on British Standard –BS ISO

Figure 82 Indenter attached to the hammer on the left; and the infrared radiometer and test sample arrangement on the right

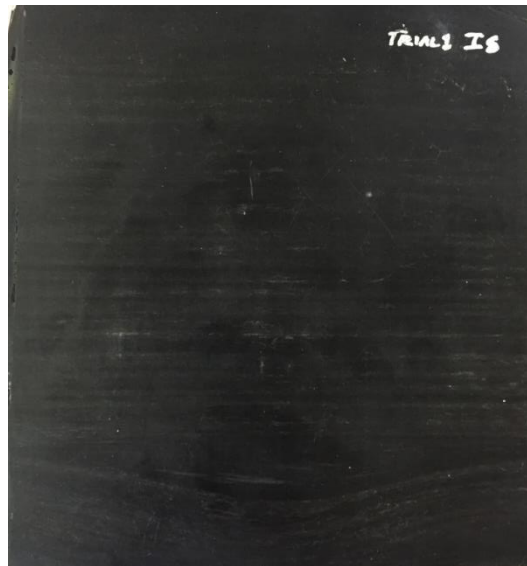
The sample (as seen in Figure 83) was manually laid up. The stacking sequence is $[0^\circ, 90^\circ, 0^\circ]_{2S}$. The sample was fabricated in the hot press as described previously. The cured thickness of the sample was 3mm and the overall dimensions of the sample were 150mm \times 150mm.

Figure 83 Digital image of CFRP Sample 1; Size 150 \times 150mm

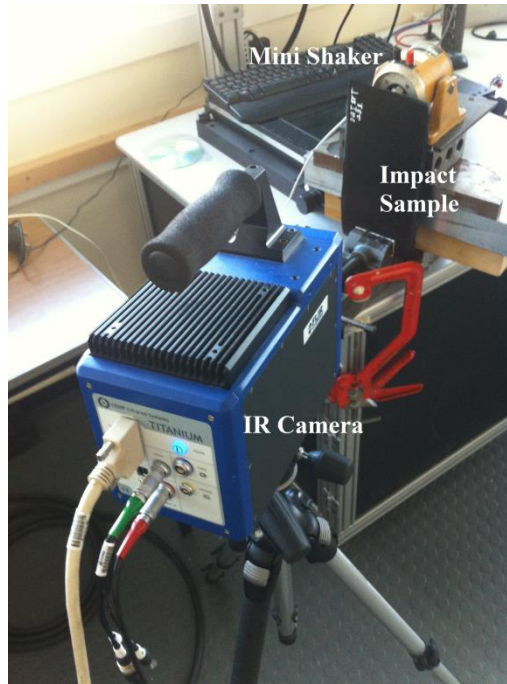
Figure 94 TSA experimental setup

Figure 94 shows the experimental setup for the TSA technique where the sample was excited using a mini electrical shaker at a synchronous frequency of ~10Hz. The IR camera looked directly at the impact side of the composite laminate from a distance of 500mm (note the image in Figure 94 is a representative image and not an exact measure of the distance). The mini shaker was controlled by a function generator and the frequency was set to 10Hz (sine wave). The sample was clamped to the table using a bench-top vice on one end and the other end rests against the shaker that has a rubber tip which excites the sample.

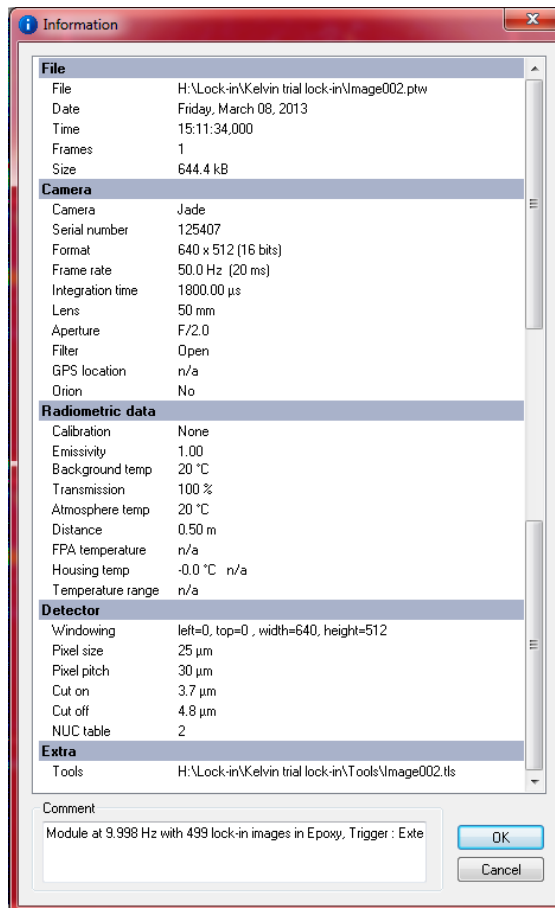
Figure 95 Cedip camera settings for TSA measurement

Description	Settings
Synchronisation frequency	9.998Hz
Acquisition frequency	25Hz
Acquisition length	500 frames

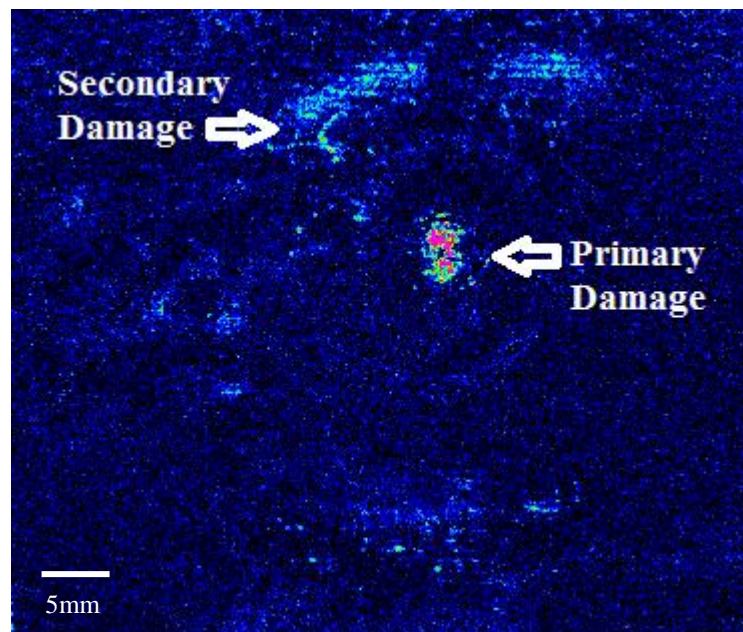
Figure 96 TSA image showing crush damage on the composite laminate at a synchronous excitation frequency of 9.998Hz

Figure 96 shows the module image obtained as a result of combination of the phase image and the amplitude image. Though the image is noisy, it clearly shows the primary impact damage in the centre of the image together with peripheral features which could be interpreted as secondary damage. The typical impact damage centre is characterised by a higher temperature pixel value indicated by the pink scale, whereas the surrounding areas on the sample show a darker image in the black to blue scale. As explained in the literature, this characteristic image is obtained as a result of heat developed due to the friction between damaged fibres at the crush area caused due to the sinusoidal vibration of the shaker. It should be noted that a significant change in temperature stress value does confirm the presence of primary damage.

It can be seen from the image (Figure 96) that there are areas where the temperature stress is higher than the sound area of the sample, especially at the periphery of the primary damage. This could be interpreted as secondary damage that was created as a result of the impact event. A better understanding of the impact event can only be understood from the live capture of the entire impact event.

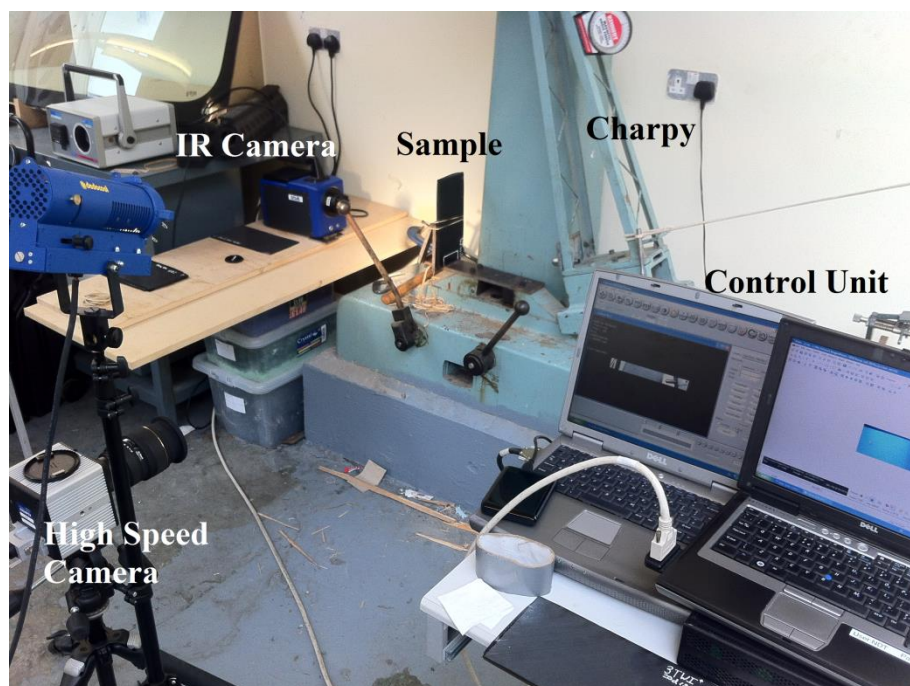
Figure 97 Modified Charpy Test Setup - now includes a high speed digital camera

Based on the preliminary testing, minor modifications were made to the test setup. This included the use of a high-speed digital camera capable of recording the entire impact even on the visual spectrum at a resolution of 1024×128 pixels and an acquisition speed of about 9000fps (frames per second – maximum) . At the same time, the IR camera was used at a reduced window size of 280×156 pixels to acquire data at 524Hz (maximum). The following is the modified Charpy experimental setup.

Figure 97 above shows the typical experimental setup of the Charpy testing which now includes the high speed digital camera.

As described in the preliminary tests (Figure 97), the infrared camera was setup in the transient mode and the entire impact event was recorded. It should be noted that the infrared camera only recorded the back surface of the laminate and following are the results obtained.
