A critical investigation of the use of infrared thermography
in determining the condition of composite materials

Submitted in partial fulfilment for the award of the degree of
Doctor of Philosophy

University of Wales Trinity Saint David

2017

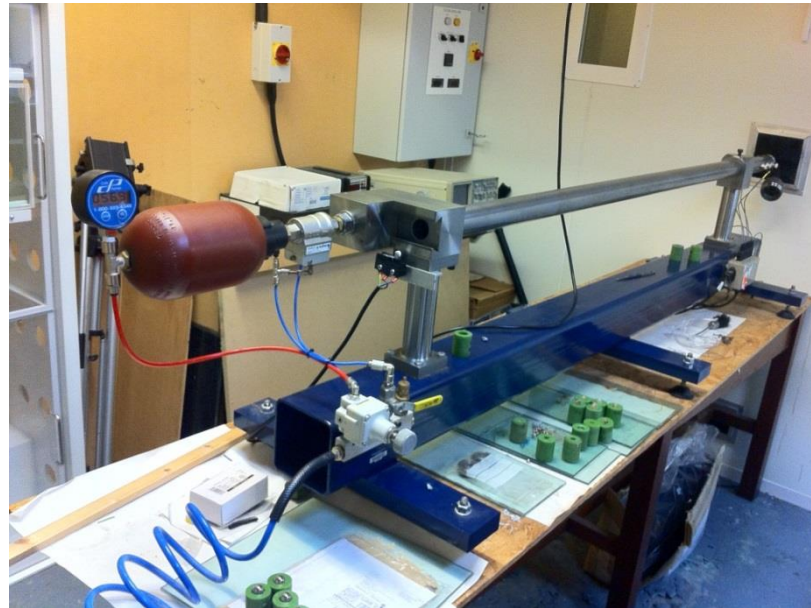
Figure 98 The Gas Gun - ballistic testing

Figure 98 to Figure 101 show the typical ballistic testing setup. Figure 98 shows the gas-gun housed in the operators room. This testing unit is separated by a climate controlled chamber that contains the gun firing end. The sabot with the stone is loaded into the gas gun as illustrated in Figure 99. The gas-gun has a barrel which carries the sabot to the impact chamber where the sample is housed at the exit of the gas-gun. A high speed camera and an IR camera are used to capture the events occurring in the impact side and non-impact side respectively (Figure 100-Figure 101).

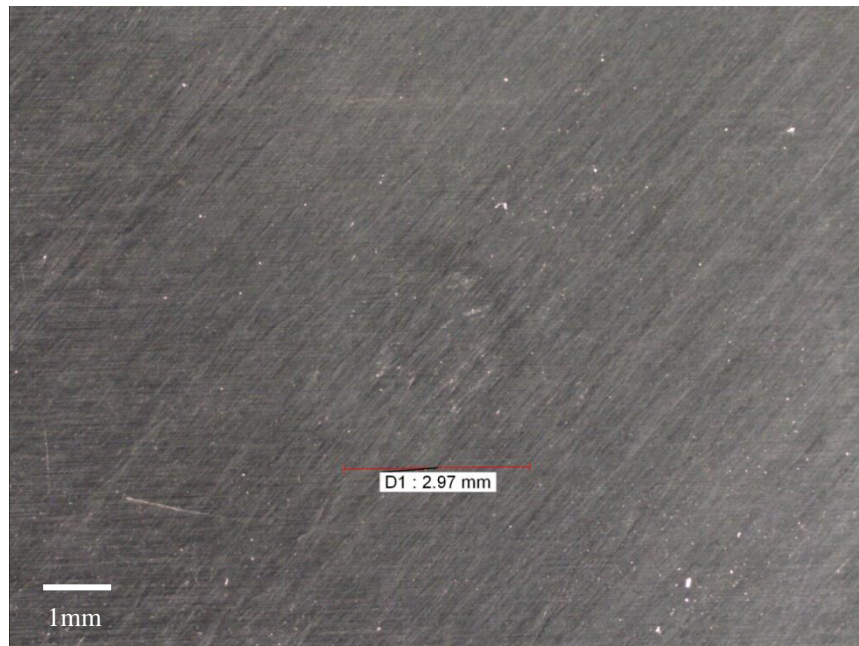
Figure 102 Sample: 3QI20d12JC2 - microscopic image with damage dimension

The microscopic image of the sample shows areas of deformation, indicated by the depression in the centre of the sample together with the actual size of the damage. It shows that the damage about 3mm has been created when the Charpy indenter impacted the sample at the estimated impact energy of 12J. The damage, though visible, had been well rounded and no severe crush damage has been found. In other words, though the sample surface has undergone a plastic deformation due to the impact energy, no fibre breakage or crush damage has been found on the sample surface.

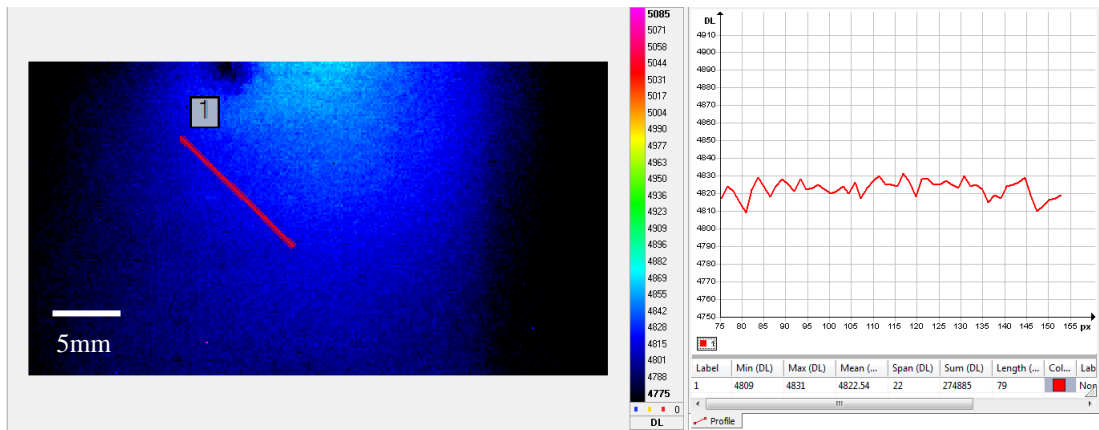
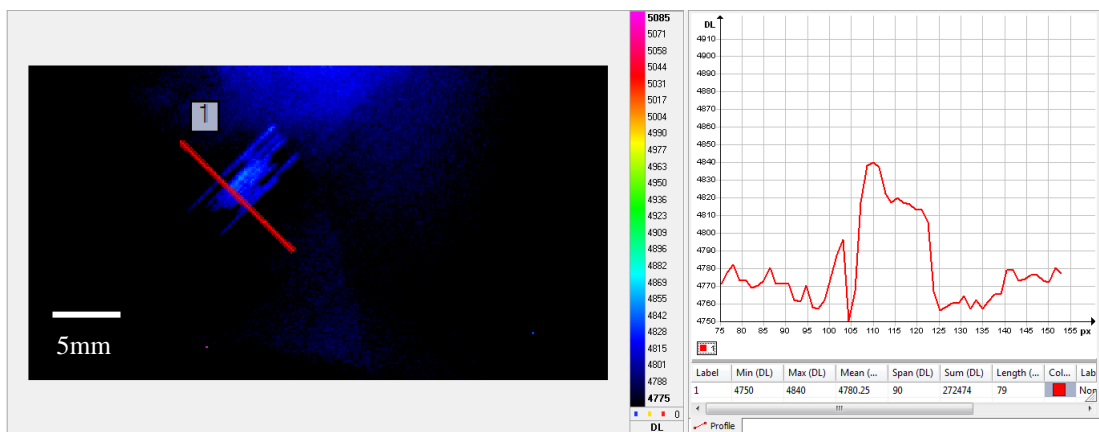
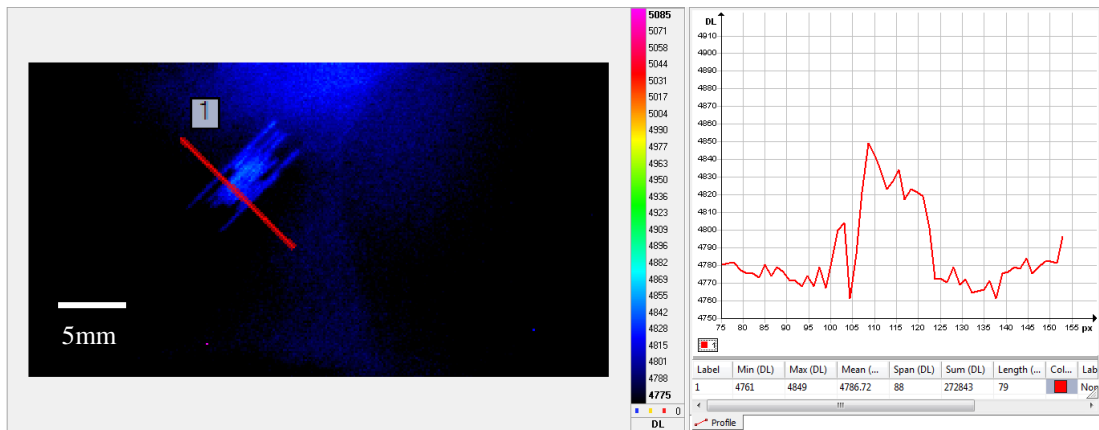
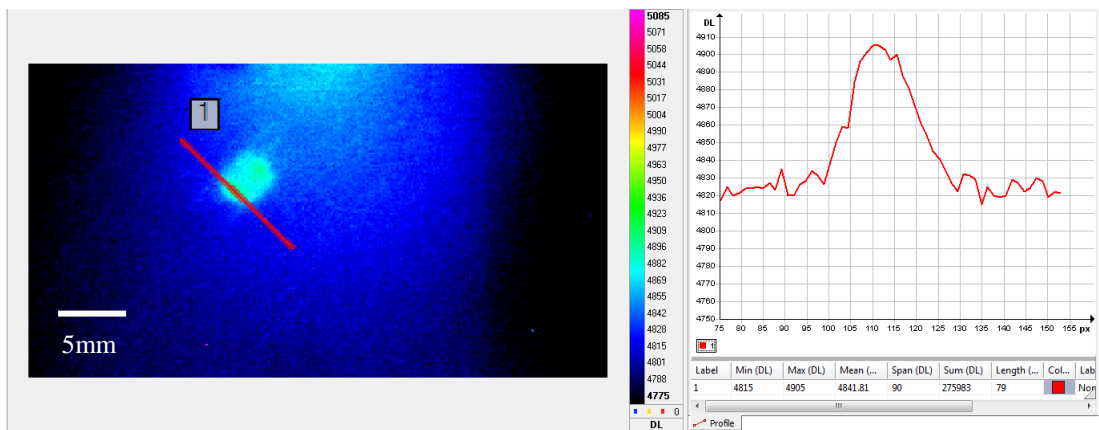
The images above (Figure 104 to Figure 108) were acquired at an acquisition frame rate of 542.1Hz for a window size of 288×156 at a camera integration time of 1ms. It can be seen from the above set of images that just after the impact event, there is a stress concentration around the fibres, which had direct contact with the indenter head. The initial impact stress beyond the strength of the fibre has led to the

plastic deformation stage with a possible fibre breakage as observed in the preliminary trials in section 4.3. Thus the resultant of the impact led to the deformation of the sample. It should be understood that the various features that constitute the impact event in CFRP are, the initial impact noise, the shock wave propagation through the material including the flexing of the laminate, creation of damage itself, and heat generated as a result of this complex process. Though the impact event can be suspected to have been completed at the first frame, the heat generated from the front surface has not completely been transmitted to the back surface and is dependent on the thermal conductivity of the material. Hence the heat continues to rise on the back surface until it becomes a circular area with a higher temperature. It can be seen that Frame 1 shows the temperature rise along the fibre orientation as seen in the preliminary tests in section 4.3.1. This temperature rise along the fibre orientation continues to rise until the heat generated due to contact between the indenter and the laminate reaches the back surface of the laminate.

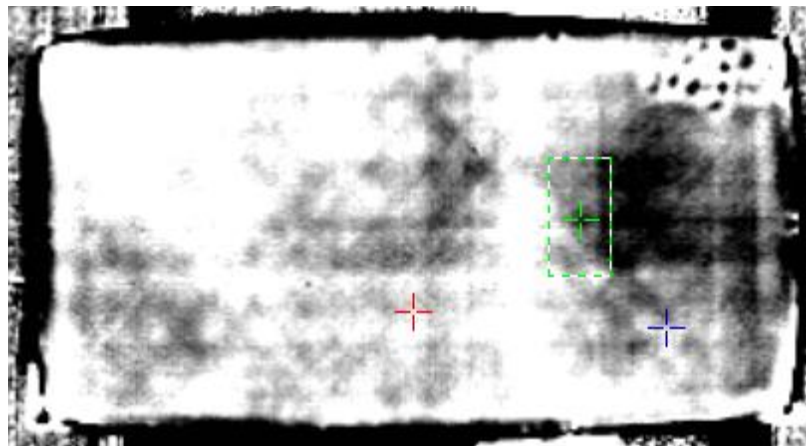
Figure 109 Pulsed thermography result; Sample: 3QI20d12JC2; Size: 200×100mm; 2D Image; Sampling: 90fms

It can be seen from the digital image and the microscopy image that the damage is an indentation on the surface. A careful visual surface inspection did not yield any severe damage such as delamination or crush damage either on the front or the back surface. The sample was completely intact and no surface breaking damage was found, for all trials. When subjected to pulsed thermography, for a t^* of 3.975s, neither the RAW thermal nor the 2D image yielded strong contrast confirming the presence of damage. This is because of the fact that the impact event ended up in the form of an intact dent and did not create a severe delamination and or surface breaking damage, indicating that the thermal diffusion in that area is quite similar to that of the non-damage area. Though the transient thermography captured the flexing of fibres due to the initial impact shock wave, it has not caused major damage.

But even with this barely visible impact damage, pulsed thermography does show some indication of damage presence does not however validate the damage created. This can also be seen with the high noise level in the thermogram. It should be noted that in the real world, this type of damage could be missed without knowing the exact location of the damage. This is primarily due to the high level of noise due to the structure of the laminate itself.

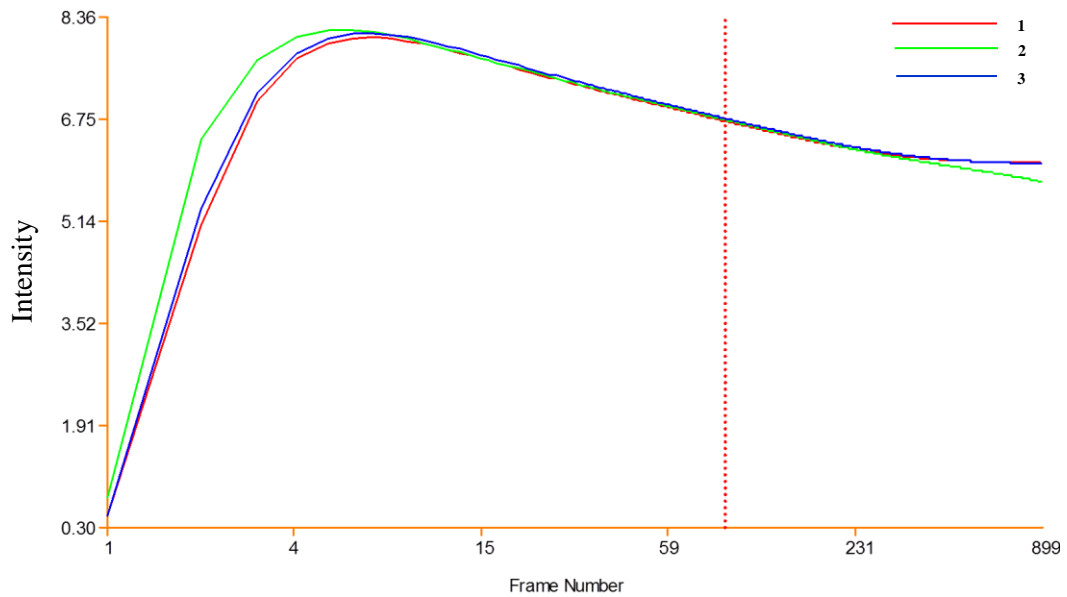
Figure 110 Pulsed thermography result; Sample: 3QI20d12JC2; RAW Thermal plot;
1&3 – sound area, 2 – damage area

Further the RAW thermal logarithmic time temperature plot as seen in the image above shows that the damage is barely noticeable. The damage does not show

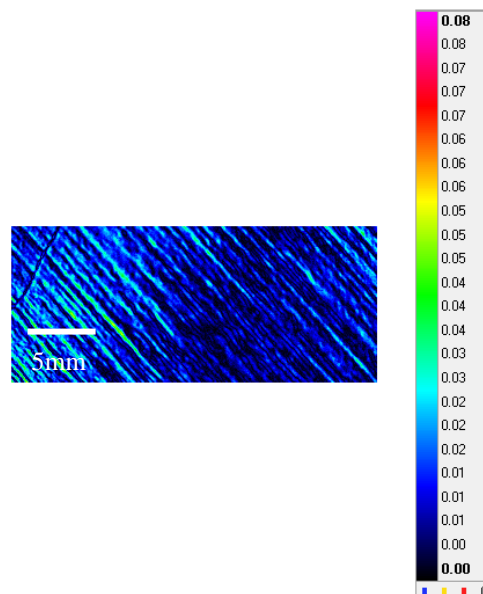
Figure 112 TSA map of Sample 3QI20d12JC2

Several trials were attempted to capture the above result. It was observed that other than a small change in the weave pattern, there was no indication of any damage. It should be noted that the intensity of the stress map was similar to the sound area thus failing to provide a clear distinction between the damage and the sound area. The tests in this case were inconclusive, suggesting that the stress build up on the damage area did not create any friction between fibres as the fibres were still intact, as suggested by the pulsed thermography results presented above.

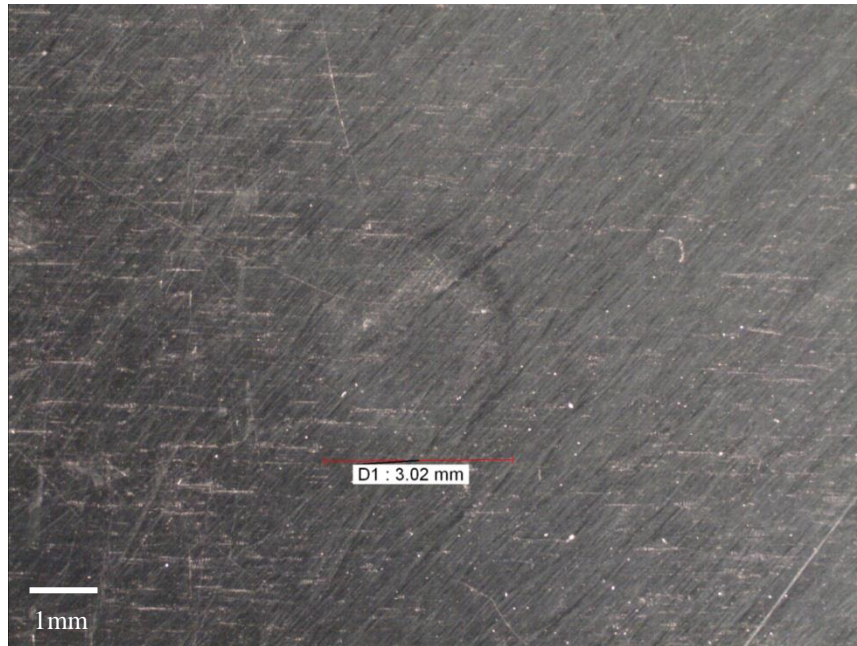
Figure 113 Microscopy image of 3QI16d8JC2 with damage dimensions

It can be inferred from the image (Figure 113) obtained from the microscope that the damage indentation is quite similar to that of the 12 J Charpy impact as presented above. Again a similar visual dent or dislocation appears on the surface of the sample, suggesting that the sample has undergone plastic deformation as indicated by previous results confirming the damage creation methodology as established previously.

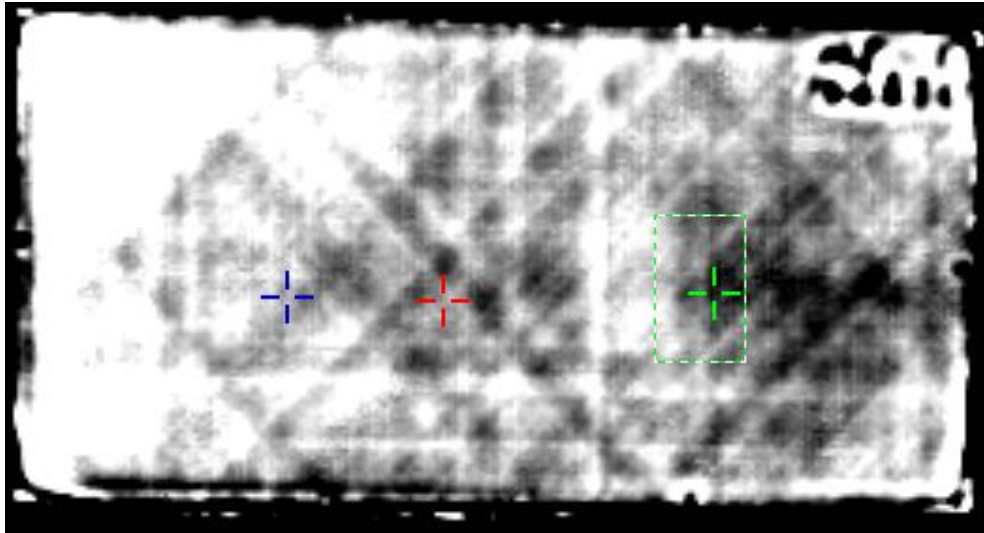
Figure 119 Pulsed thermography result; Sample: 3QI16d8JC2; Size: 200×100mm; 2D Image; Sampling: 90fms

From the RAW thermal log t-T plot, it was observed that the data pattern is quite similar to the 12J Charpy impact sample with the t^* occurring at 3.975s. In this case, the pulsed thermal image does not clearly show the damage. The marker was placed based on an estimated damage location and hence cannot be used to deduce the results. Thus pulsed thermography results are inconclusive in this case.

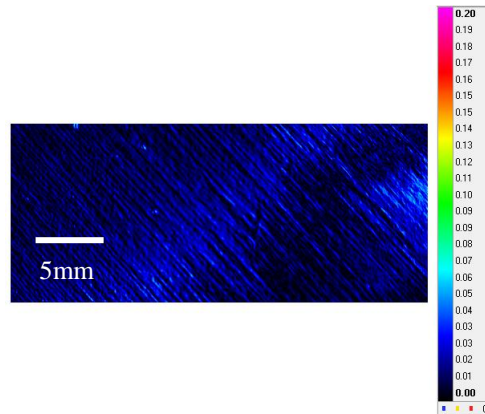
Figure 121 TSA stress map of Sample 3QI16d8JC2

The above image is the average image obtained from exciting the sample at 10Hz for an acquisition length of 2999 images. The image again fails to show any localised stress similar to the previous results (12J sample).

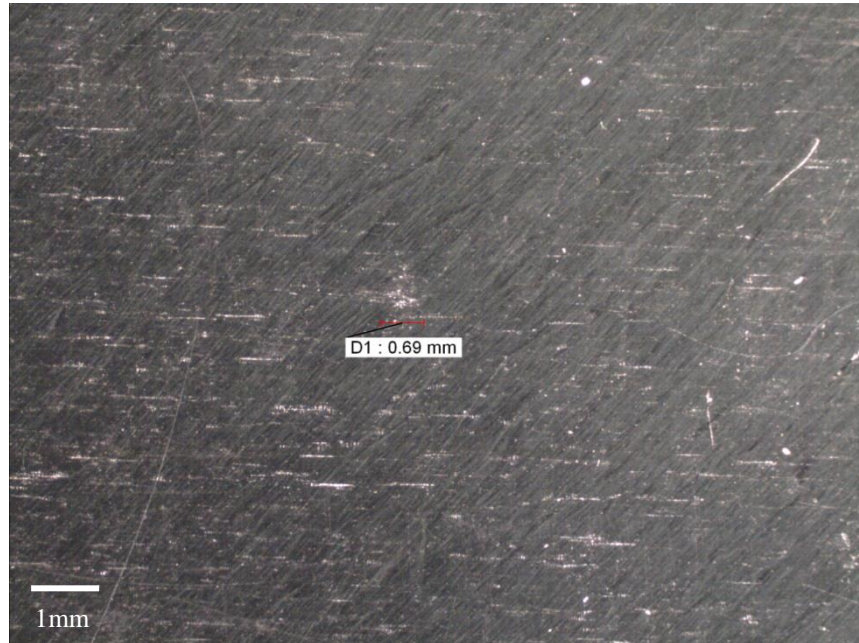
Figure 122 Microscopy image of 3QI12d4.5JC3 showing damage site – no visible damage

In this case, the damage is barely visible both visually and through the microscope. There is no visual deformation as seen in the previous cases (12J & 8J impact) and the size of the damage is relatively small (~0.7mm).

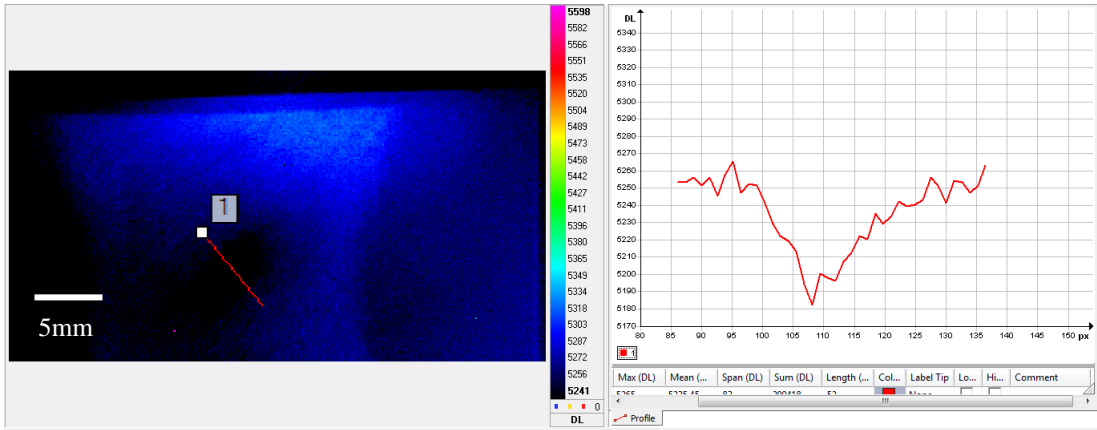
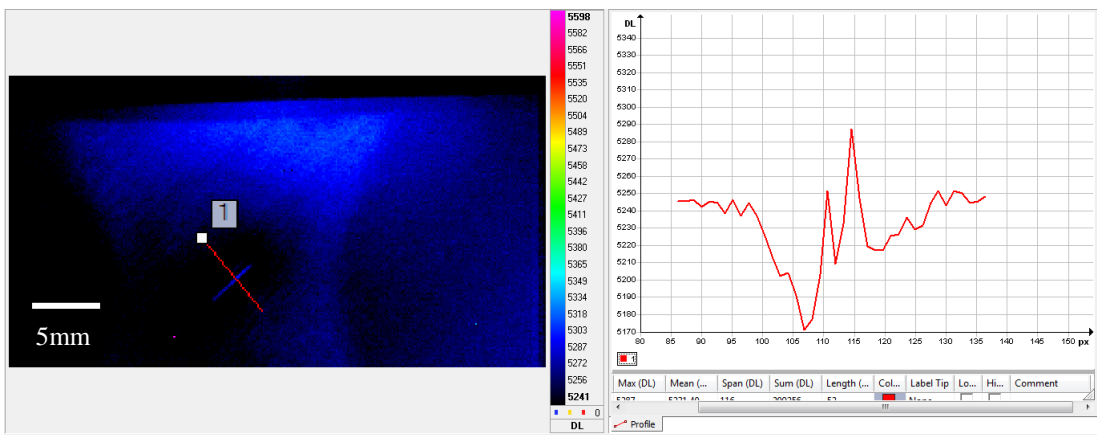
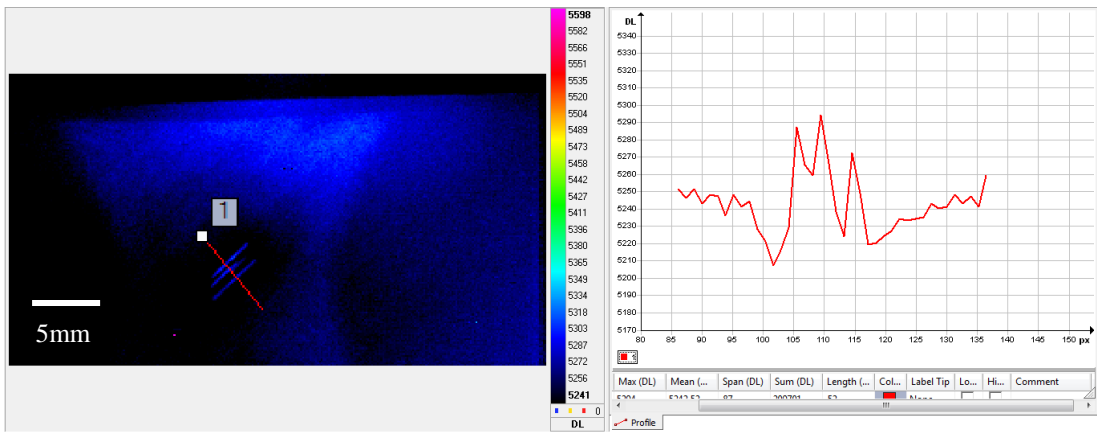
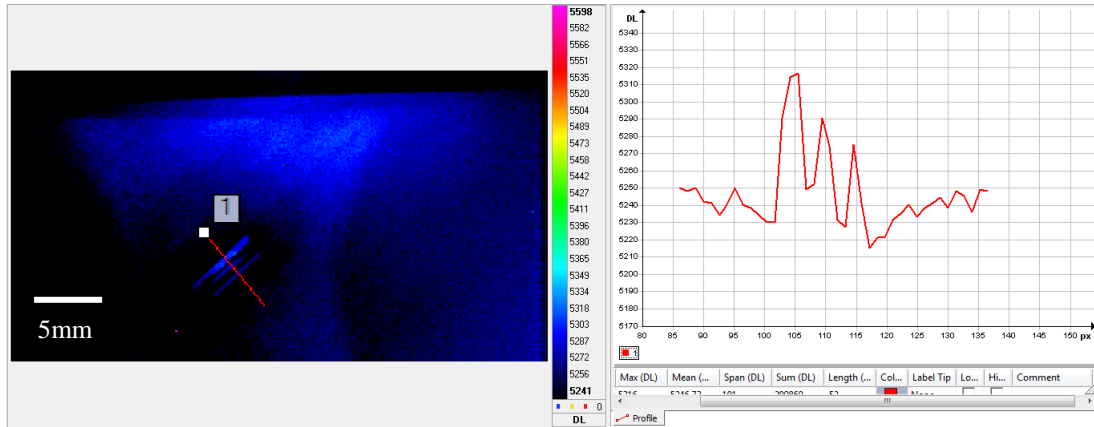
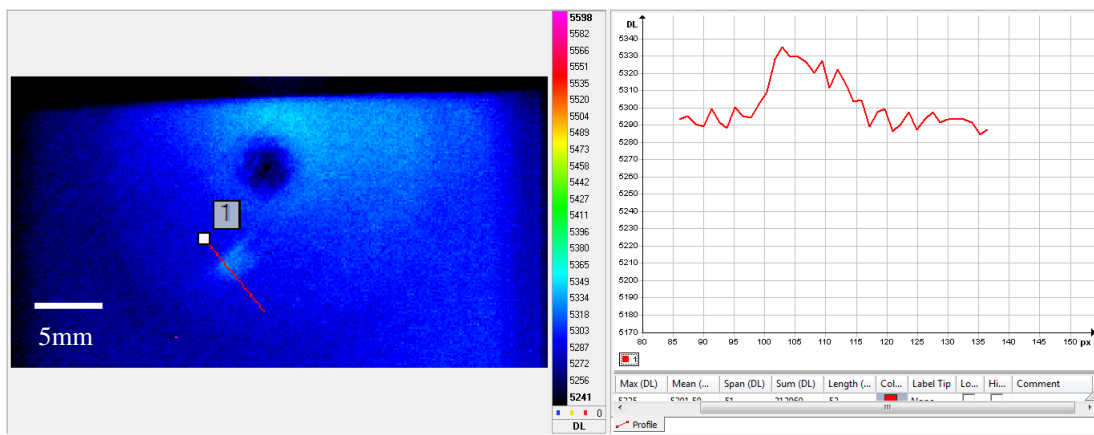
From the above set of images, it was observed that at a lower energy there is first drop in temperature as observed in the 8J impact case. This temperature continues to drop until the first stress on the fibre appears in Frame 5. Further, it was seen that the lower and higher temperature areas continue to appear side by side as the damage stress, now past the thermoelastic zone continues to grow from Frame 5 – 7. At Frame 8 it changes to a faint overall temperature pattern not completely circular as seen in the previous cases. However the temperature around the damage region continued to rise which can be inferred from the temperature pixel profile plot as seen in the images above.

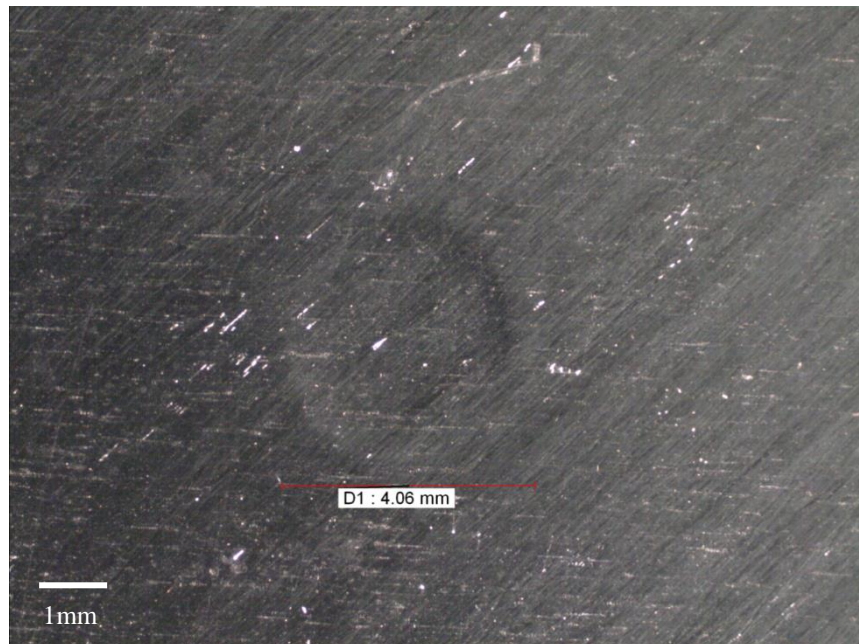
Figure 131 Microscopic image of 3TWI20d12JC3 with dimension of the damage

Both the visual and microscopic images show a good level of damage that is clearly visible. It was also noticed that all trials had similar effects indicating that the damage creation is dependent on the laminate's stacking or lay-up sequence.

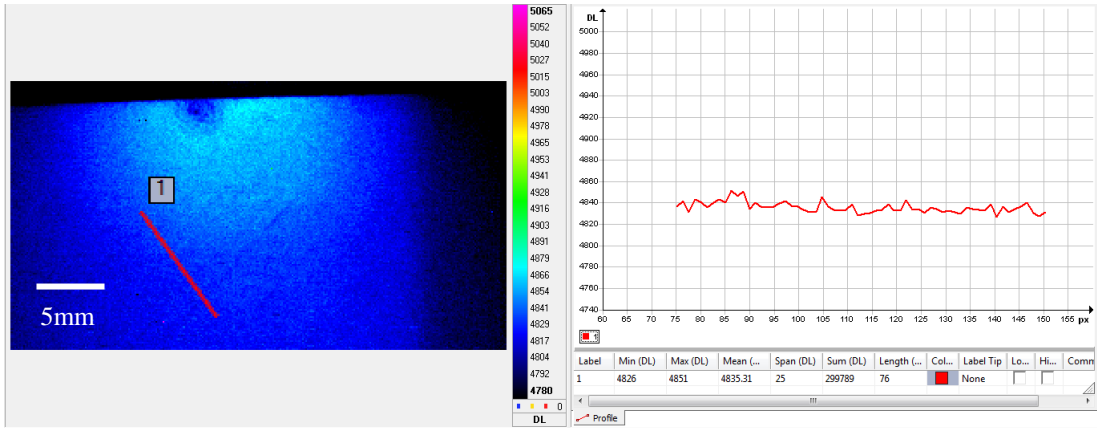
It can be seen from the above set of images that the temperature response time is much longer with the 12J impact. As before the individual stress concentrations along the fibre orientation is very clear until it hits Frame 8 where two localised areas of high temperature form on the thermogram. These then form into a single circular area showing a higher temperature range than the surrounding damage free area as the heat diffusion reaches the back wall (as seen in Frame 20).

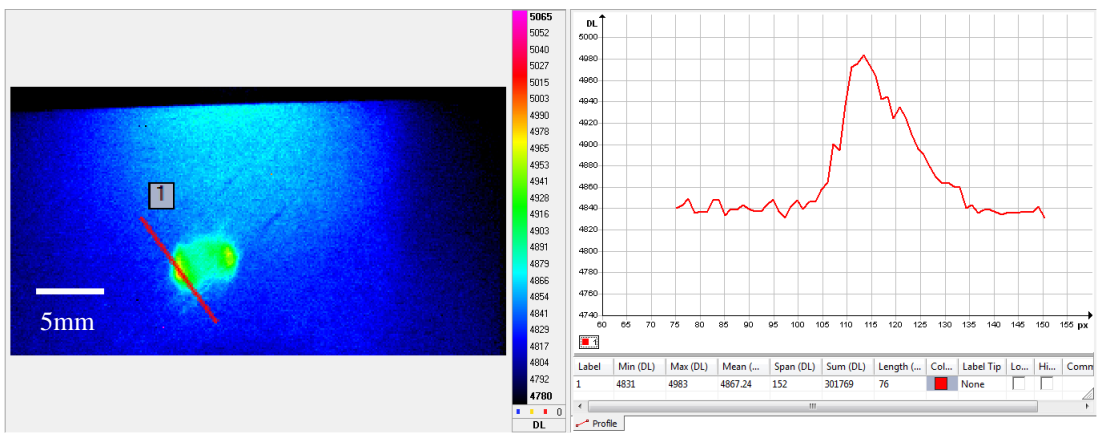
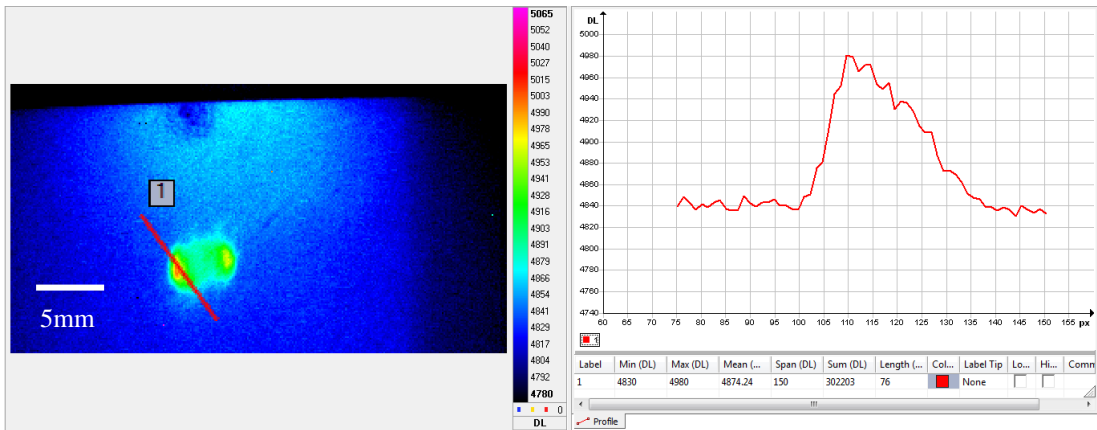
Figure 136 Sample: 3TWI20d12JC3 at Frame – 8

Figure 137 Sample: 3TWI20d12JC3 at Frame – 12

Figure 138 Sample: 3TWI20d12JC3 at Frame – 20

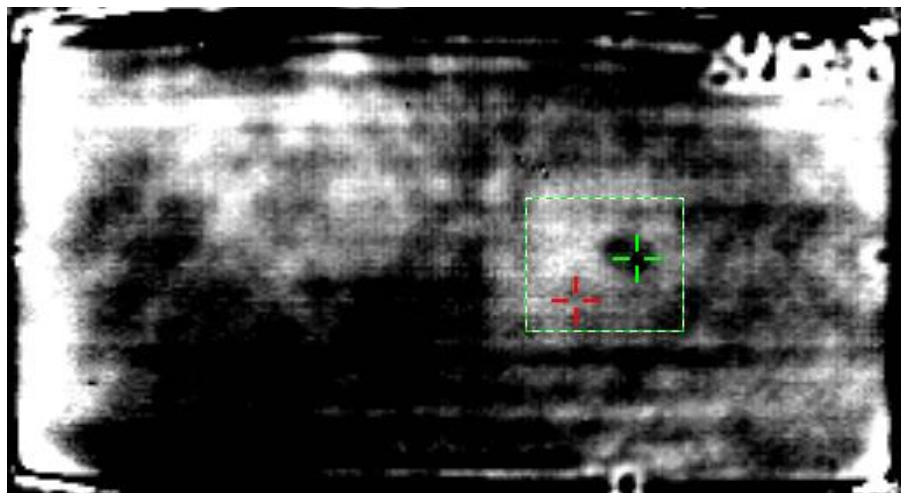
Figure 139 Pulsed thermography image; Sample: 3TWI20d12JC3; Size: 200×100mm; 2D image; Sampling: 90 frames

As before there is no clear distinction between the damage and the sound area of the sample as seen from the log time temperature plot above. However, with image analysis, the damage appears on the thermal image. The pattern is quite similar to that of the transient thermography results showing twin concentric areas of damage. It should be noted that the overall noise level on the thermogram and the close behaviour in terms of the time temperature curve makes it challenging to establish the feature as damage.

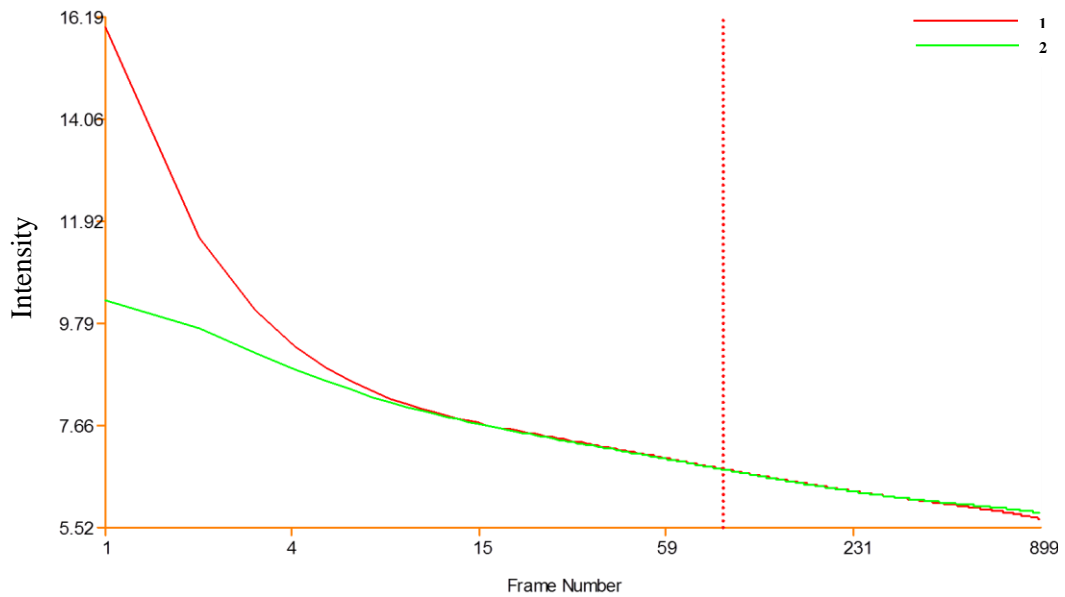
Figure 140 Pulsed thermography image; Sample: 3TWI20d12JC3; Log t-T plot;
1 – sound area, 2 – damage area

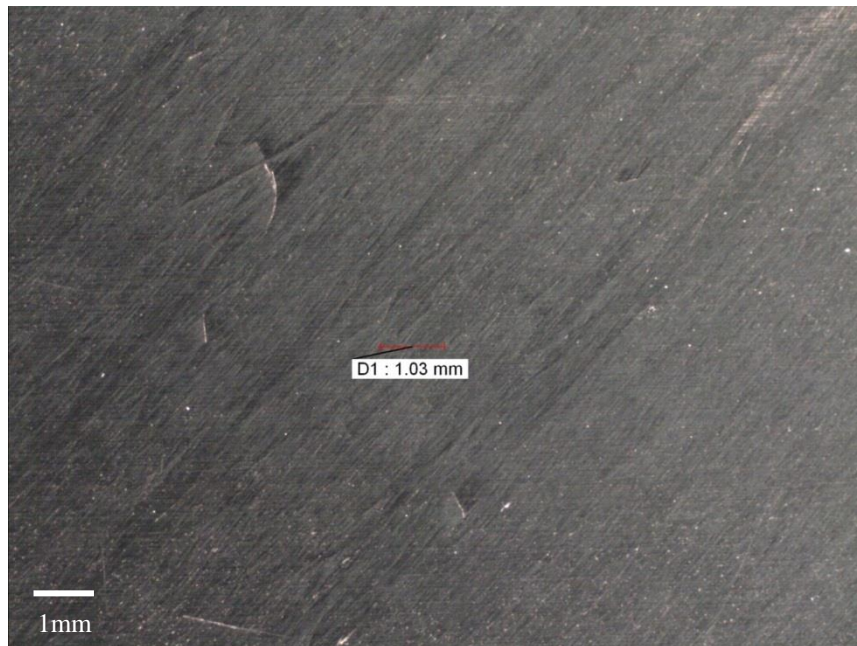
Figure 141 Microscopic image of 3TWI16d8JC2 with dimensions of damage

The deformation formed as a result of impact is barely visible from the microscopic image above and does not show any additional indications confirming the presence of damage in the laminate.

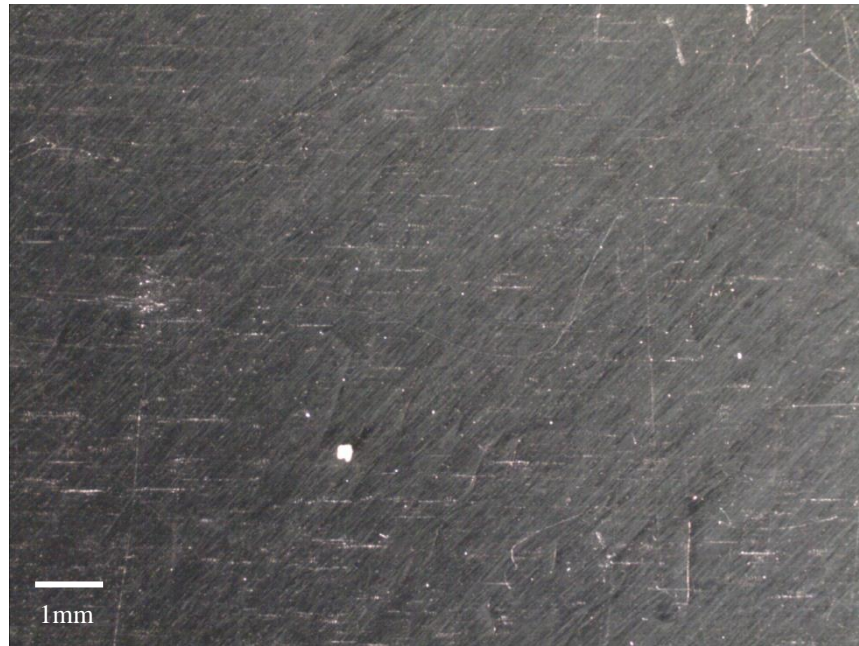
Figure 149 Microscopic image of 3TWI12d4.5JC3

The microscopic image does not show any indication of damage and hence the result is inconclusive.

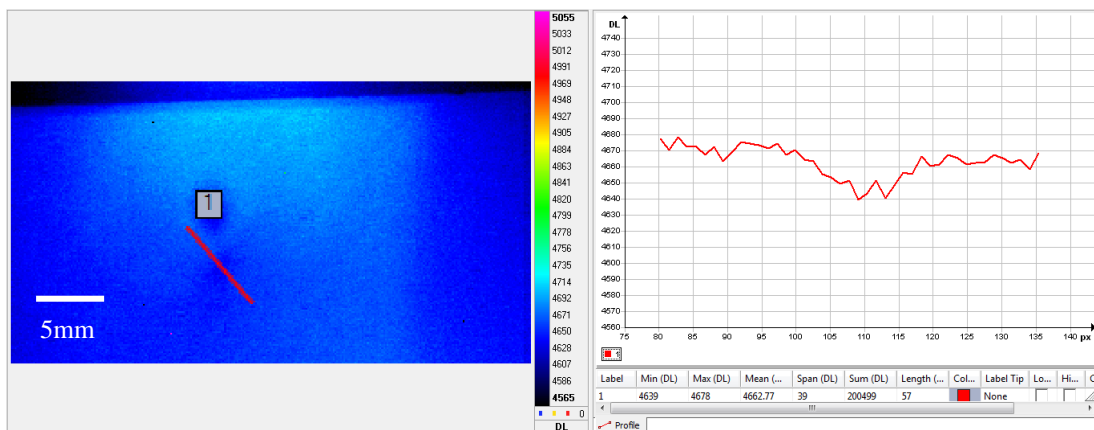
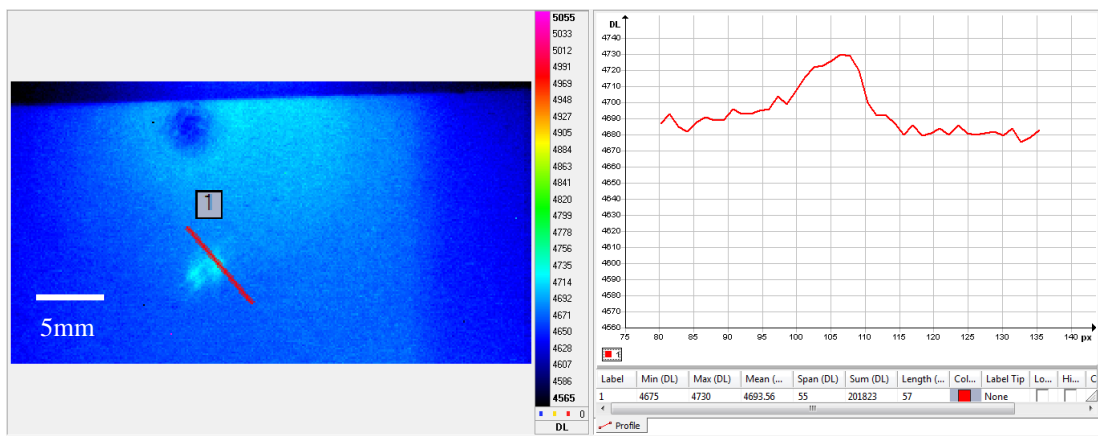
Figure 150 Sample: 3TWI12d4.5JC3 at Frame - 0

Figure 151 Sample: 3TWI12d4.5JC3 at Frame – 1

Figure 152 Sample: 3TWI12d4.5JC3 at Frame – 2

Figure 153 Sample: 3TWI12d4.5JC3 at Frame – 3

Figure 154 Sample: 3TWI12d4.5JC3 at Frame – 4

Figure 155 Sample: 3TWI12d4.5JC3 at Frame – 6

For the 4.5J Charpy impact on 3mm TWI laminate, only transient thermography data shows the localised temperature rise along the fibre direction and follows the same heat diffusion pattern as observed before. All remaining inspection methods including microscopic evaluation, pulsed thermography and TSA methods do not detect the damage. This leads to a possible conclusion that the damage created is so small that it is beyond detectability threshold of the detection systems. One possible way of detecting this change could be through sample sectioning and microscopic evaluation for localised cracks. Due to the nature of the work, only selected NDT techniques have been applied for damage detection.

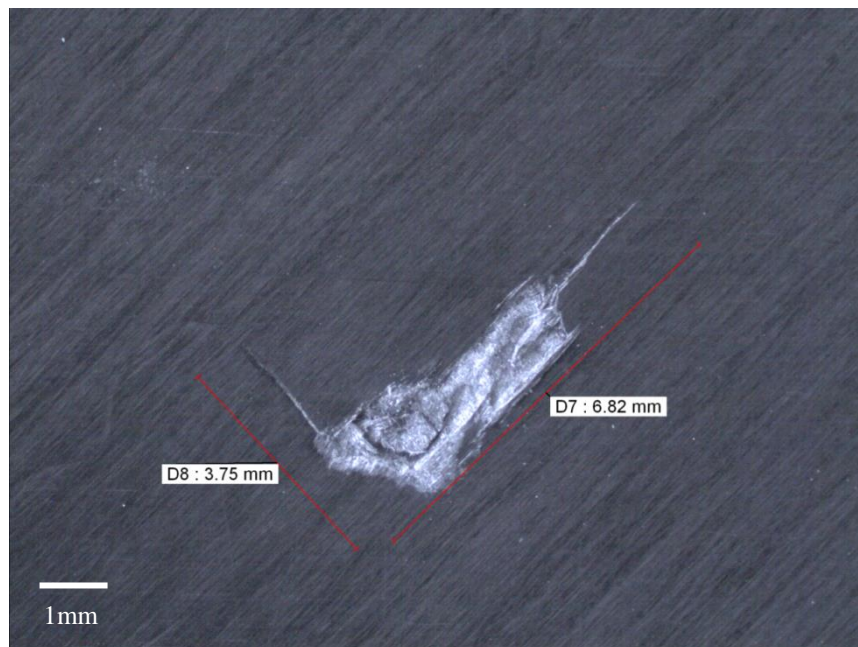
Figure 156 Microscopic image of 3QI12JS2

The above microscopic image shows the major damage created due to the gas gun impact testing using a stone of mass 6.7g and was set to impact at a velocity of 60m/s as described at the start of the section 4.4. The impact event created severe crush damage together with fibre breakage for an estimated area of 25.58 sq.mm as illustrated in the image above. Previously, the Charpy had a well-defined hemispherical indenter head creating a standard defined load condition as described in the literature and hence no surface breaking damages occurred and the laminates were left with surface dents. However, in case of the gas gun, stones were used to achieve the damage, and the rough surface of the stone has created localised high

stress at the impact area. There is existing evidence that the damage type created is dependent on the impactor shape (Mitrevski, Marshall et al. 2005). As the stone has sharp edges, the area of contact is a point load as opposed to a surface load, which explains why crush damage was created in this case.

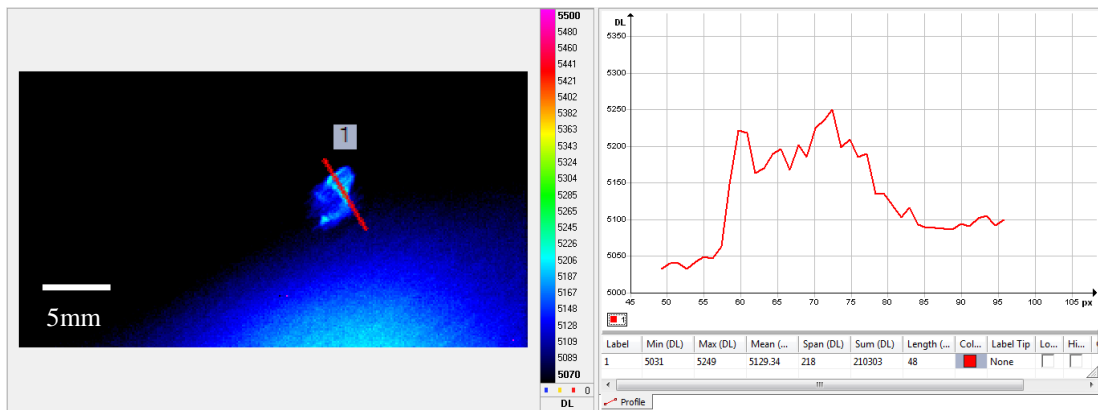
The following results were obtained during the impact event. As described in the earlier parts of section 4.4, the impact event was observed from the back surface of the laminate with the acquisition frequency of 542.1Hz and a window size of 288×156 pixels for an integration time of 1ms.

Figure 157 Sample: 3QI12JS2 at Frame - 0

Figure 158 Sample: 3QI12JS2 at Frame - 1

Figure 159 Sample: 3QI12JS2 at Frame - 2

Figure 160 Sample: 3QI12JS2 at Frame - 3

Figure 161 Sample: 3QI12JS2 at Frame - 8

The above transient thermograms for the 12J gas-gun impact test do show a similar stress pattern occurring along the fibre orientation initially as see with the Charpy samples above. However, the heat shape pattern is irregular at the heat diffusion takes place indicating that the back wall heat pattern is dependent on the impactor type and geometry. For the Charpy it was circular due to the hemispherical indenter, whereas for the gas-gun, it reflects the irregular shape of the stone. It was

also observed that the temperature at the impact area was higher in comparison with the Charpy impact.

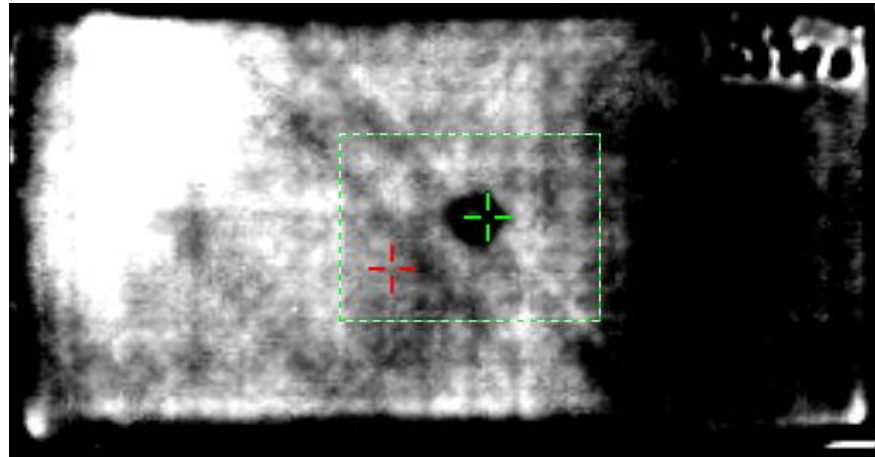
Figure 162 Pulsed thermography results: Sample: 3QI12JS2; Size: 200×100mm; 2D image; Sampling: 55fms

The pulsed thermography results clearly show the damage created due to the impact event. This can also be seen in the log t-T plot above where the damage has a higher heat capacity (indicated by green curve & marker) than the sound area of the laminate (indicated by red curve & marker).

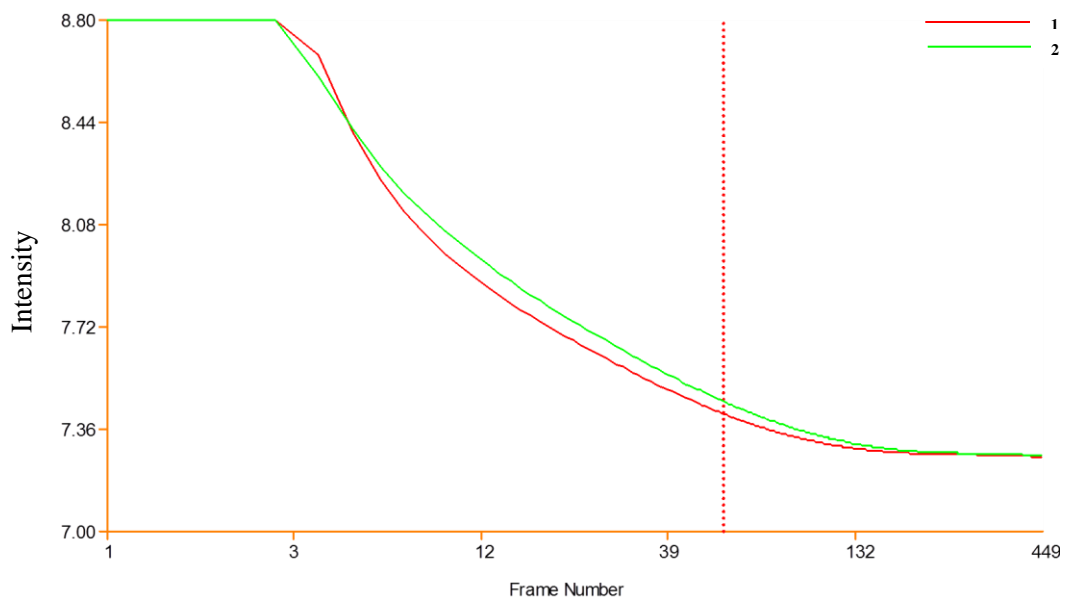
Figure 163 Pulsed thermography results: Sample: 3QI12JS2; Log t-T plot; 1 – sound area, 2 – damage area

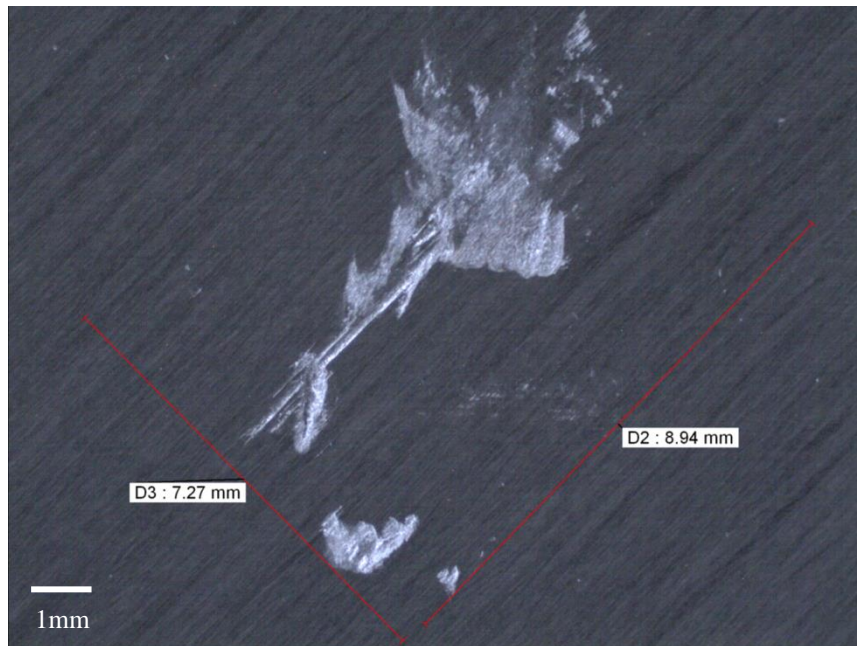
Figure 165 Microscopic image of 3QI8JS1 with dimensions of damage

As before, the stone ($m=5.9g$; $v=52.07m/s$) impact on the surface has created the crush damage with cracks occurring along the fibre orientation for the impact energy of 8J.

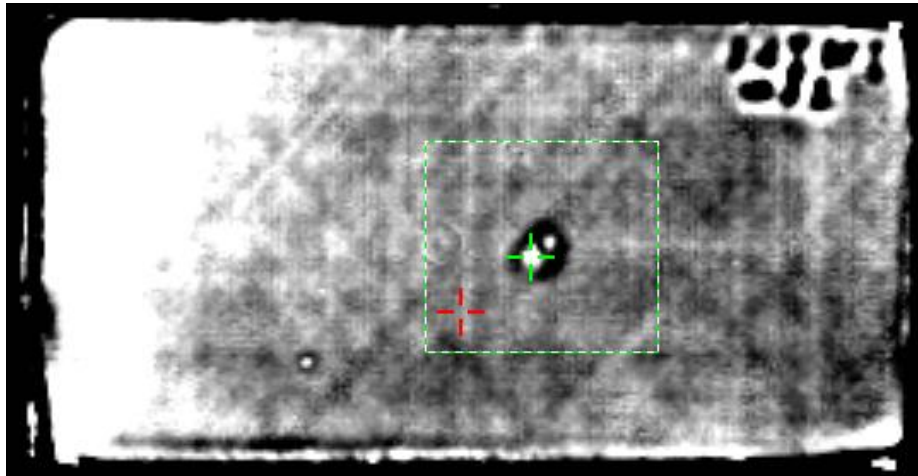
Figure 170 Pulsed thermographic image; Sample: 3QI8JS1; Size: 200×100mm; 2D image; Sampling: 55fms

From the pulsed thermography data, the damage is clearly visible, also confirmed by the log t-T plot above. The image also shows two distinct hot spots and can be correlated to the transient thermography data validating the damage occurrence in the laminate. The crush damage has also caused further sub-surface damage as indicated by the thermogram above.

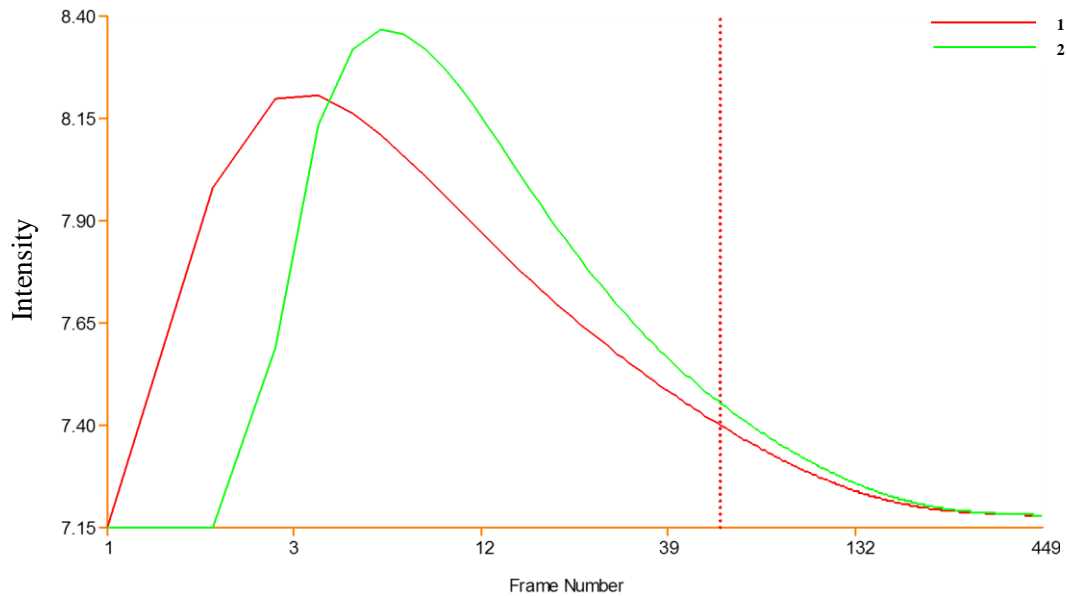
Figure 171 Pulsed thermographic image; Sample: 3QI8JS1; Log t-T plot; 1 – sound area, 2 – damage area

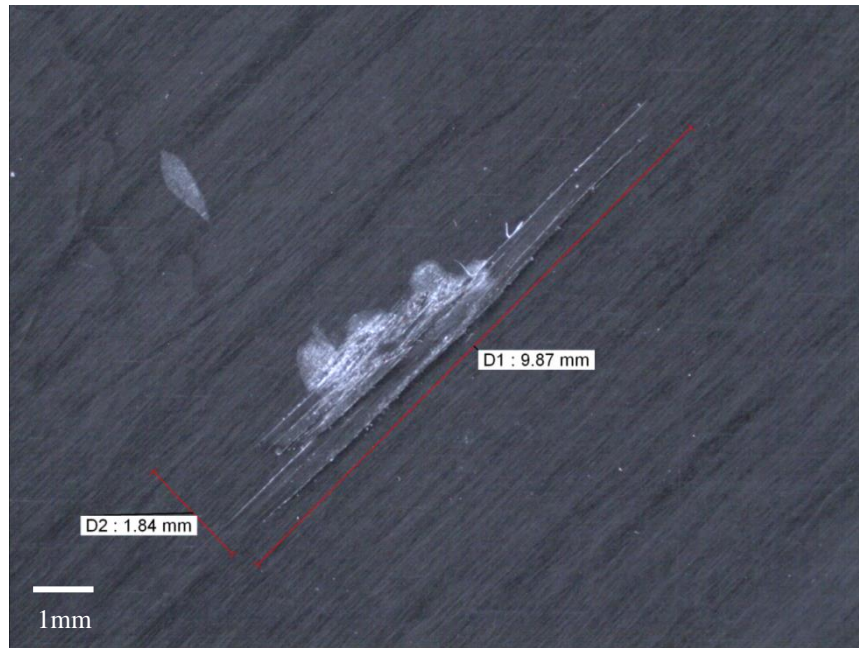
Figure 173 3QI4.5JS1 laminate's microscopic image with damage measurements

Again, for this laminate with 4.5J gas-gun impact, the damage is clearly visible in all tests. Crush damage together with cracks and fibre breakage can be observed in the microscopic image which can be validated by both pulsed and TSA inspection methods. However, it should be highlighted that the transient thermography data showed damage and maintained a profile as observed in the microscope, pulsed and TSA images. It was also observed that, due to the low energy of impact, the heat intensity at the back wall did not show a huge distinct rise as observed previously, but still sensitive enough to show the stress associated with the damage creation.

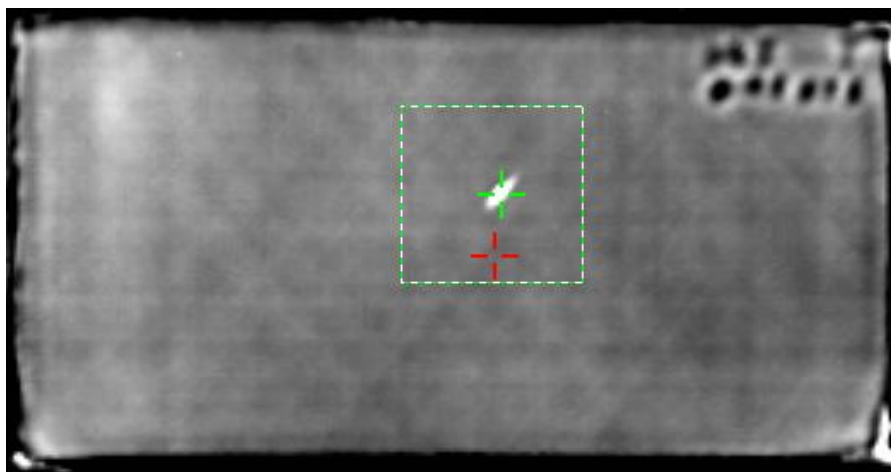
Figure 177 Pulsed thermography image; Sample: 3QI4.5JS1; Size: 200×100mm; 2D image; Sampling: 55fms
