A critical investigation of the use of infrared thermography
in determining the condition of composite materials

Submitted in partial fulfilment for the award of the degree of
Doctor of Philosophy

University of Wales Trinity Saint David

2017

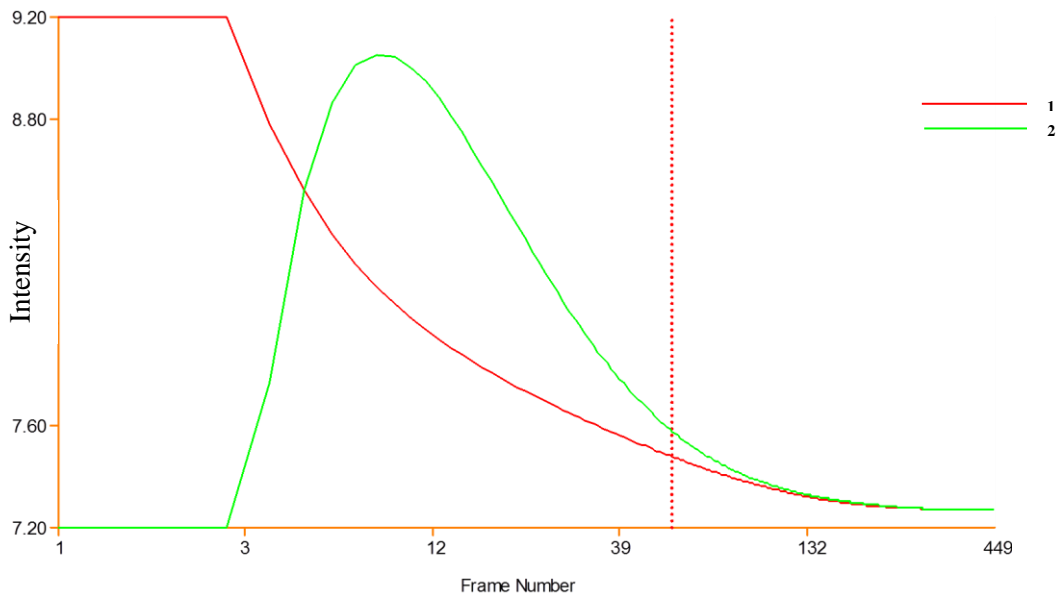
Figure 178 Pulsed thermography results; Sample: 3QI4.5JS1; Log t-T plot;
1 – sound area, 2 – damage area

Again, for this laminate with 4.5J gas-gun impact, the damage is clearly visible in all tests. Crush damage together with cracks and fibre breakage can be observed in the microscopic image which can be validated by both pulsed and TSA inspection methods. However, it should be highlighted that the transient thermography data showed damage and maintained a profile as observed in the microscope, pulsed and TSA images. It was also observed that, due to the low energy of impact, the heat intensity at the back wall did not show a huge distinct rise as observed previously, but still sensitive enough to show the stress associated with the damage creation.

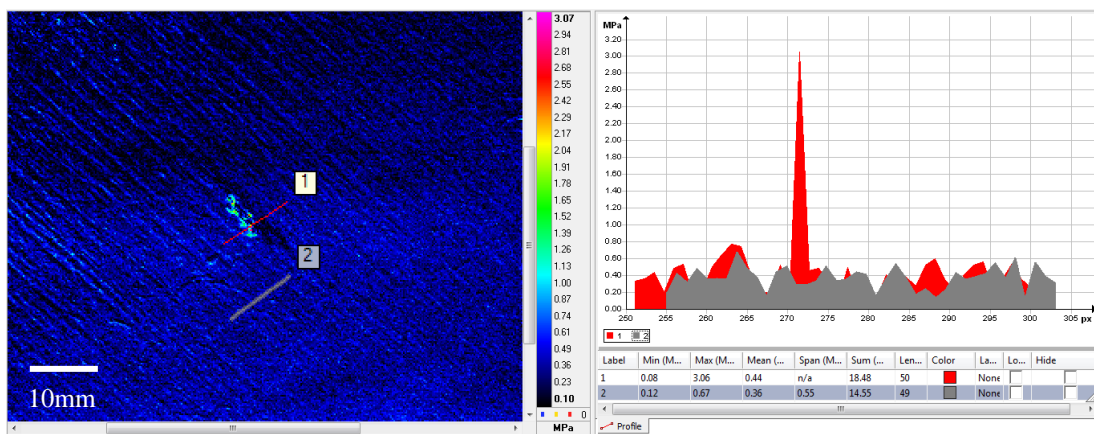
Figure 179 TSA stress map of 3QI4.5JS1 with a profile plot on the right

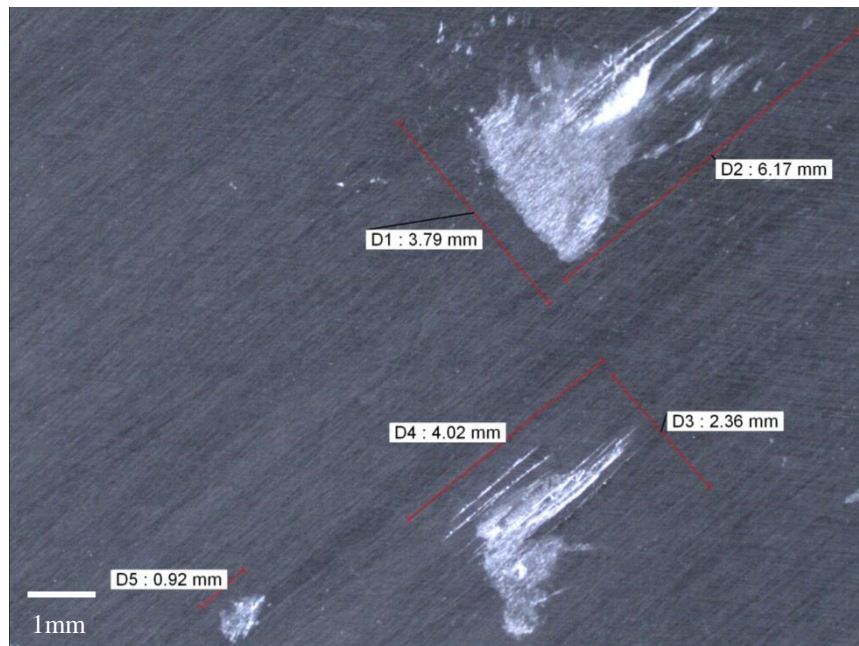
Figure 180 Microscopic image of 3TWI12JS3 laminate with damage measurements

The 3mm TWI laminate has shown some resistance to the 12J stone impact. Also the chip formed was much smaller when compared with that of the 3mm QI laminate. This can be evidenced by the transient thermogram results where the standard fibre stress characteristics observed in previous cases is missing. Moreover, a careful study revealed that there were secondary contact areas that appear at a low contrast in the data. The pulsed thermography system does struggle to identify the damage at the set frame indicating that the damage created was much shallower than the previous cases. This can be evidenced by looking at the 2D image at Frame 23 and Frame 55 to identify the damage created. Only the primary damage was picked up by the pulsed system, whereas the TSA system picked up the second damage (label 2) and is in line with the microscopic image.

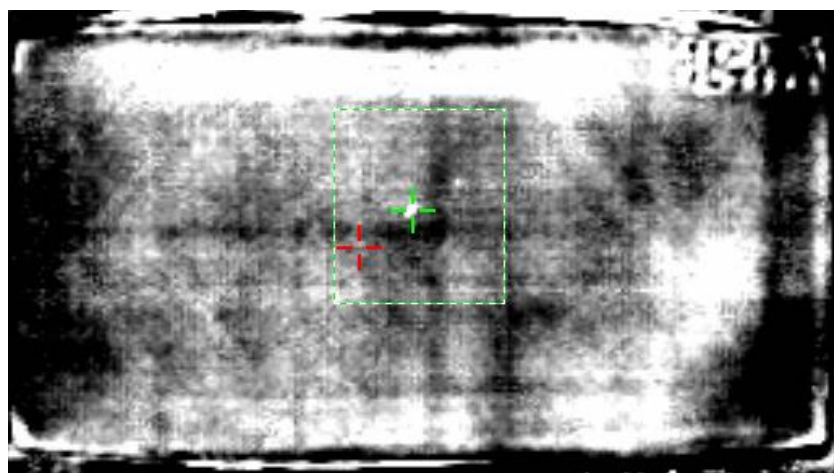
Figure 184 Pulsed thermography results; Sample: 3TWI12JS3; Size: 200×100mm; 2D image; Sampling: 23 fms

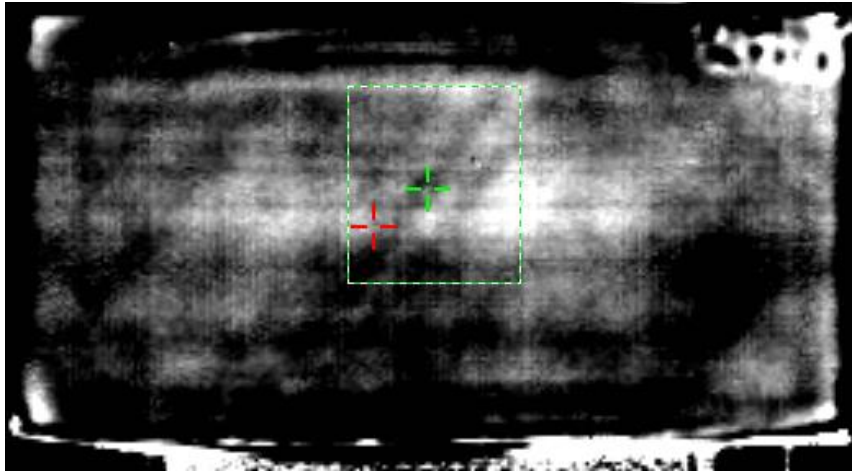
Figure 185 Pulsed thermography results; Sample: 3TWI12JS3; Size: 200×100mm; 2D image; Sampling: 55 fms

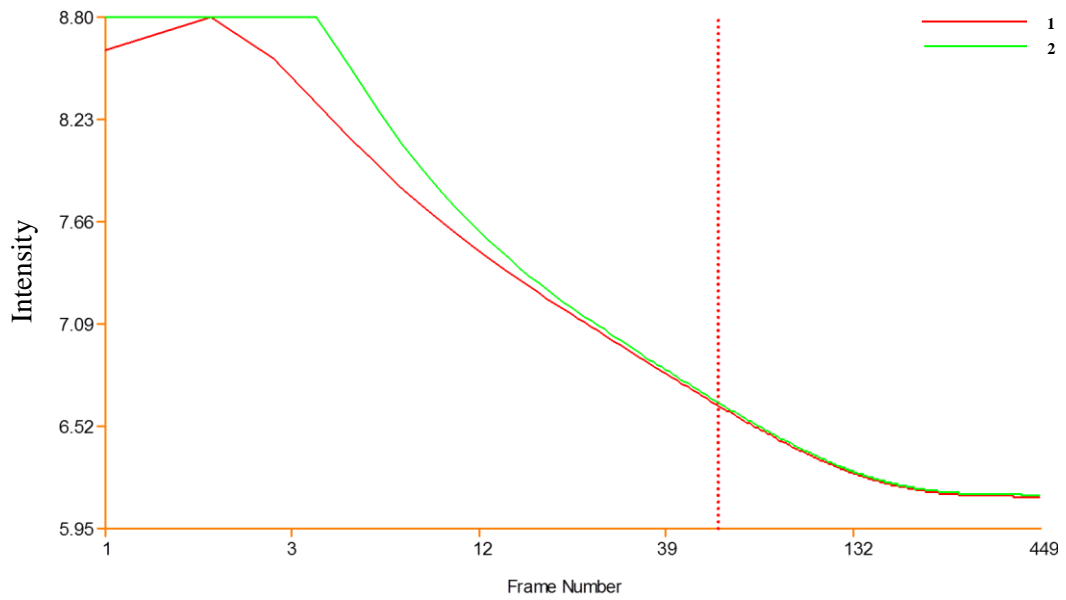
Figure 186 Pulsed thermography results; Sample: 3TWI12JS3; Log t-T plot; 1 – sound area, 2 – damage area

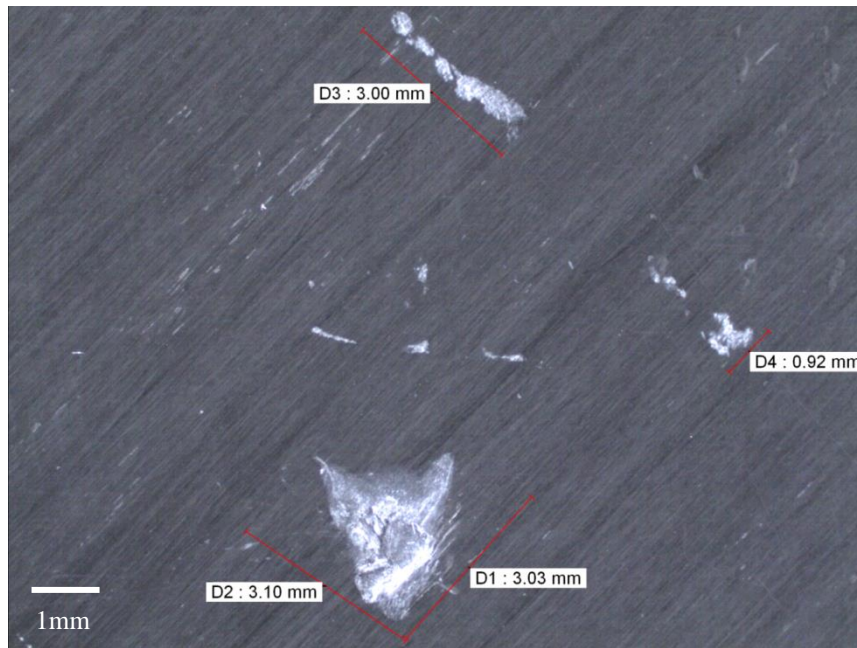
Figure 188 Microscopic image of 3TWI8JST1 laminate with damage measurements

From the above results, the following can be observed; the damage creation was confirmed from the transient thermography results. The pulsed data only presents the primary damage, as anticipated whereas the TSA stress map above clearly picked up indications of all damage and is in agreement with the microscopic image above.

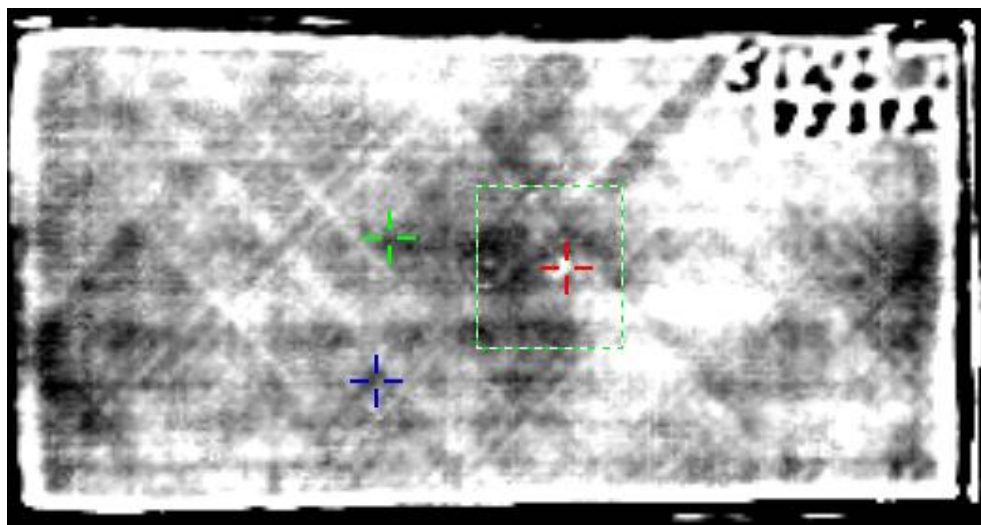
Figure 192 Pulsed thermography results; Sample: 3TWI8JST1; Size: 200×100mm; 2D image; Sampling: 39ms

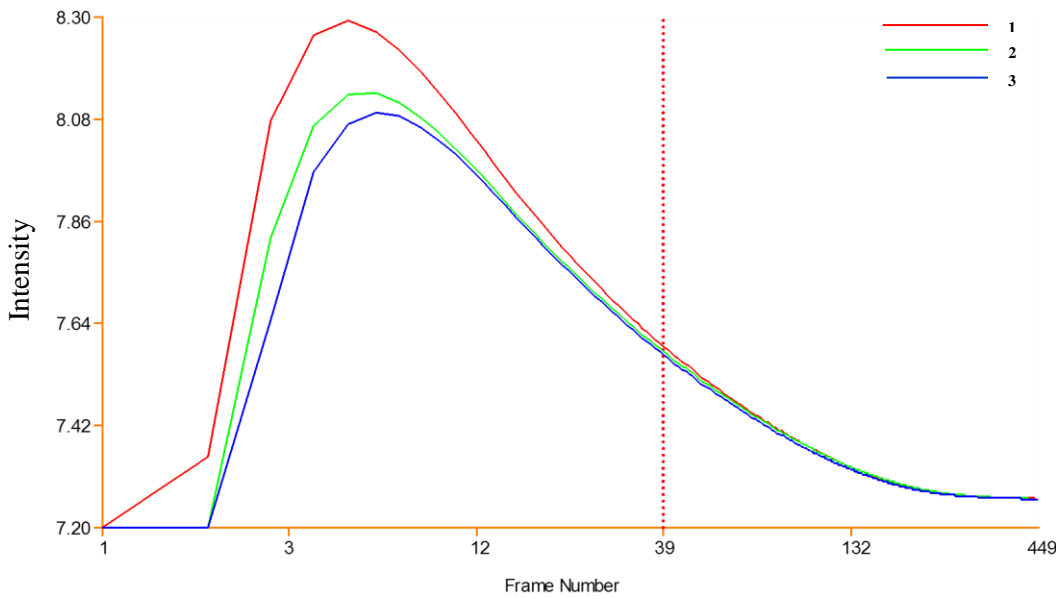
Figure 193 Pulsed thermography results; Sample: 3TWI8JST1; Log t-T plot;
1 – damage area, 2&3 – sound area

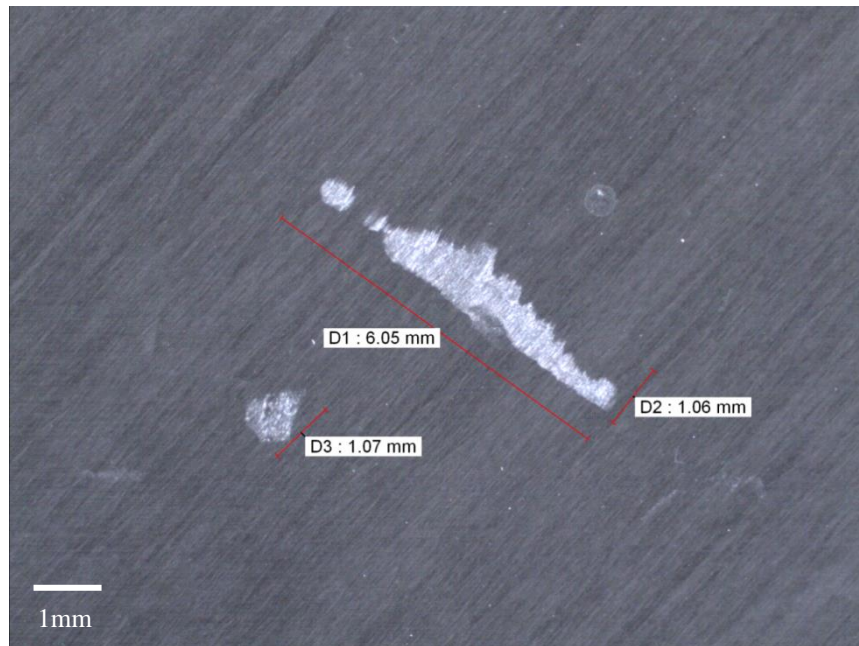
Figure 195 Microscopic image of 3TWI4.5JS3 laminate with damage measurements

The transient thermography results for the sample 3TWI4.5JS3 differ from the rest of the samples presented so far. The rise in temperature on the back surface is minimal and more evidence of the particles flying off from the front surface is noticed indicating the possibility that the stone used in this case disintegrated when it hit the laminate surface thus indicating that the damage created is minimal. The pulsed thermography results only indicated a low temperature rise at the damage location and hence were unable to characterise the damage. However, the TSA method acquired promising results where the damage is clearly picked up. The

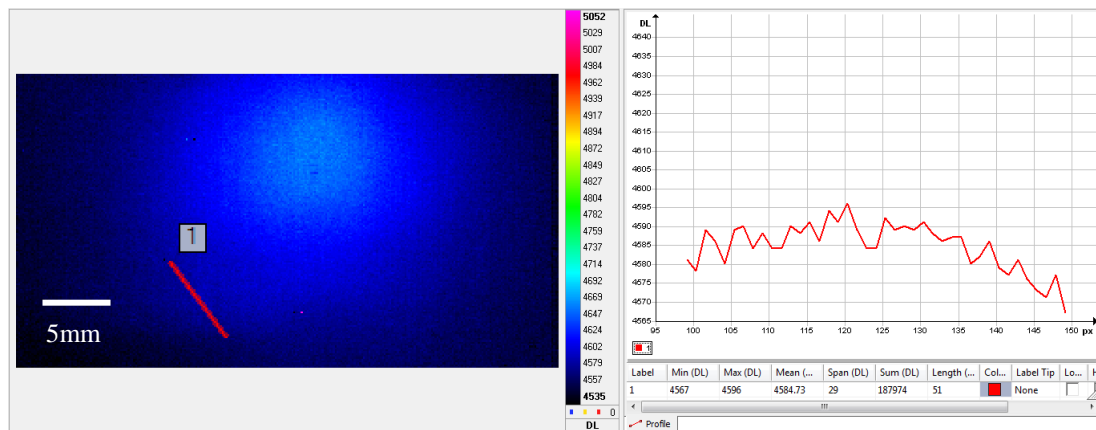
Figure 196 Sample: 3TWI4.5JS3 at Frame - 0

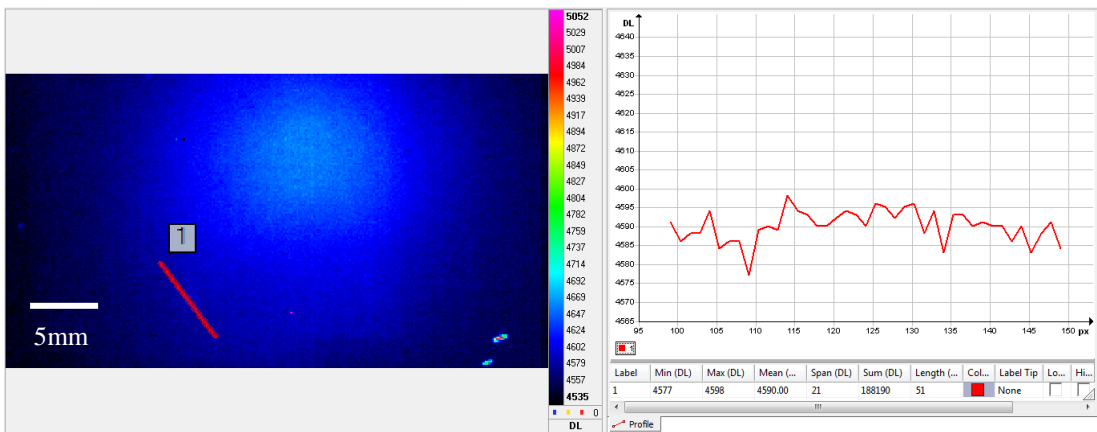
Figure 199 Sample: 3TWI4.5JS3 at Frame - 15

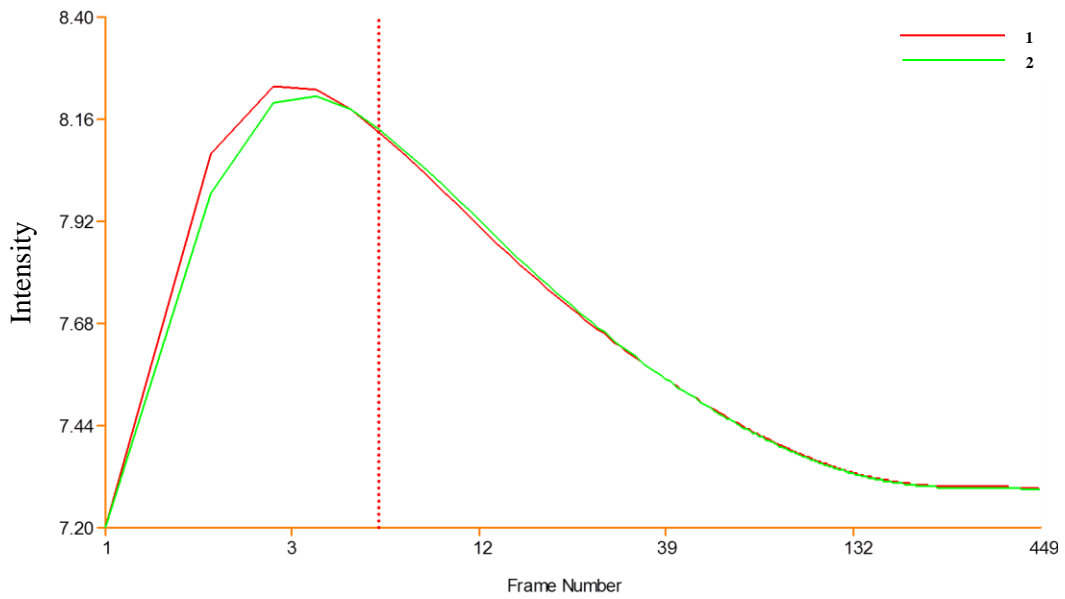
Figure 202 Pulsed thermography results; Sample: 3TWI4.5JS3; Log t-T plot;
1 – damage area, 2 – sound area

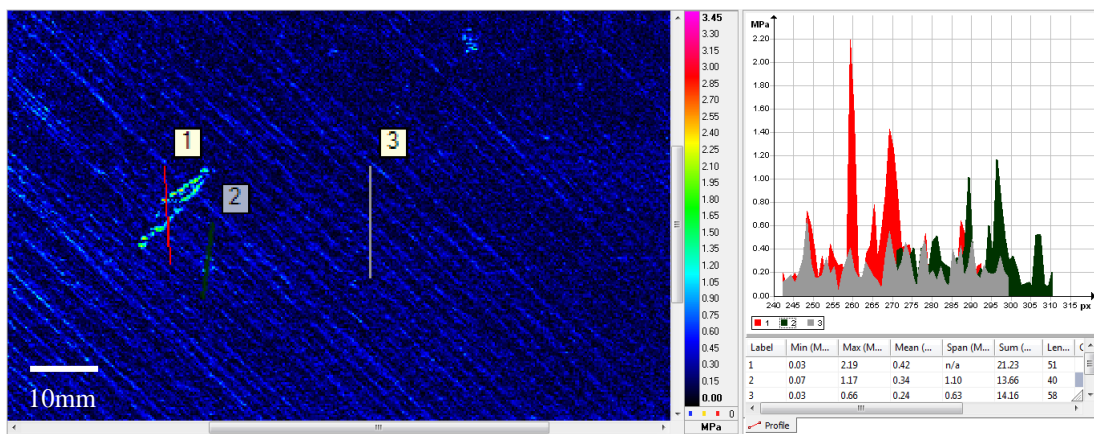
Figure 203 TSA stress map for 3TWI4.5JS3 with profile plot on the right

improved sensitivity of the system meant, even a superficial damage that has not shown any crush or fibre breakage has now been picked up – as indicated in the image above (Figure 203).

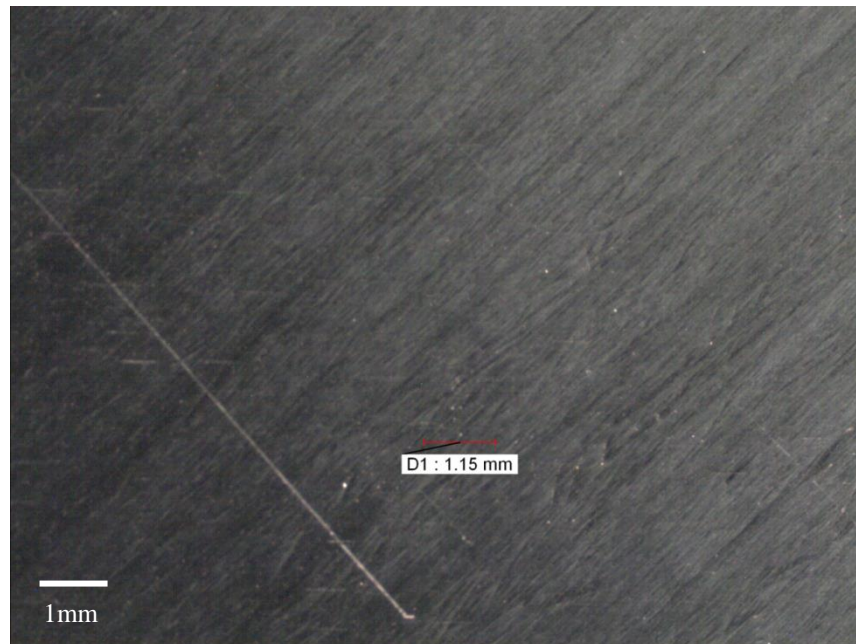
Figure 204 Microscopic image of 6QI20d12JC3 laminate with damage measurements

The results obtained for the sample 6QI20d12JC3 showed a low contrast indication of the damage area as seen in the microscopic image above. The transient results did not show any temperature rise in any of the 3 trials carried out on similar samples. Further, neither the pulsed nor the TSA method yielded any promising information that would characterise the damage, indicating that the impact energy was entirely absorbed by the laminate itself and thus the shock wave did not produce any noticeable damage. This is mainly due to the strength of the laminate and its impact resistance properties. The only way this could be classed as damage is by performing mechanical tests such as compression after impact or interlaminar shear tests to measure the drop in material strength.

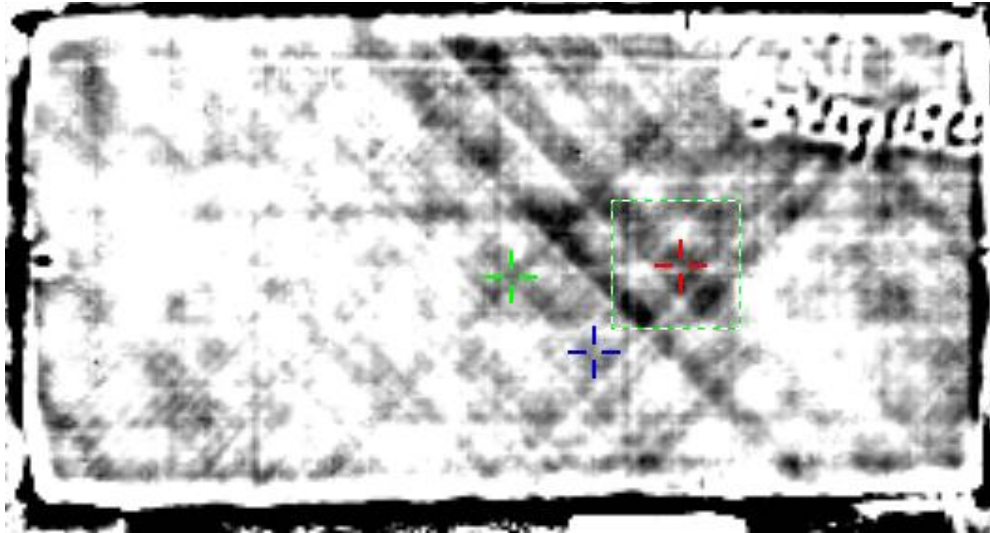
Figure 205 Pulsed thermography results; Sample: 6QI20d12JC3; Size: 200×100mm; 2D image; Sampling: 55 fms

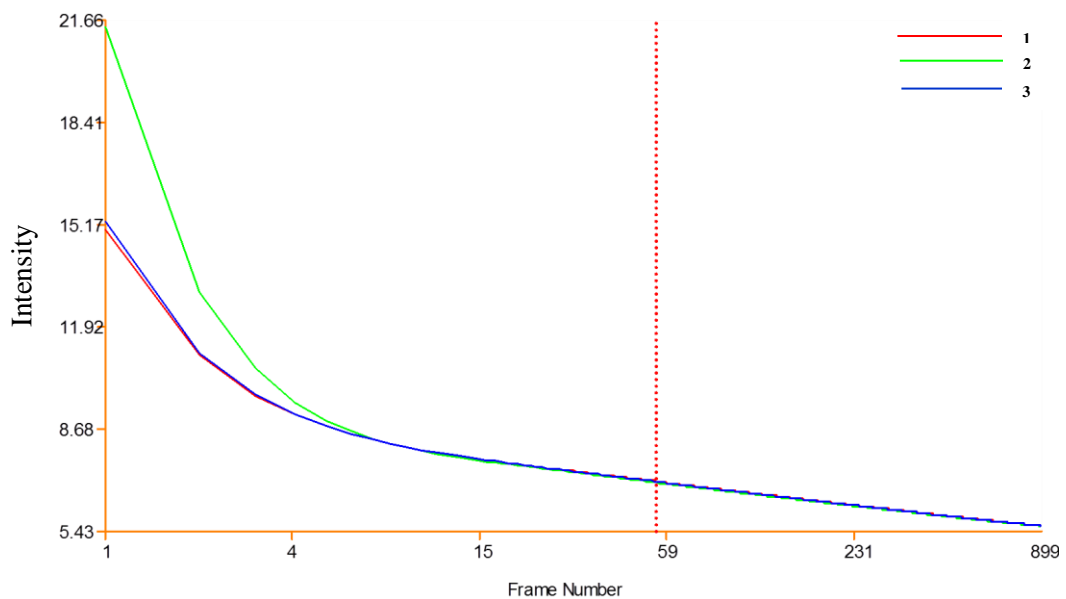
Figure 206 Pulsed thermography results; Sample: 6QI20d12JC3; Log t-T plot; 1 – damage area, 2&3 – sound area

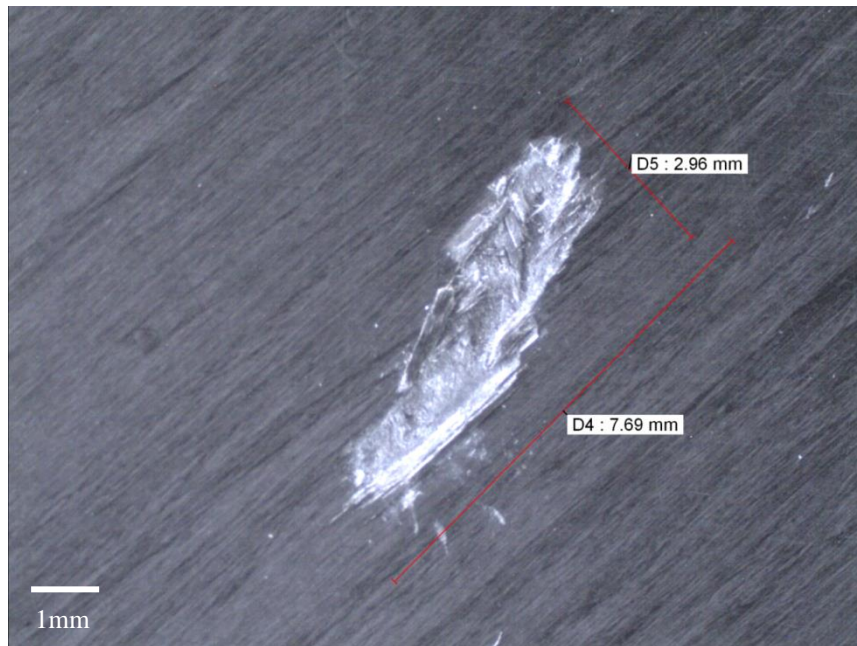
Figure 207 Microscopic image of 6QI12JS1 laminate showing damage area 1

The ballistic impact on 6QI12JS1 laminate showed two damage areas as seen in the microscopic image above. Further the damage was picked up by both pulsed and TSA thermography methods. It was observed that the thermal stress intensity from the TSA results showed less contrast due to the low severity of the damage itself. This can be validated through the reduction in the stress values complementing the impact resistance of the laminate.

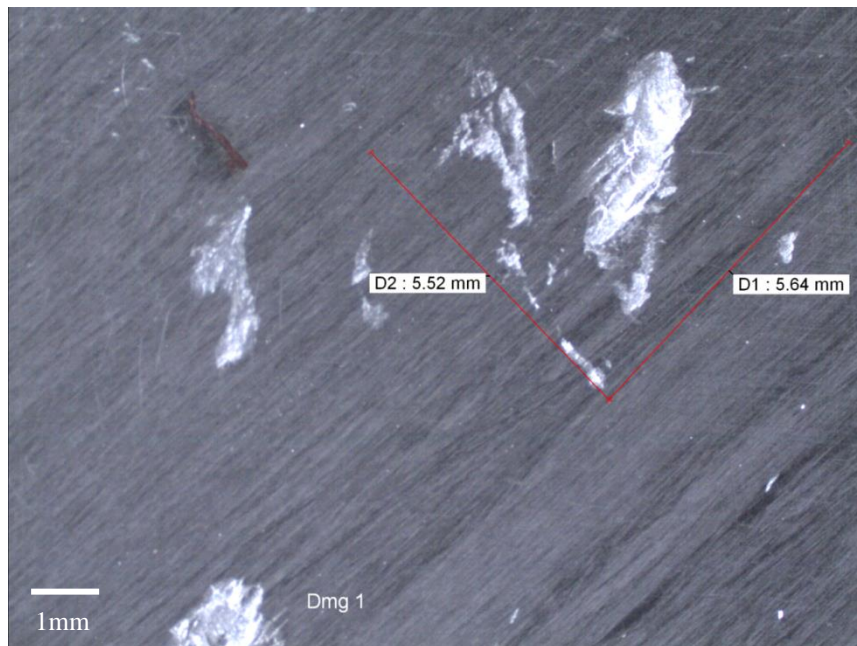
Figure 208 Microscopic image of 6QI12JS1 laminate showing damage area 2

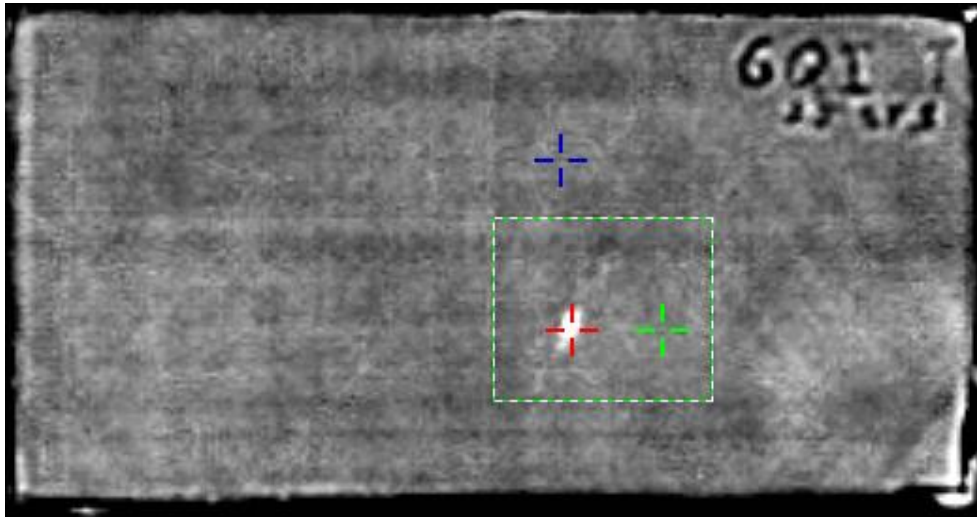
Figure 209 Pulsed thermography results; Sample: 6QI12JS1; Size: 200×100mm; 2D image; Sampling: 17 fms

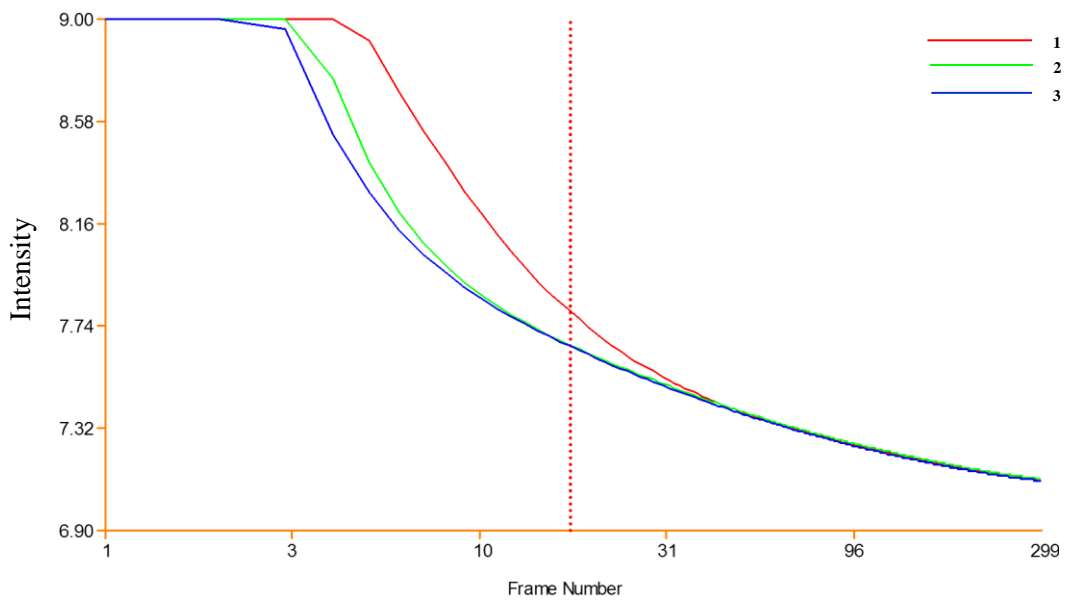
Figure 210 Pulsed thermography results; Sample: 6QI12JS1; Log t-T plot; 1 – damage area, 2&3 – sound area

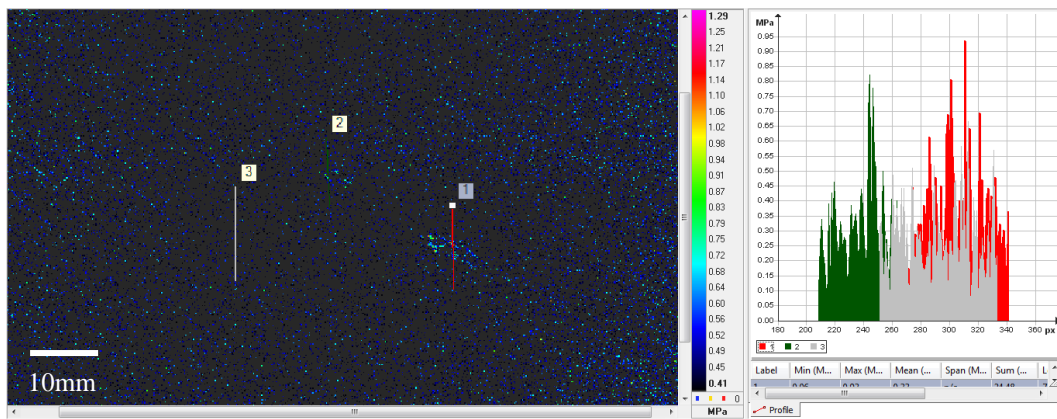
Figure 211 TSA stress map for 6QI12JS1 with profile plot on the right

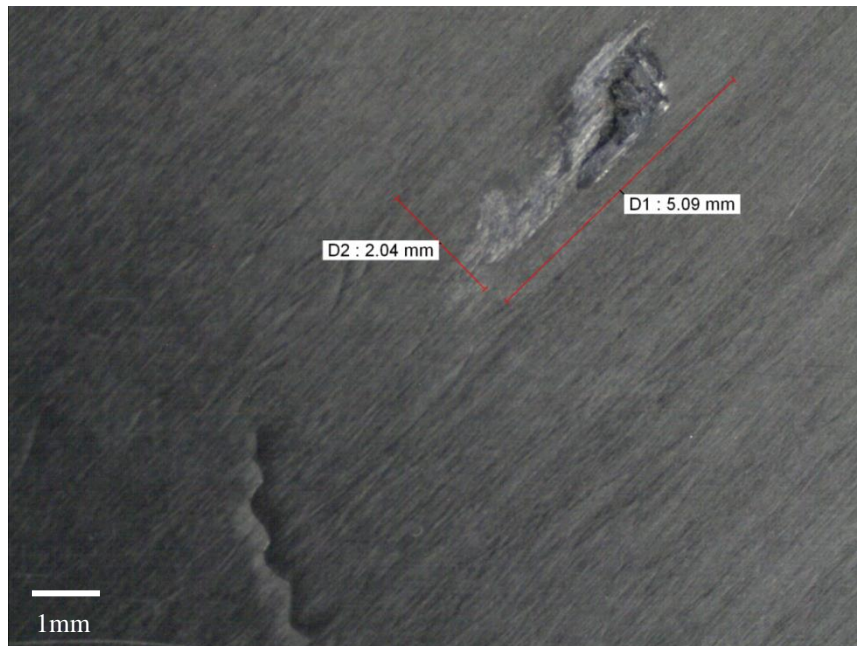
Figure 212 Microscope image of 6QI8JS1 with damage measurement

The above results detect the damage created on 6QI8JS1 laminate when subjected to an 8J ballistic impact test. Both pulsed thermography and TSA methods have detected the damage.

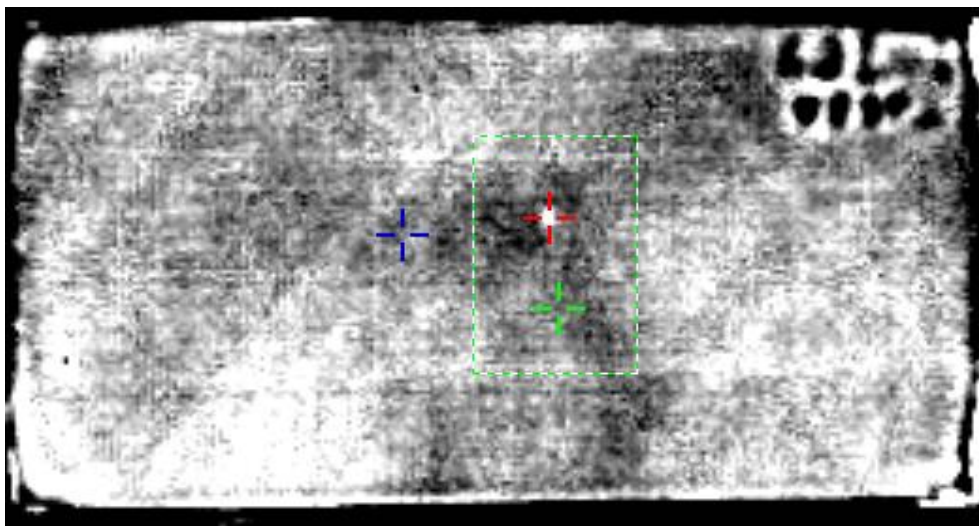
Figure 213 Pulsed thermography results; Sample: 6QI8JS1; Size: 200×100mm; 2D image; Sampling: 23 fms

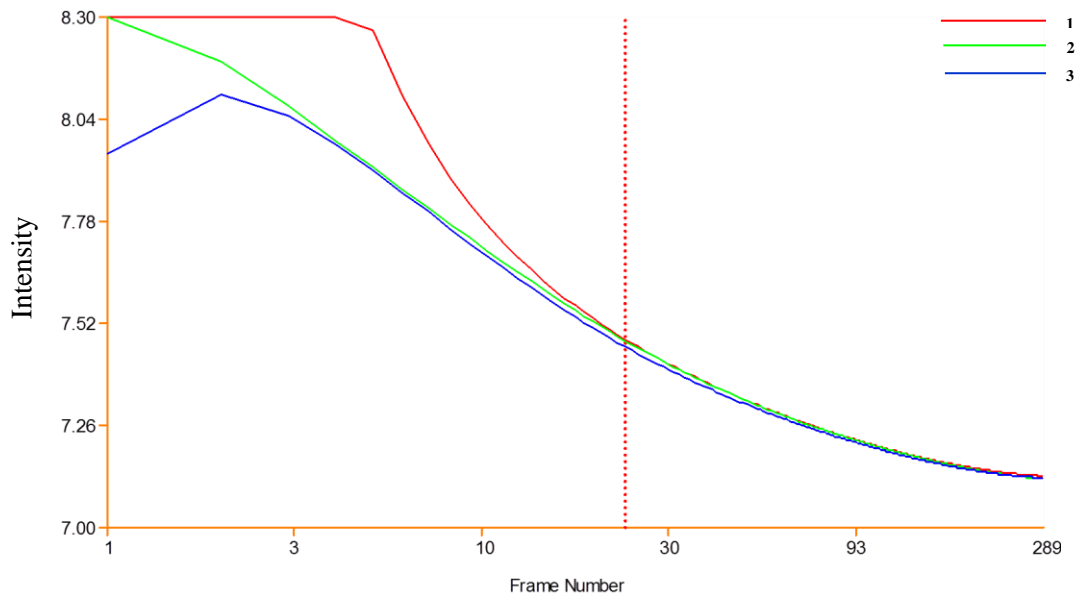
Figure 214 Pulsed thermography results; Sample: 6QI8JS1; Log t-T plot
1 – damage area, 2&3 – sound area

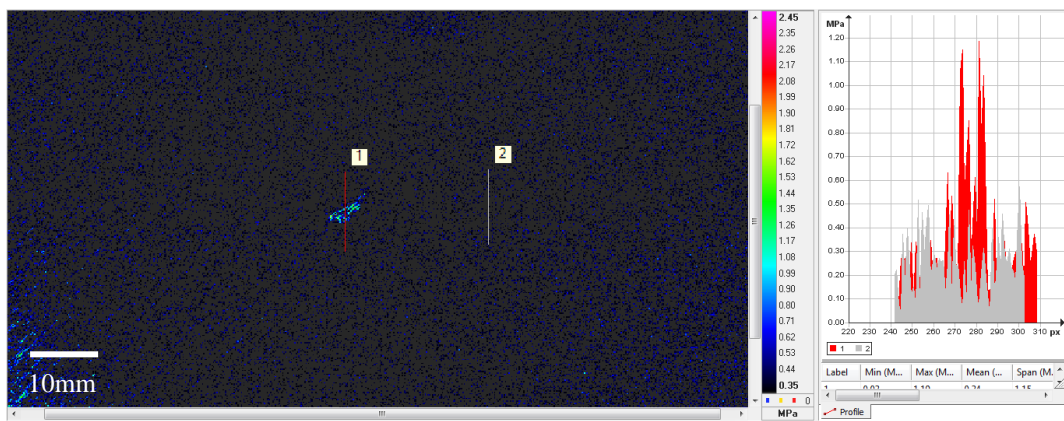
Figure 215 TSA stress map for 6QI8JS1 with profile plot on the right

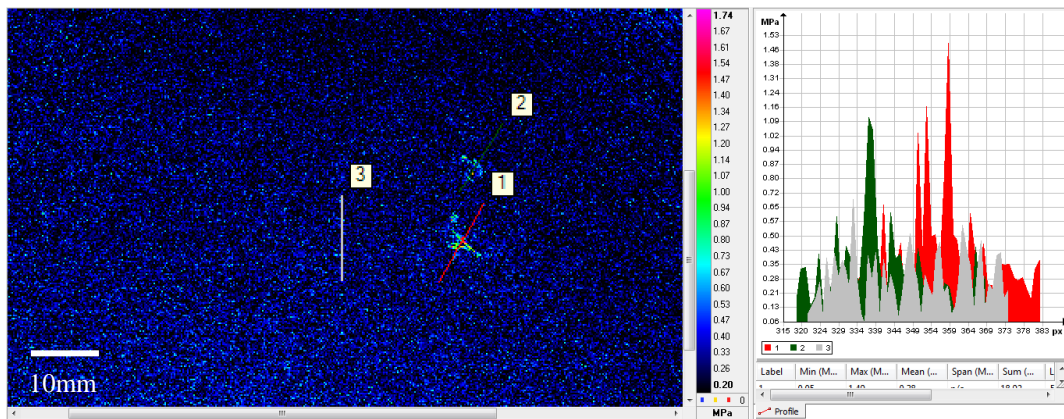
Figure 217 TSA stress map for 6QI4.5JS3 with profile plot on the right

The pulsed thermography inspection did not detect the created impact damage as the damage dimension was much smaller and no serious surface damage was observed. However, the TSA method showed promising results where all near surface damage

were detected, as seen from the TSA stress map above (Figure 217). Further the results clearly showed the localised stress concentration that cracks were formed and may be classed as damage thus proving the applicability of TSA method.

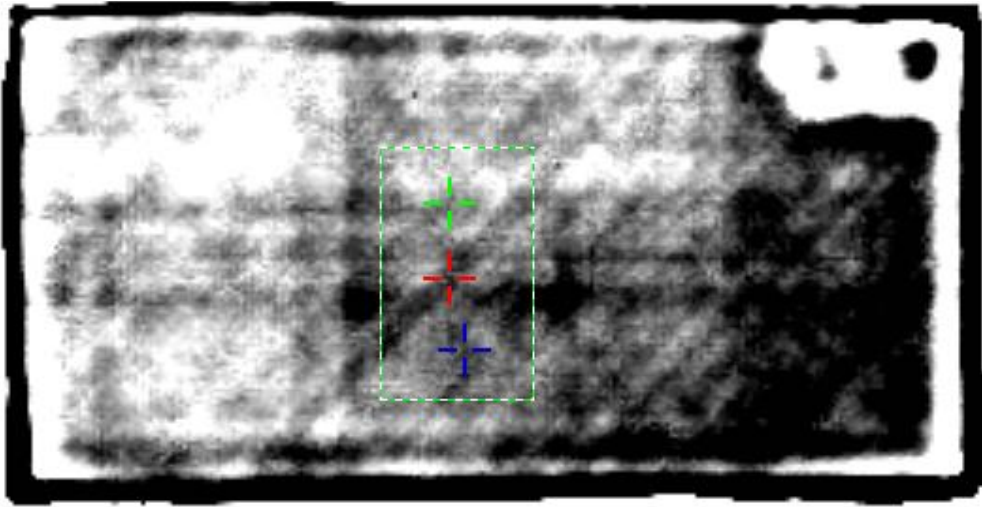
Figure 219 Pulsed thermography results; Sample: 6TWI12JS1; Size: 200×100mm; 2D image; Sampling: 44 fms

As before, the 12J stone impact on the 6mm TWI laminates did not produce any temperature rise on the back wall as seen in the case of the 3mm laminates. The damage created also varied across different laminates for the same energy level. The data presented in Figure 219 and Figure 220 only picked up low contrast indication of the damage. This again concurs with the previous statements that the stone disintegrated before passing on the impact energy and that the laminate was showing better impact resistance characteristics. The TSA image picked up the damage easily.

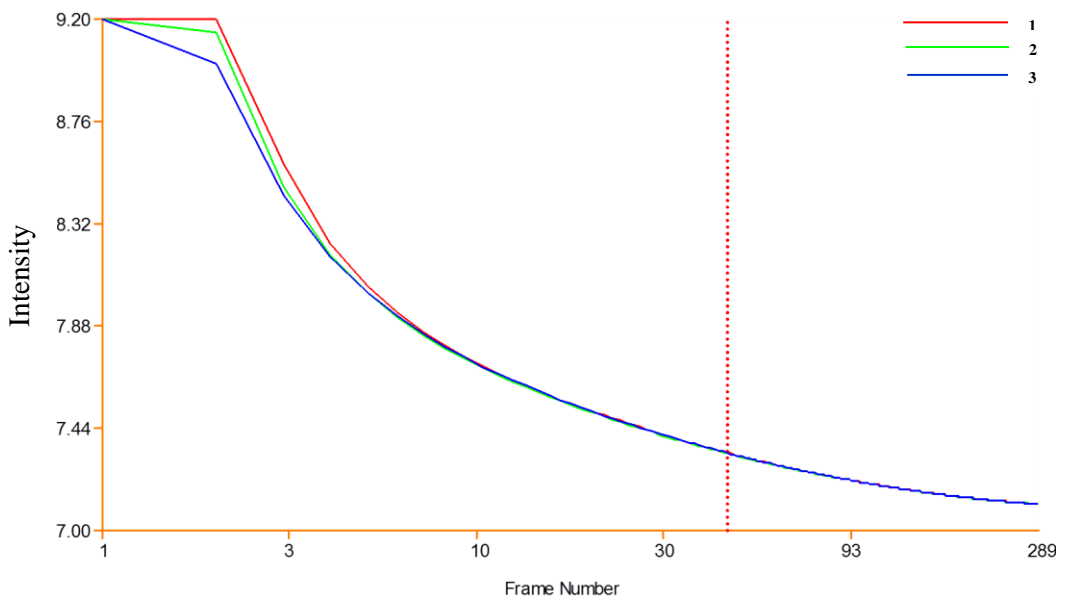
Figure 220 Pulsed thermography results; Sample: 6TWI12JS1; Log t-T plot; 1 – damage area, 2&3 – sound area

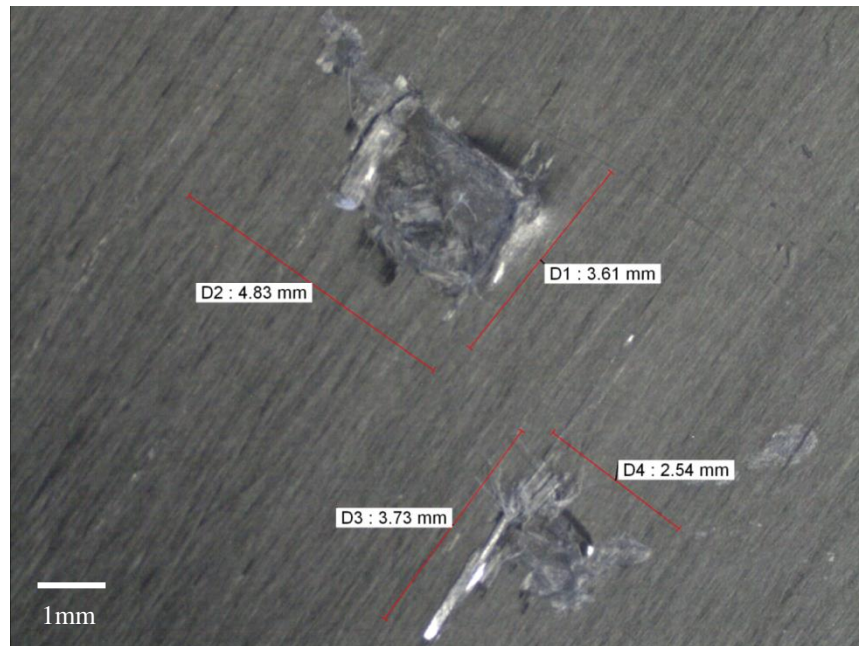
Figure 222 Microscope image of 6TWI8JS1 with damage measurements

In the case of the 8J impact both the pulsed and TSA thermography methods identified damage easily. The TSA image coincides with the microscopic visual image thus confirming the creation of damage due to impact.

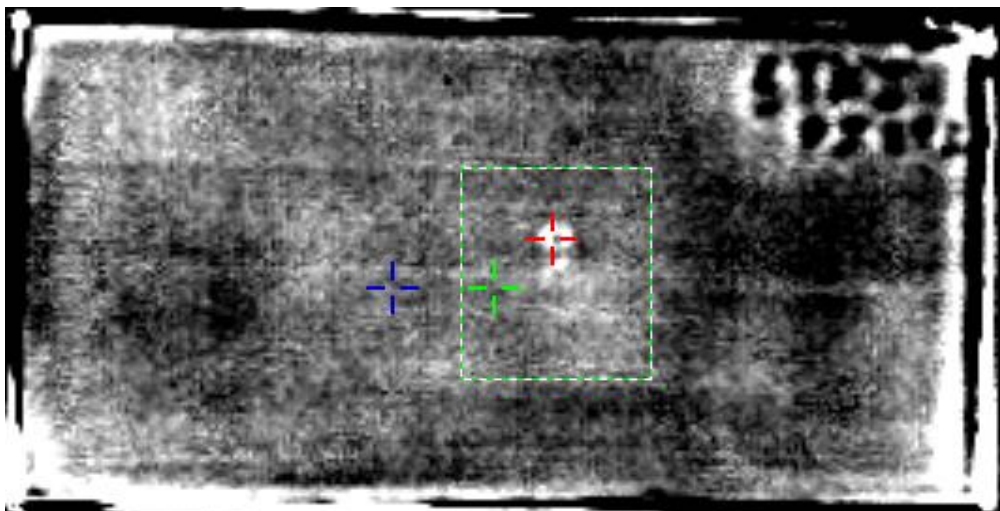
Figure 223 Pulsed thermography results; Sample: 6TWI8JS1; Size: 200×100mm; 2D image; Sampling: 24 fms

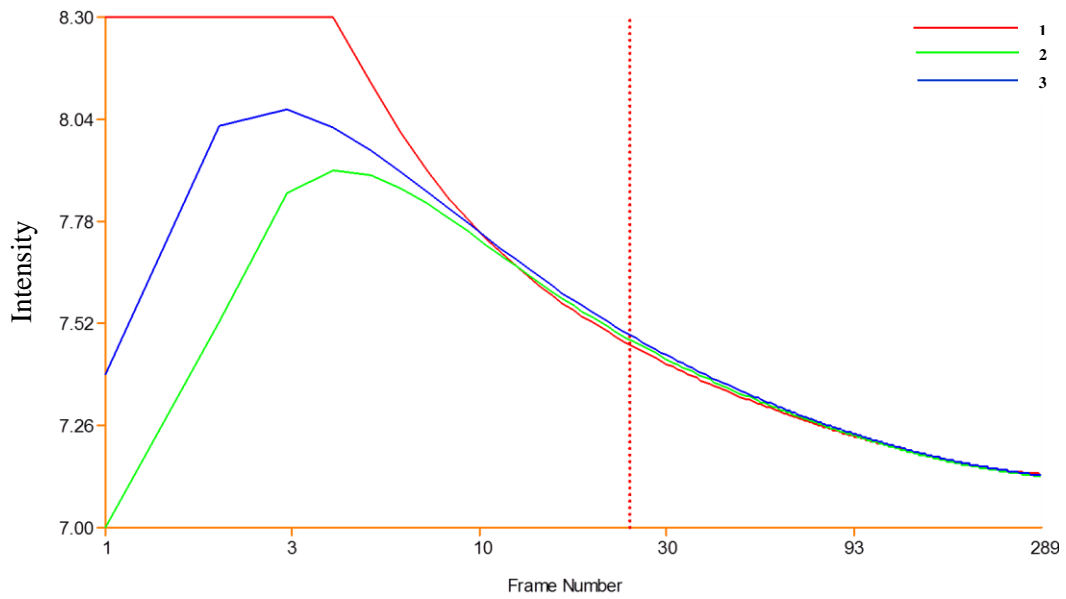
Figure 224 Pulsed thermography results; Sample: 6TWI8JS1; Log t-T plot;
1 – damage area, 2&3 – sound area

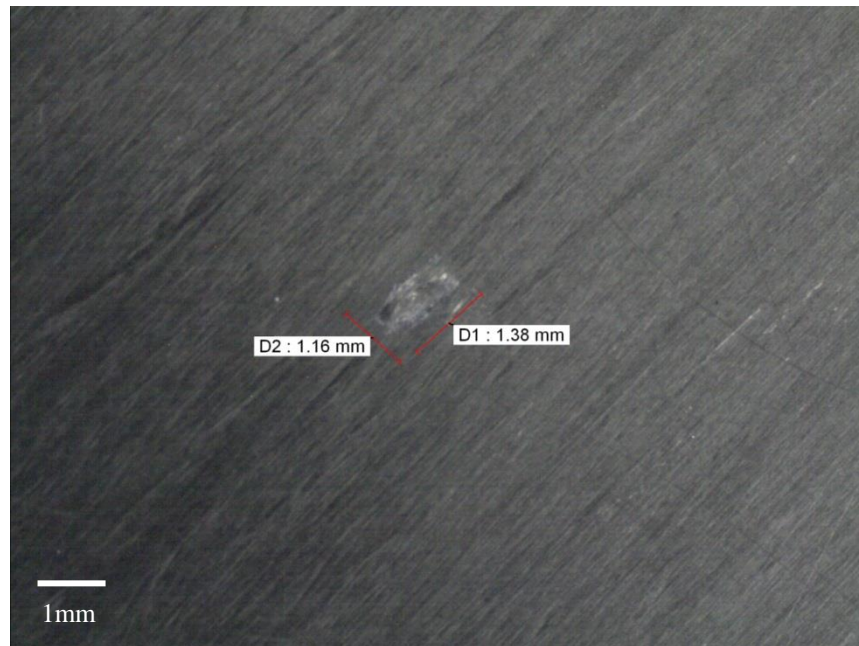
Figure 226 Microscope image of 6TWI4.5JS2 with damage measurements

For the 4.5J impact, the damage created was so small that the pulsed system did not pick up any damage indications. However, the TSA method picked up the damage. It should be noted that the intensity of the damage identified by the TSA method is far less sensitive than the microscopic image. The TSA data still confirms the creation of the damage.

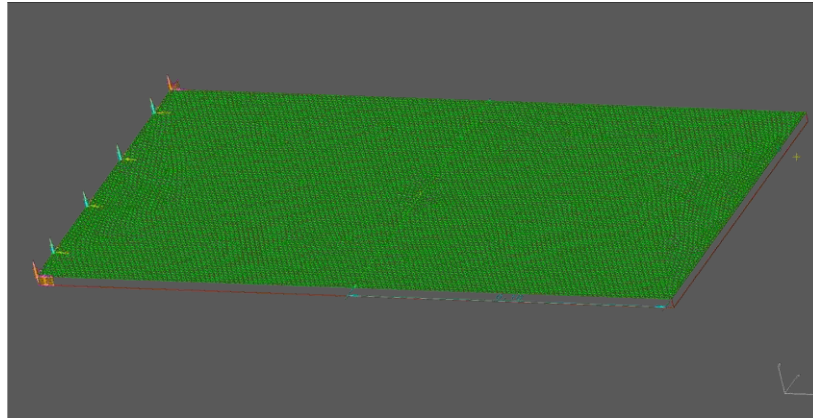
Figure 228 Mesh model of virgin CFRP laminate; Size: 200×100×3mm

As seen in Figure 228 and Figure 229, only one edge was restrained and normal mode dynamics analysis was used to determine the modal frequencies of both the virgin and damage plate. The following are the results obtained on solving the above model.

Similar to the theoretical modelling as presented in section 4.2.2, a Finite Element Method (FEM) solver was used to simulate the vibrational analysis study to determine if there is any shift in modal frequency of certain vibrational modes due to the presence of damage. The geometric model was designed in the Siemens NX-Ideas package and a mesh density of 10 elements to resolve for damage. For the model, the material properties of CFRP and air gap were used (as per Appendix 7). As before the CFRP material was assumed to be homogeneous. The samples with and without damage were designed to match a 3mm laminate and had the dimensions 200×100×3mm. The only difference between the no-damage or virgin plate and the plate with damage was a centre cut out from the sample. The dimensions of the cut-off are 20×2.5×3mm.

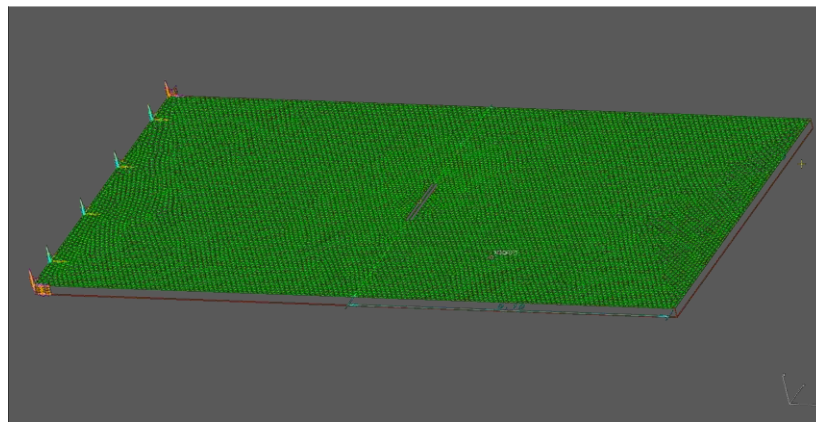
Figure 229 Mesh model of CFRP laminate with centre cut-off; Size: 200×100×3mm; Cut-off size: 20×2.5×3mm

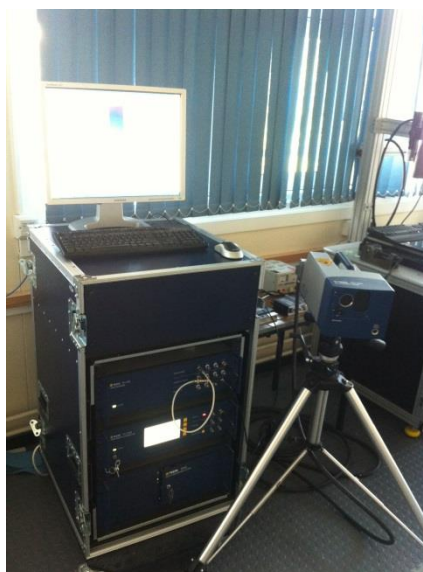
Figure 230 The Polytec PSV400 Laser Doppler Vibrometer

Figure 230 and Figure 231 show the test setup used for the LDV measurement. It can be seen that the sample is clamped on the lower end using a bench vice and the bench top electro-dynamic is located on the top end of the laminate being inspected. The samples were then marked to show the vice grip area so that the sample could be re-introduced into the vice at the same level. Care was also taken to make sure the same number of turns was used to secure the sample in place. However, due to the abstract nature of the test setup, the random error that may be caused during every loading and unloading of the sample needs to be estimated to increase the accuracy of measurement.

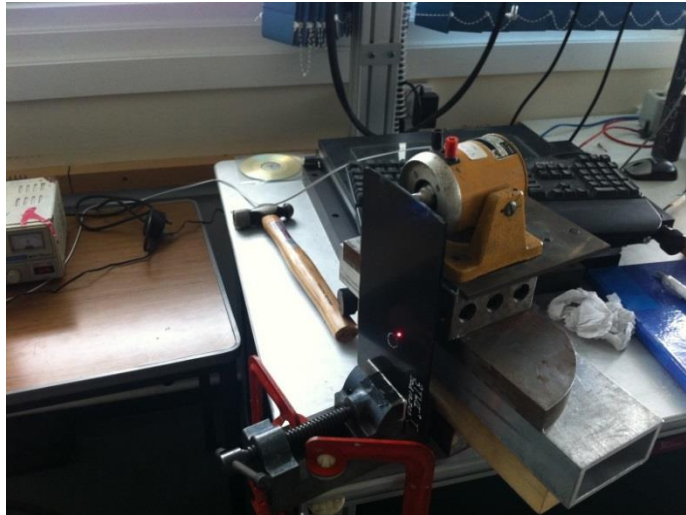
Figure 231 Test sample for the LDV measurement, clamped to a bench vice. This image also shows the laser spot on the sample together with the bench top shaker

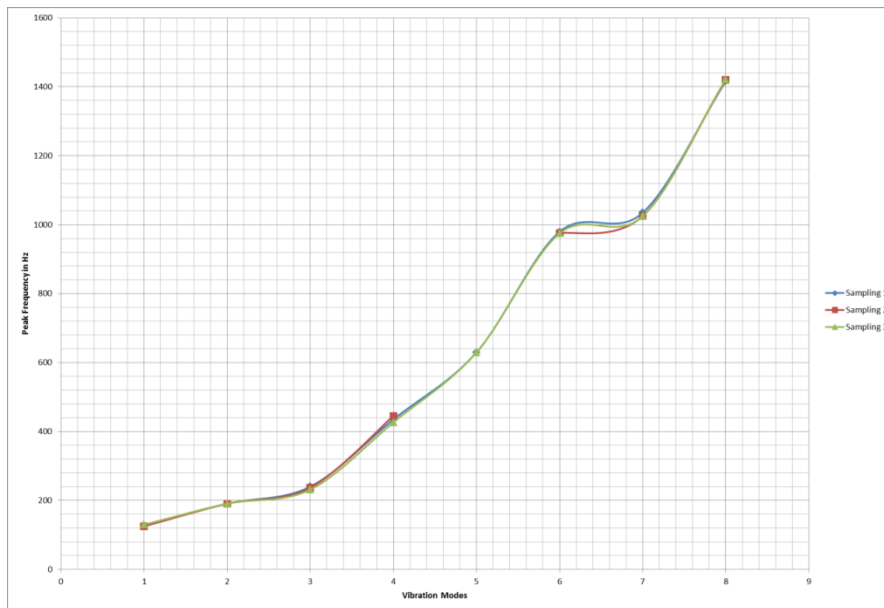
Figure 232 Graph showing the averaged trials under each loading and analysing at 8 modal frequencies

The above results were derived from looking at modal frequency images to establish the error in the LDV measurements. For this exercise, only the 1st trial from the first loading condition has been used to isolate 8 modal frequencies. The following are the 8 modes identified for this analysis.

It can be seen that 5 out of 8 modal frequencies were found to be either same or within a difference of $\pm 5\text{Hz}$. It should be noted that mode 5 wasn't considered for this error identification as sampling 2 did not identify the peak modal frequency. It should be noted that the sample used here was a post Charpy impact sample 3TWI20d12JC3T.
