A critical investigation of the use of infrared thermography
in determining the condition of composite materials

Submitted in partial fulfilment for the award of the degree of
Doctor of Philosophy

University of Wales Trinity Saint David

2017

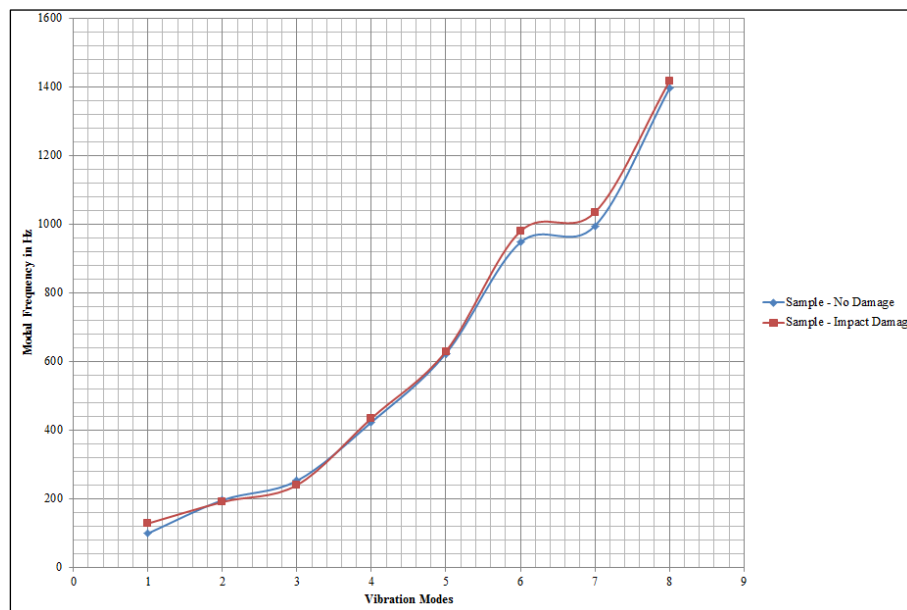
Figure 241 Vibration Modes vs modal frequencies (average values) of the laminate before and after impact

It can be observed from the table (Table 32) that modes 1, 6, 7, 8 show a change in frequencies between 20Hz and 40Hz. Though there is a small change in frequencies between modes 2, 3 and 4, they weren't considered for this analysis as they were within the margin of the random error estimation of ± 5 Hz. It is also worth

Based on the random error in experimental data capture of $\pm 5\text{Hz}$, it can be noticed that the difference in modal frequencies is greater than 25Hz confirming the hypothesis that this modal frequencies change is due to the presence of damage and is in line with the theoretical model. It should be noted that in order to establish the damage created, the random error measurement was performed on the damaged laminate to capture the maximum variation due to the presence of the damage.

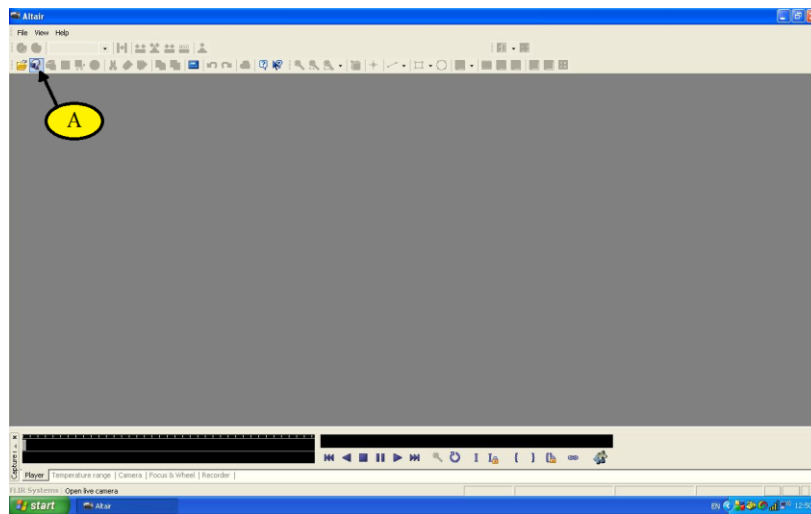
Figure 242 Altair software interface

1. Turn ON the camera and the laptop. Make sure that the data transfer card is in position and the camlink cable is connected to the camera and the laptop.
2. Allow the camera to settle down before opening the Altair software.
3. Open the Altair software and choose the working directory.
4. Click the LIVE camera icon (A) in the Altair window for the laptop to communicate with the camera and open a Live image window.

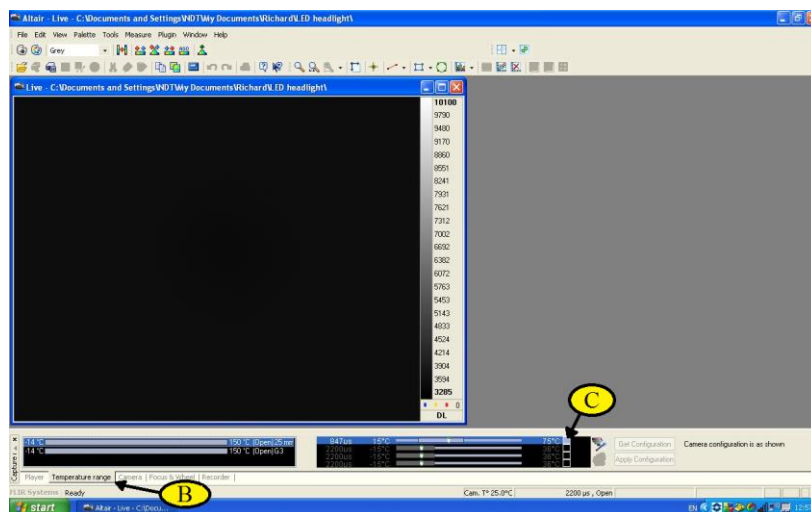
Figure 243 Altair software with camera live feed

5. At the bottom of the software window, make sure to check the Temperature tab (B) and click on an existing NUC table (C)

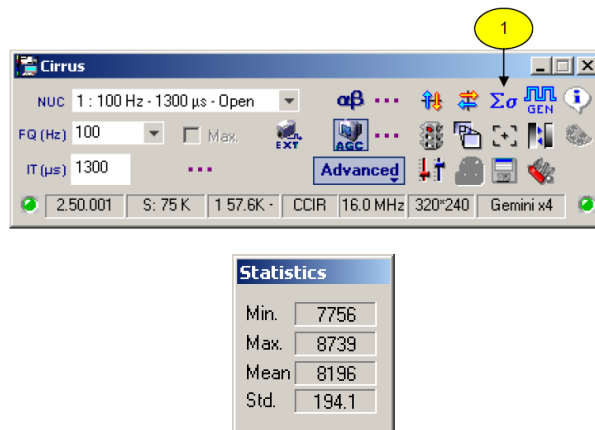
Figure 244 Cirrus Control interface with digital temperature level window

6. Use the Temperature tab and select the appropriate temperature range.
7. To set the overall temperature range of the camera, move the slider in the NUC selection to match the operating environment's temperature. Make sure to note the Integration time.
8. Now set the temperature on the "Live" window of the camera to the operating (Working environment) temperature and make a note of the digital temperature reading. The temperature scale can be changed between digital and Celsius degree scale by clicking on the DL tab just below the temperature scale.
9. Use the windowing tab in the bottom tool bar to window down the pixel size of the image. Define the size of the window for custom settings.
10. Minimize the Altair software window and start the CIRRUS software.
11. Now click the tab marked " $\Sigma\sigma$ "(1) to show the digital level – DL for the camera.

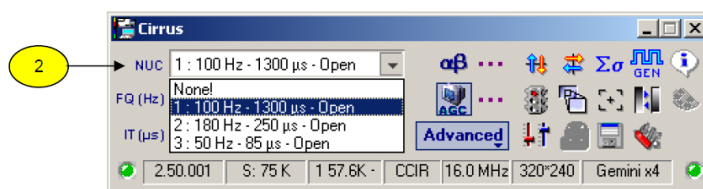
Figure 245 Cirrus control window

12. The main screen now shows the current NUC applied to the camera (2)

- i. The current setting for the camera in this case is
 - a. Frequency – 100Hz

- b. Integration time - 1300 μ s
 - c. Filter – No filter
- ii. Depending on the camera there will be 3 – 6 NUC values. “None” indicates no correction is applied and “Open” mean that there is no filter applied to the camera.

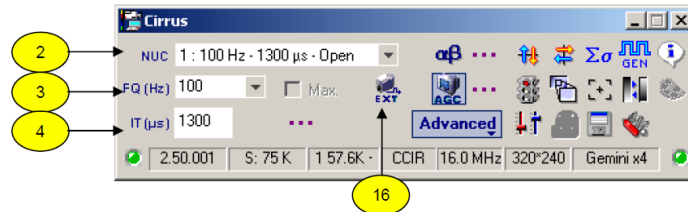
Figure 246 Cirrus control window with annotations

13. Now carry out the following steps to input settings to the CIRRUS software.
- a. Select the NUC to replace from the available list (2)
 - b. Select an appropriate frequency. (3) This should be noted even when it does not affect the main work area
 - c. Specify the integration time (IT) (4) which was noted previously from the Altair software
 - d. Leave the Filter Wheel window option as Open as there are no filters applied in this case.
 - e. Click “ $\alpha\beta$ ” to update NUC & BPR (Bad Pixel Replacement) settings (5)

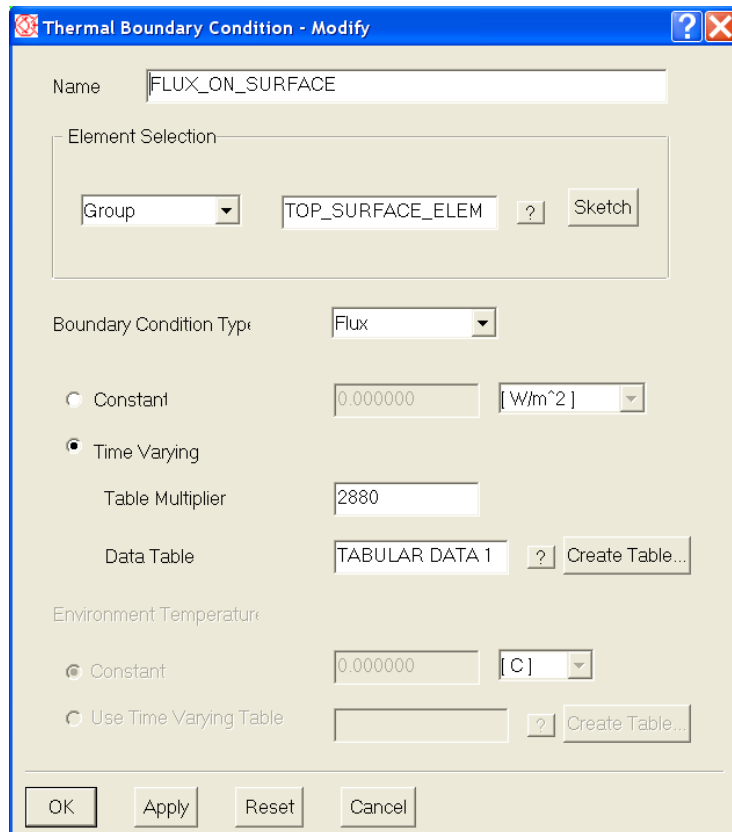
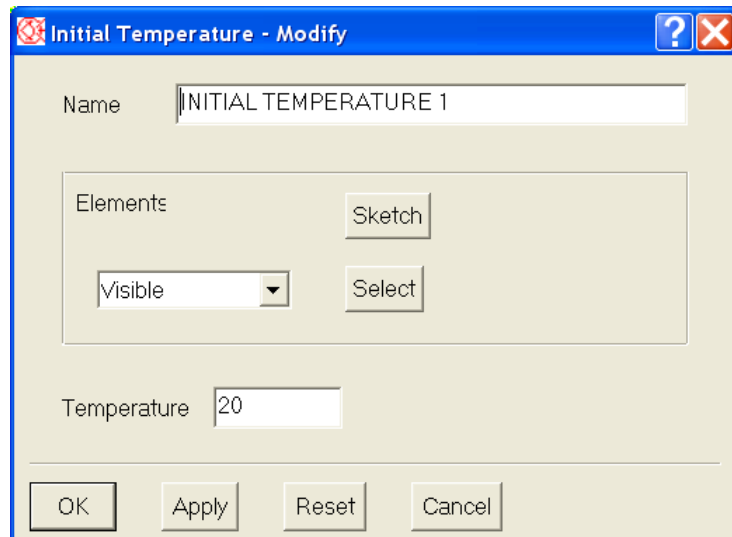
Applied thermal boundary conditions:

The following are the snapshot of the modelling process together with boundary conditions used for running the Ideas solver.

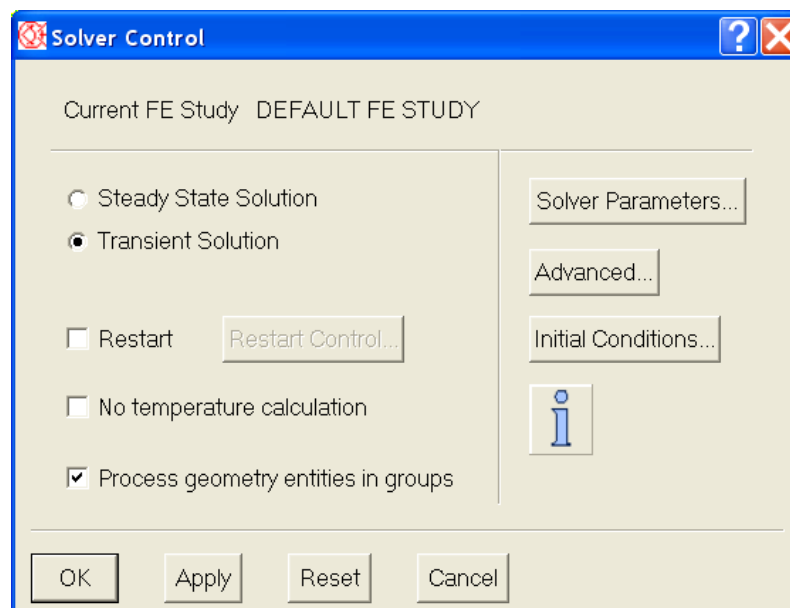
Solver control parameters:
